SLOPE STABILIZATION AND PERFORMANCE MONITORING
OF I-35 AND SH-183 SLOPES USING
RECYCLED PLASTIC PINS

MASTER OF SCIENCE IN CIVIL ENGINEERING

THE UNIVERSITY OF TEXAS AT ARLINGTON

December 2015

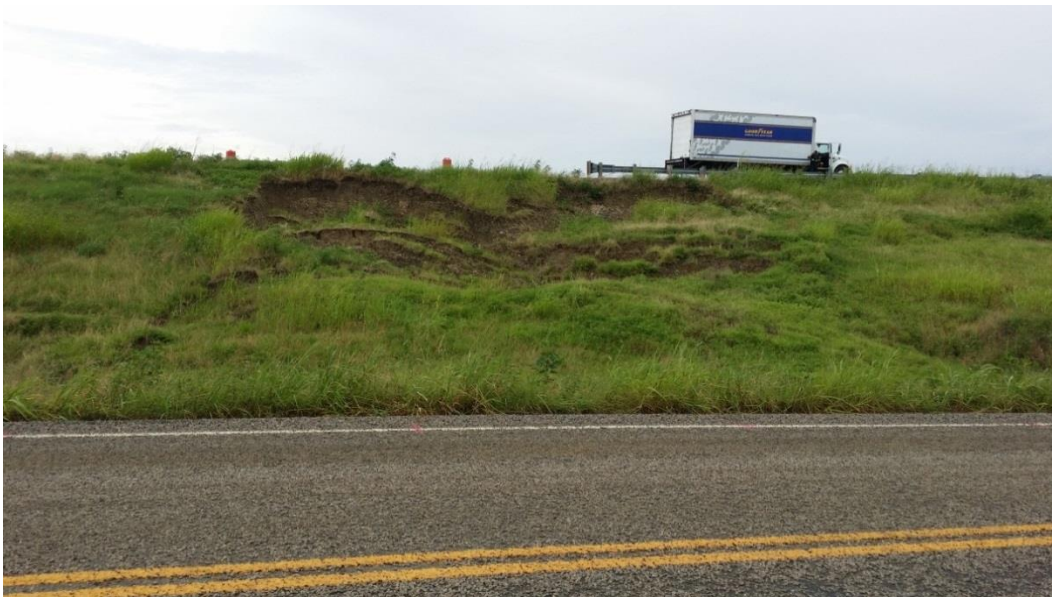
Figure 2-1 Slope Failure at US 287 north bound after heavy rainfall.

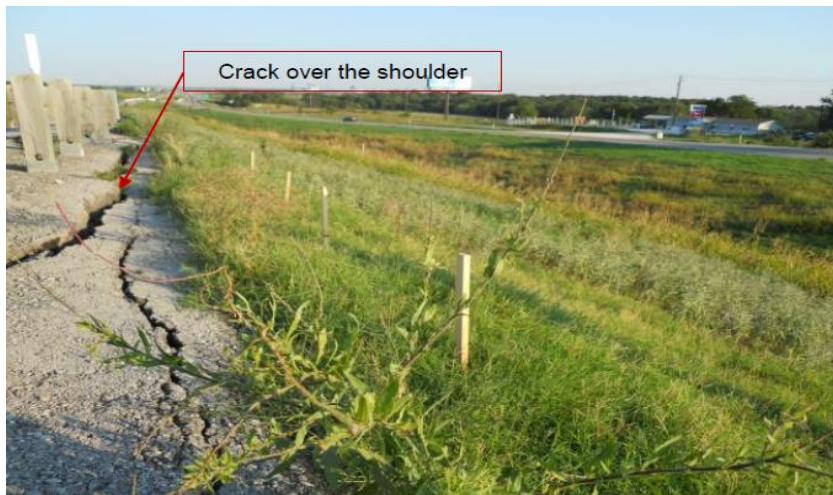
Figure 2-17 Observed cracks at US 287 slope along the crest (Khan, 2013)

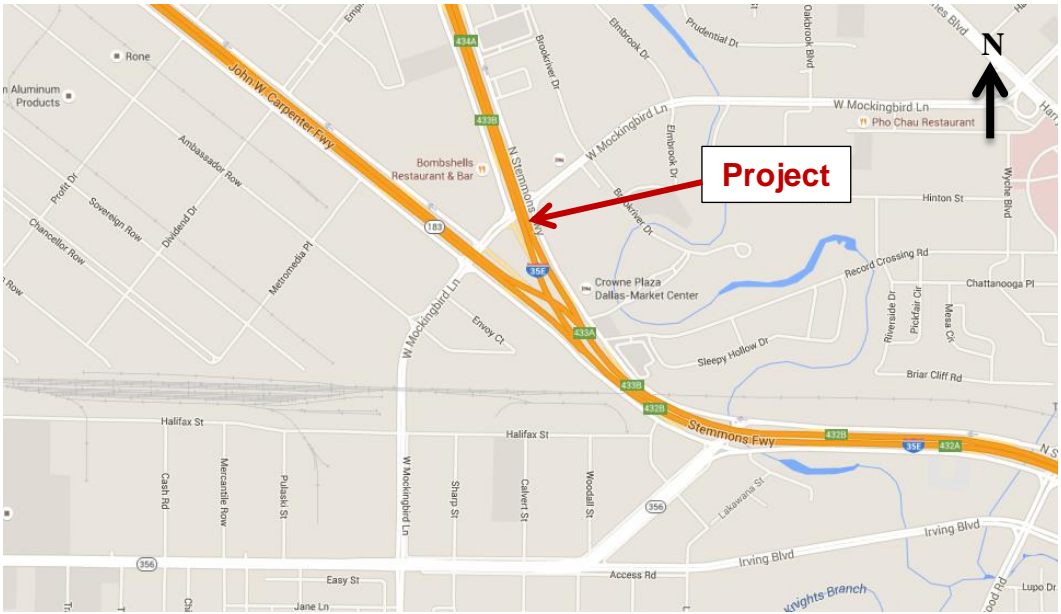
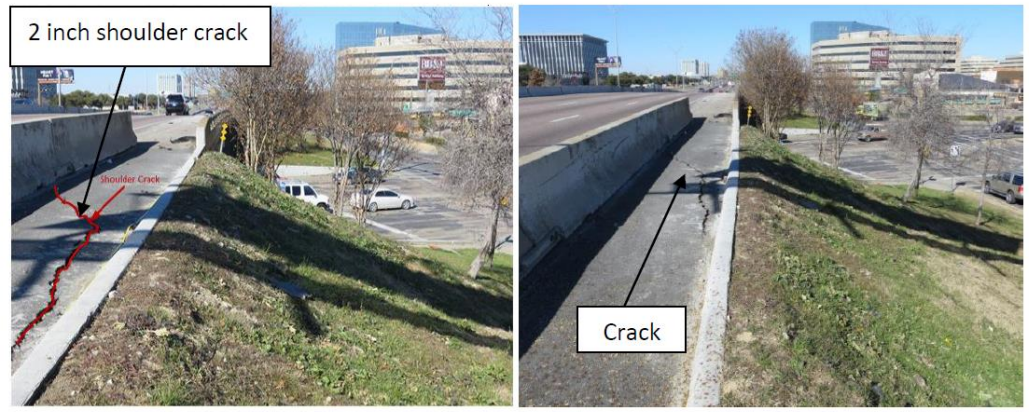
The Slope is located along north bound I-35E near the south of Mockingbird Lane overpass and the failure photos are as shown in Figure 3-1(a) and 3-1(b), respectively. Crack was observed over the shoulder due to the surficial movement at the slope. The crack propagated up to 42 ft. over the shoulder. The schematic of the failure condition are presented in Figures 3-2.

Figure 3-1 Project Information (a) Project location of I-35 slope, (b) Failure photos of I-35.

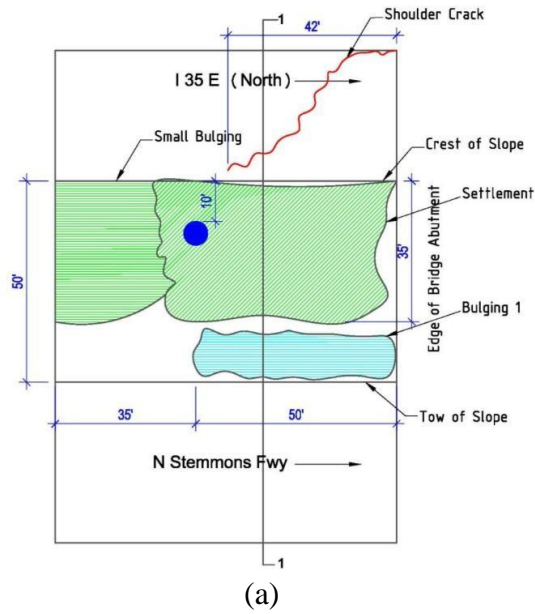
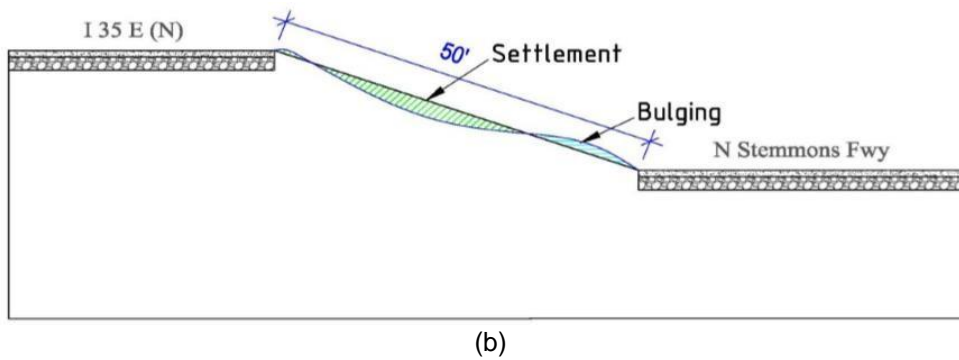
Figure 3-2 Schematic of the failure condition, (a) Front elevation view,
(b) Cross-section 1-1

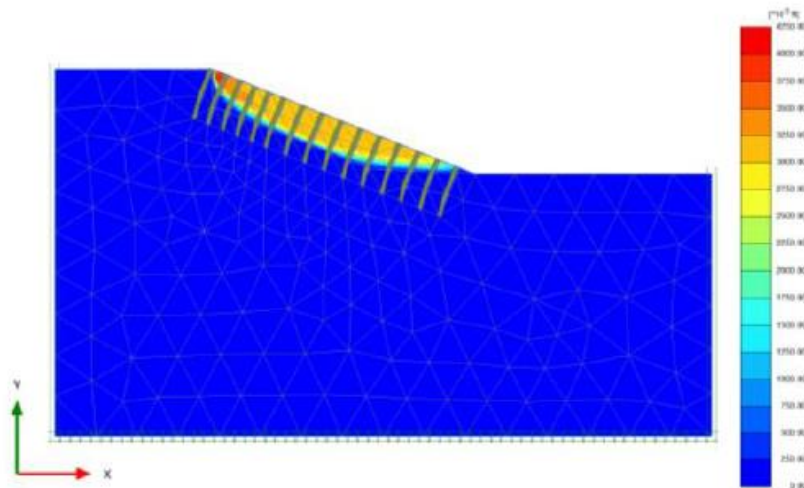
The stability analysis of the unreinforced slope indicated that the factor of safety was 1.03 which is very close to the failure. The failure plane is presented in Figure 3-6.

Figure 3-6 Slope stability of I-35 slope using Plaxis (FOS 1.03)

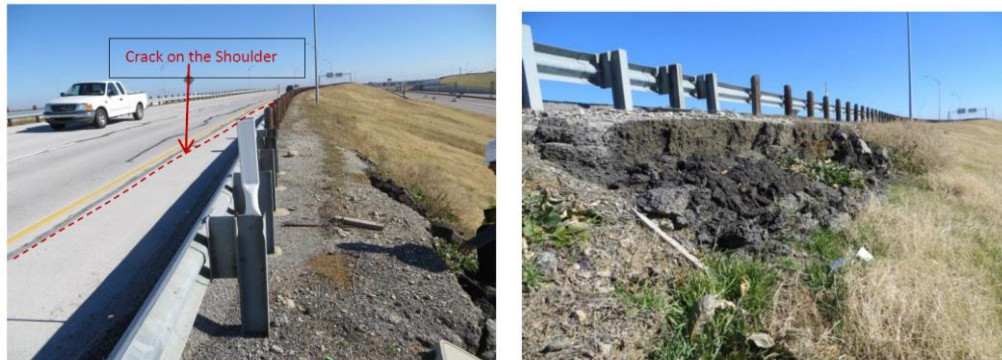
Figure 3-9 Slope failure photos at SH 183

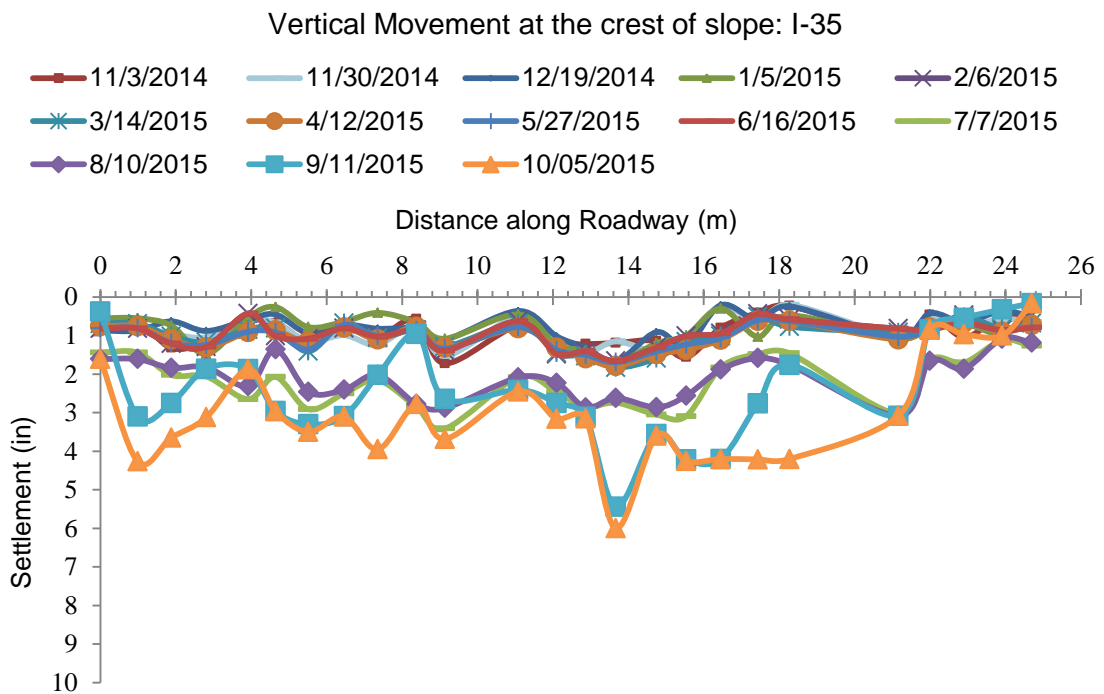
Figure 4-8 Settlement at the crest of the I-35 Slope

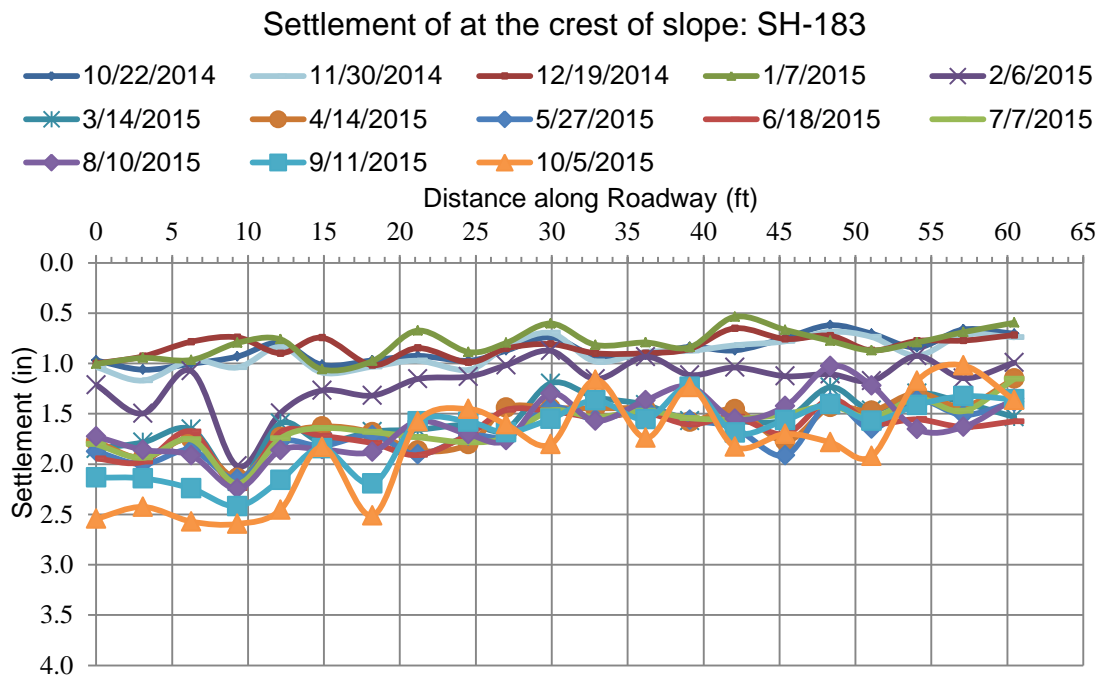
Figure 4-15 Settlement at the crest of the SH-183 Slope
