STUDIES ON FIELD STABILIZATION METHODS TO PREVENT
SURFICIAL SLOPE FAILURES OF EARTHFILL DAMS

Presented to the Faculty of the Graduate School of
The University of Texas at Arlington in Partial Fulfillment
of the Requirements
for the Degree of

THE UNIVERSITY OF TEXAS AT ARLINGTON

December 2008

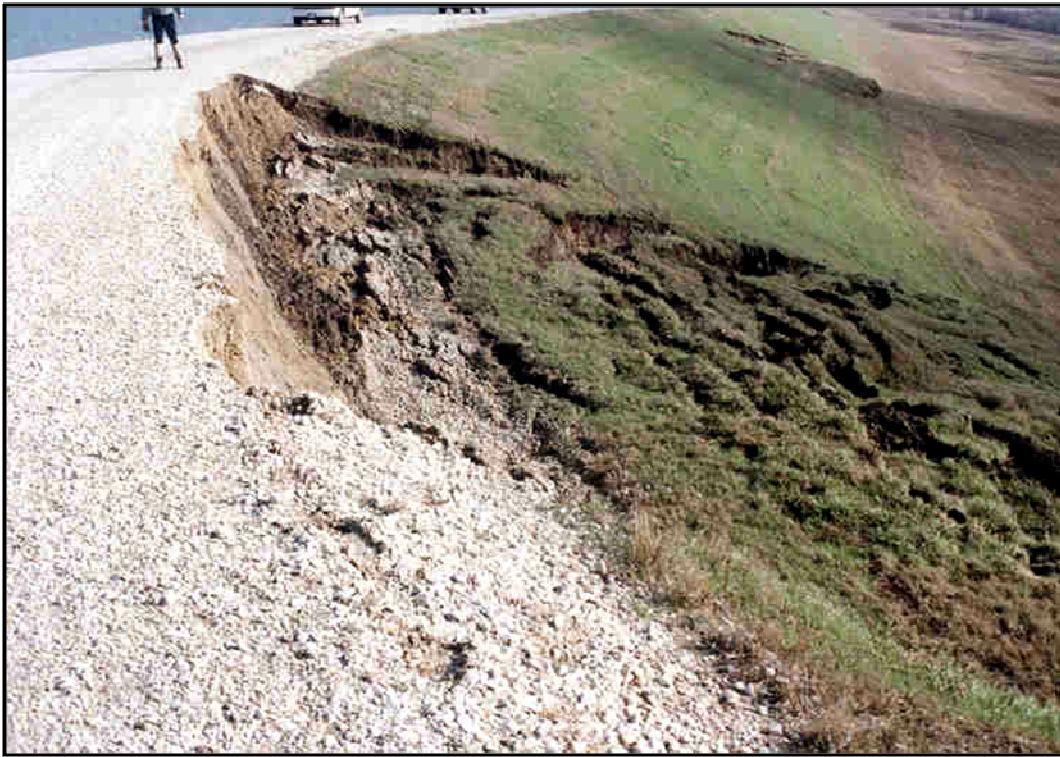
Figure 1.1 Surficial failure at Bardwell Dam (Source: USACE)

permeability parallel to slope increases and thus the seepage occurs parallel to the slope (Day, 1996). The condition of reduced shear strength and increased shear stresses due to saturation of soil mass leads to surficial failures. Surficial failures are classified as shallow slope failures as the average depth of failure varies from 0.3 m to 1.2 m (1 ft to 4 ft) (Day, 1996). In many cases the failure surface is parallel to the slope face (Day, 1996). Figure 1.1 shows a typical surficial failure occurred at Bardwell Dam of United States Army Corps. of Engineers (USACE).

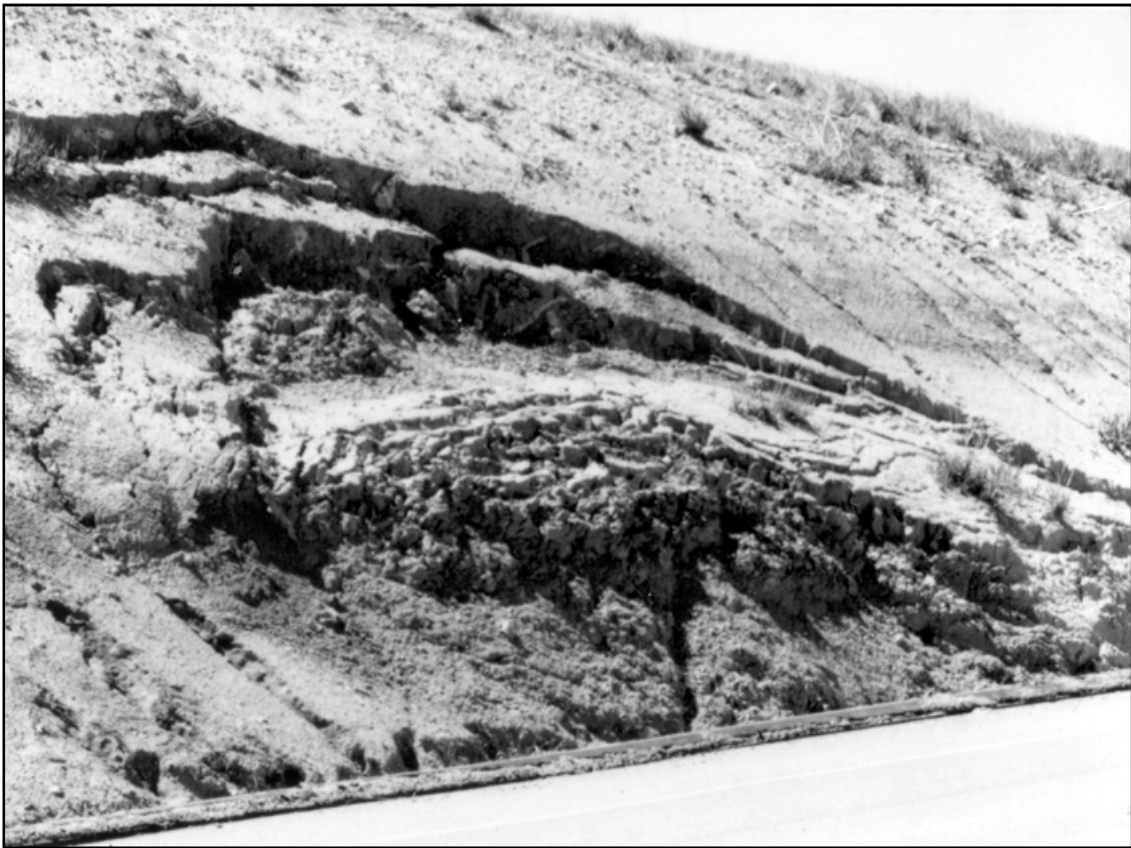
Figure 2.2 Surficial failure triggered by heavy rains in Colorado in 1973
(Source: USGS)

Figure 2.2 shows a surficial failure on Boulder County road, 3.2 km (2 miles) west of Jefferson County Airport, Colorado, USA. The crown of slide was about 6 m (20 feet) above road level. Steepness of slope and heavy rain triggered the failure on 8th May, 1973. Study of number of slope failures revealed that most of the failures were preceded by rainfall.

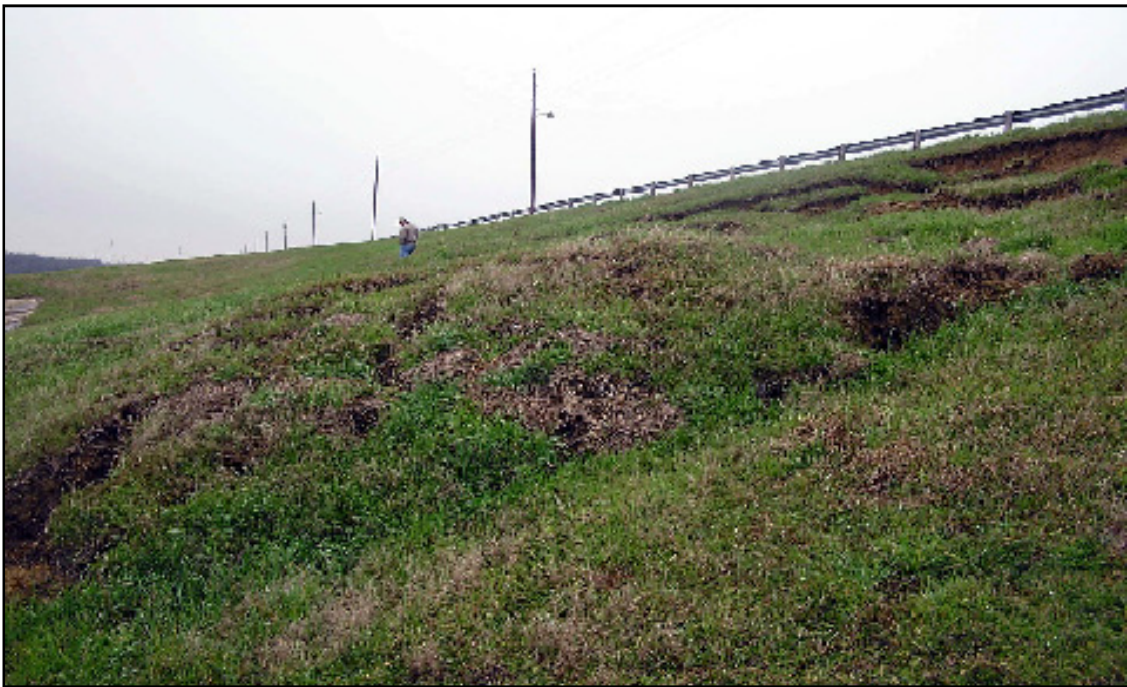
Figure 2.11 A Surficial slope failure at the Grapevine Dam, Texas, USA

another kind of slope failure known as surficial failure or surface sloughing as referred in section 2.4.3.2. These failures are classified as shallow slope failures as the average depth of failure varies from 0.3-1.2 m (1-4 ft) (Day, 1996). In many cases the failure surface is parallel to the slope face (Day, 1996). A typical surficial failure occurred at Grapevine Dam in Texas State of USA is shown in Figure 2.11.

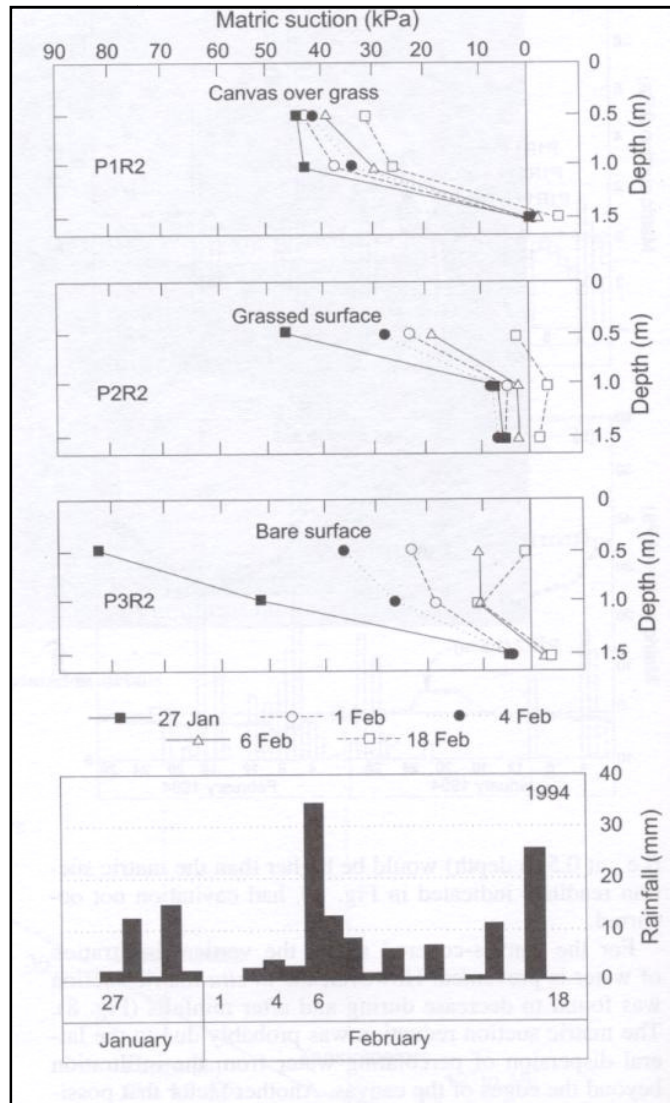
Figure 2.22 In-situ changes in suction due to rainfall (Source: Lim et al. 1996)

Piezometric observations showed that a perched water table probably developed at 1.5m (5 ft) below the ground surface. It can be concluded that with continued rainfall the soil at top few meters get saturated and pore pressures get increased.

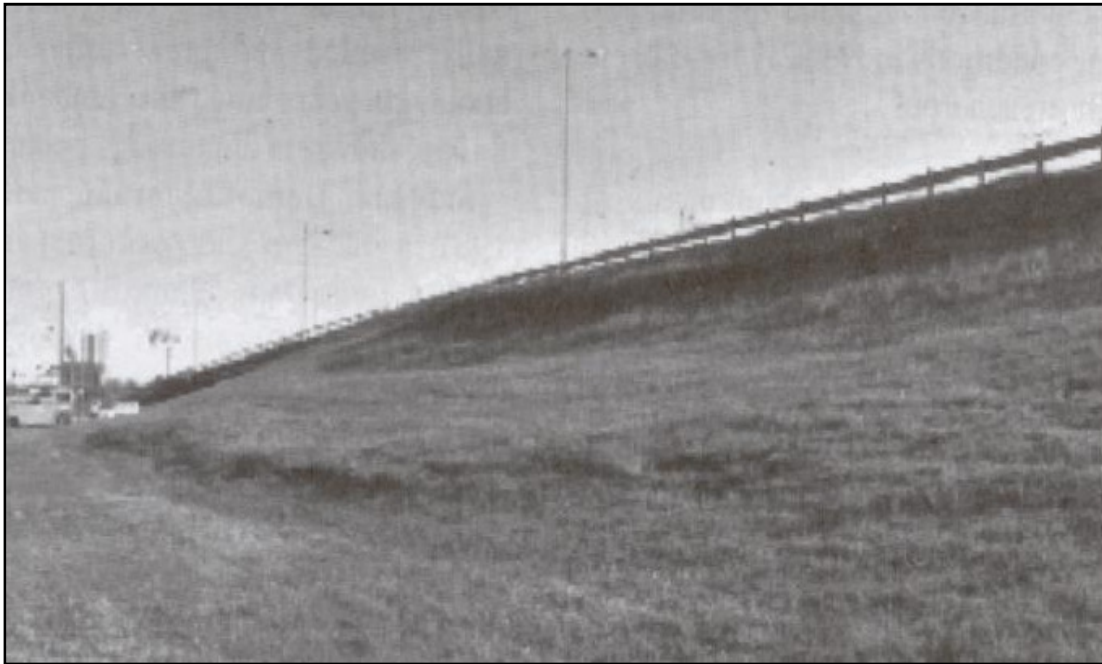
Figure 2.24 A surficial slide near Houston on highway embankment
(Source: Duncan and Wright, 2005)

It was concluded that the soil swelled and grew softer and weaker due to repeated drying and wetting of soil over the period of time as a result of alternating dry and wet seasons, resulting in surficial failure (Duncan and Wright, 2005).

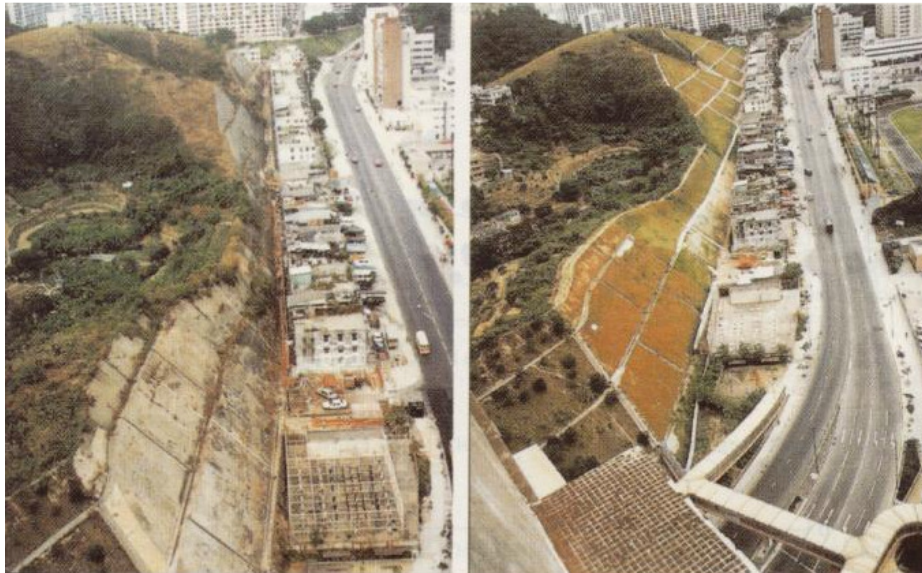
Figure 2.28 Slope before and after retrofitting (Ortigao and Sayao, 2004)

Figure 2.28 shows the condition of a slope in Hong Kong before and after retrofitting.

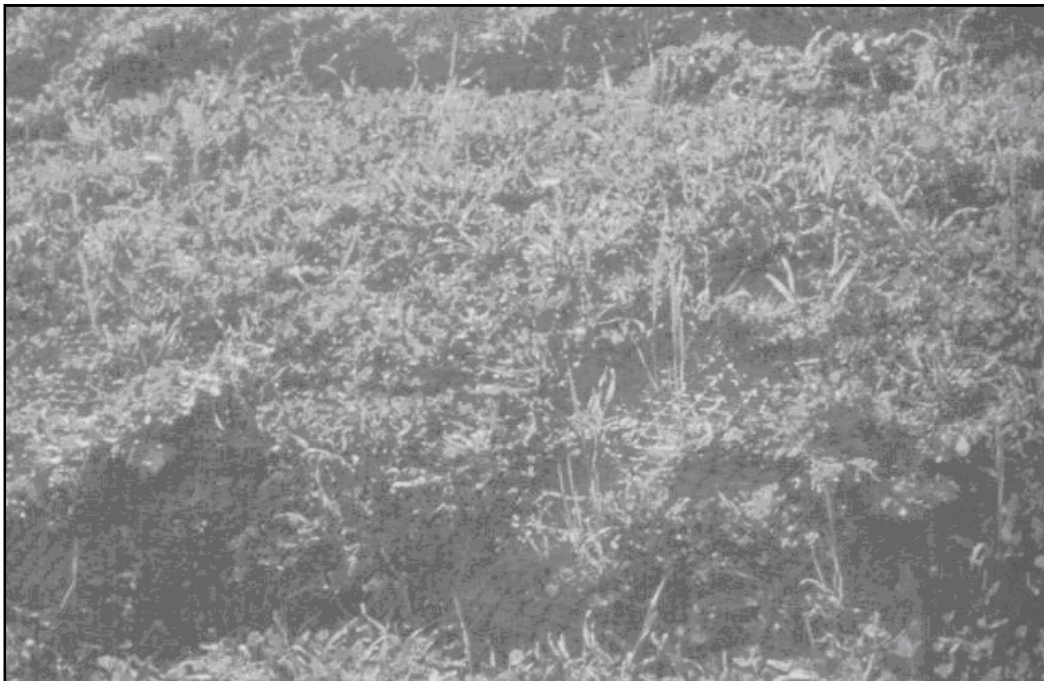
Figure 2.32 Vegetated surface on geogrid
(Source: Gray and Sotir, 1996)

Vegetation is highly effective and it stabilizes the soil surface by intertwining of its roots, minimizes seepage of runoff by intercepting rainfall, and retards runoff velocity. A photograph showing the use of geogrid and hydro seed treatment is shown in Figure 2.32.

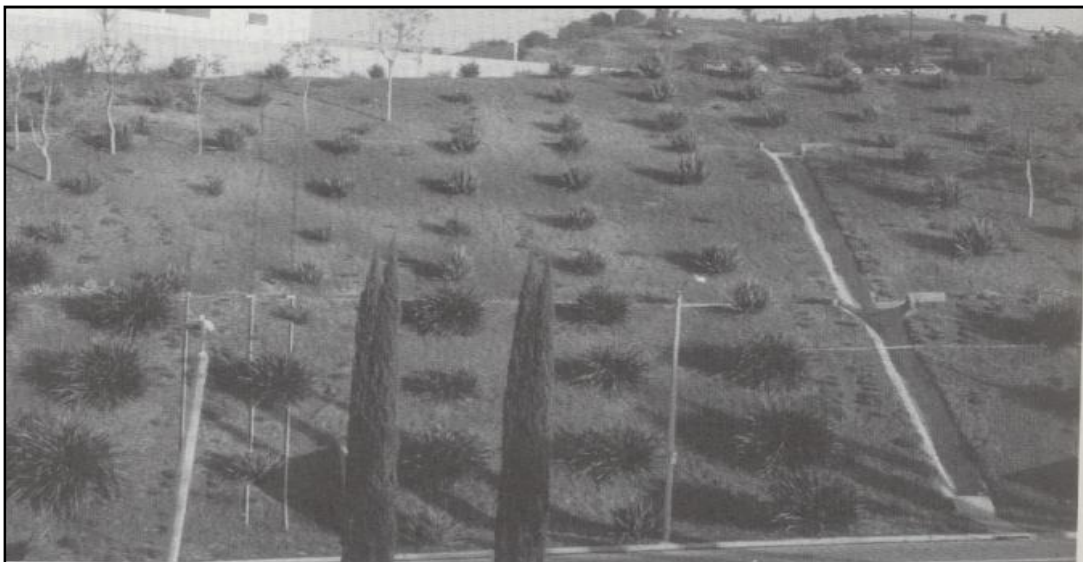
Figure 2.33 Landscaped slope with drainage and plantings
(Source: Gray and Sotir, 1996)

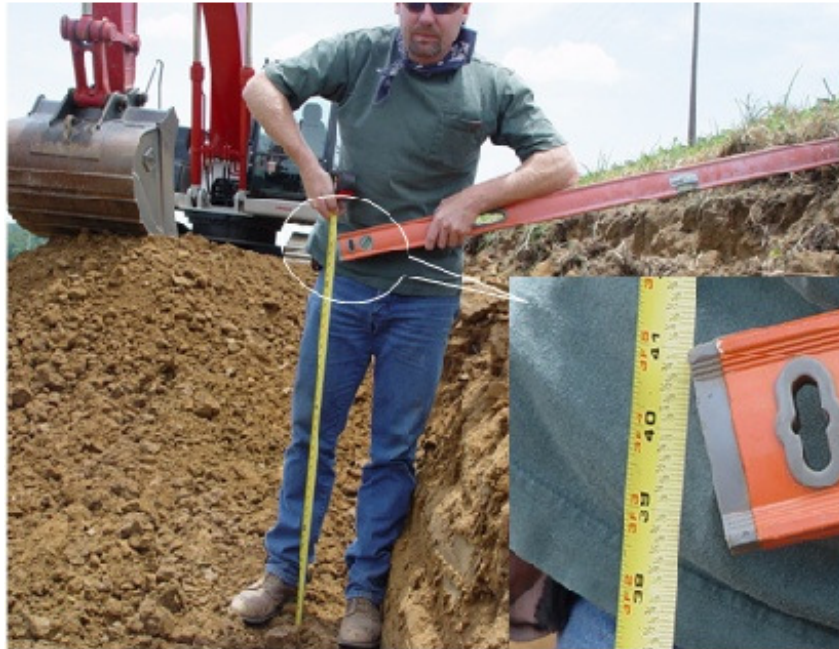
Figure 4.8 Depth of excavation near top of berm

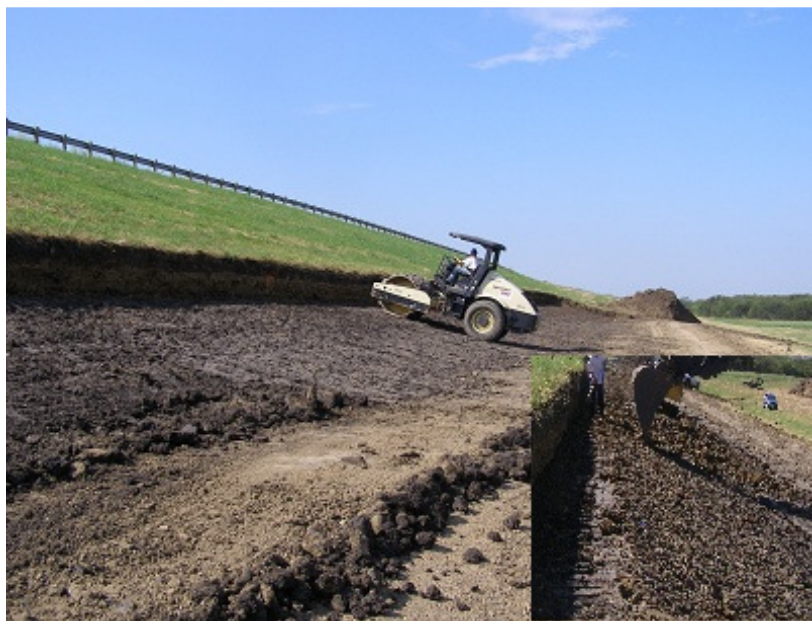
Figure 4.9 Preparation of bottom surface of excavation
(Inset: preparation of berm)

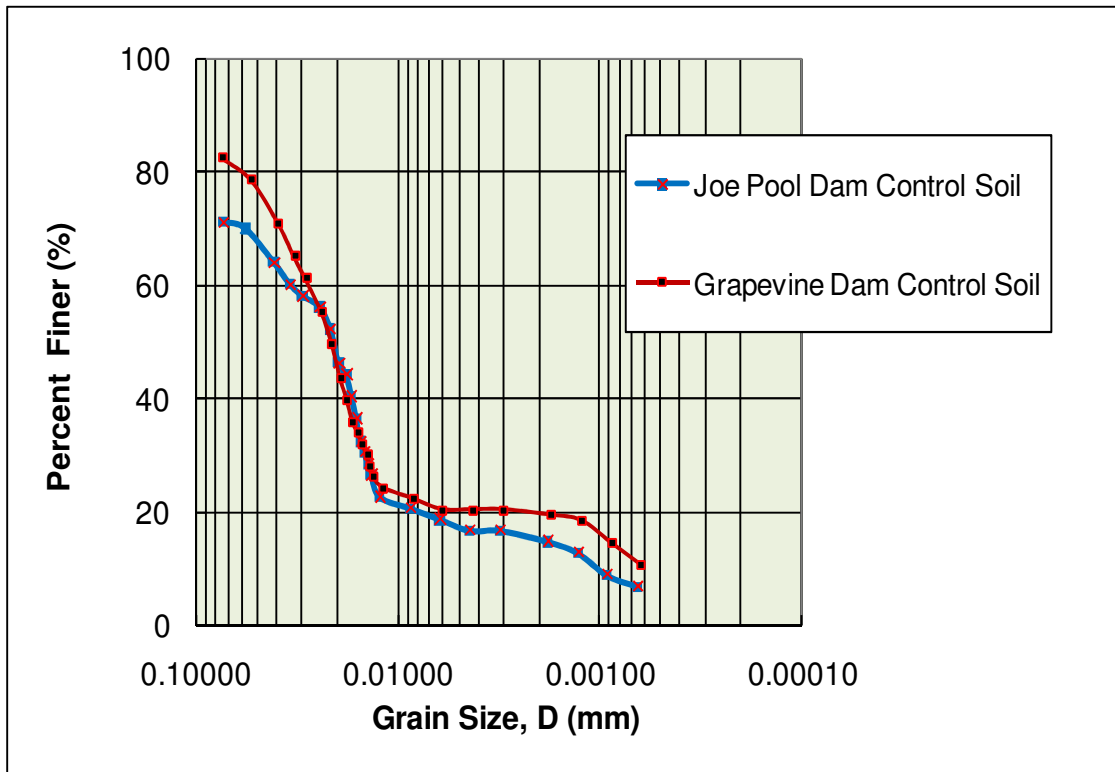
Figure 4.10 Hydrometer analysis – Grain size distribution of finer aggregate of Joe Pool Dam and Grapevine Dam

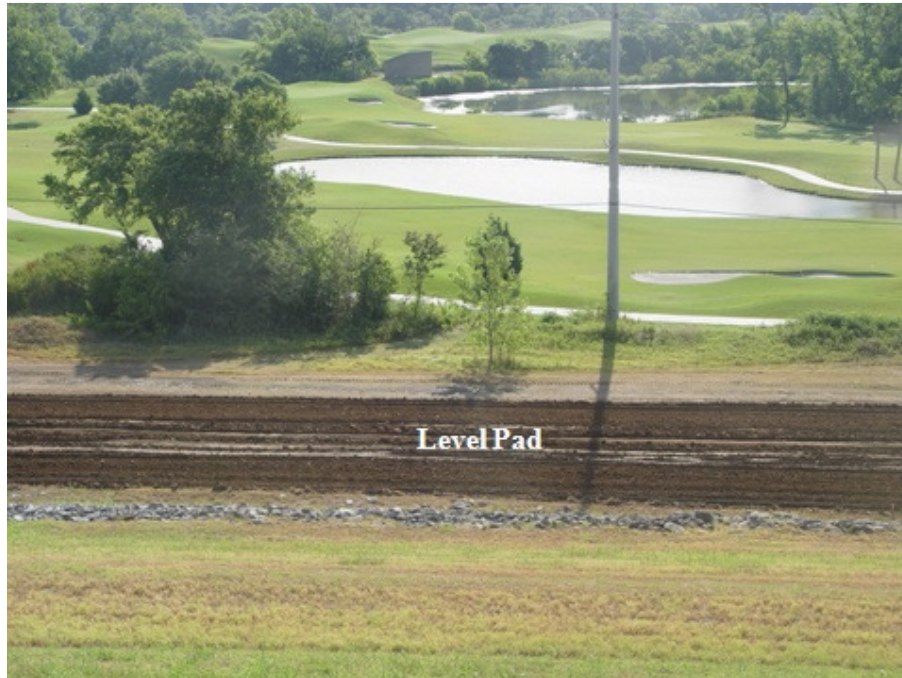
Figure 4.12 Pulverized and moistened soil at level pad ready for mixing with admixtures

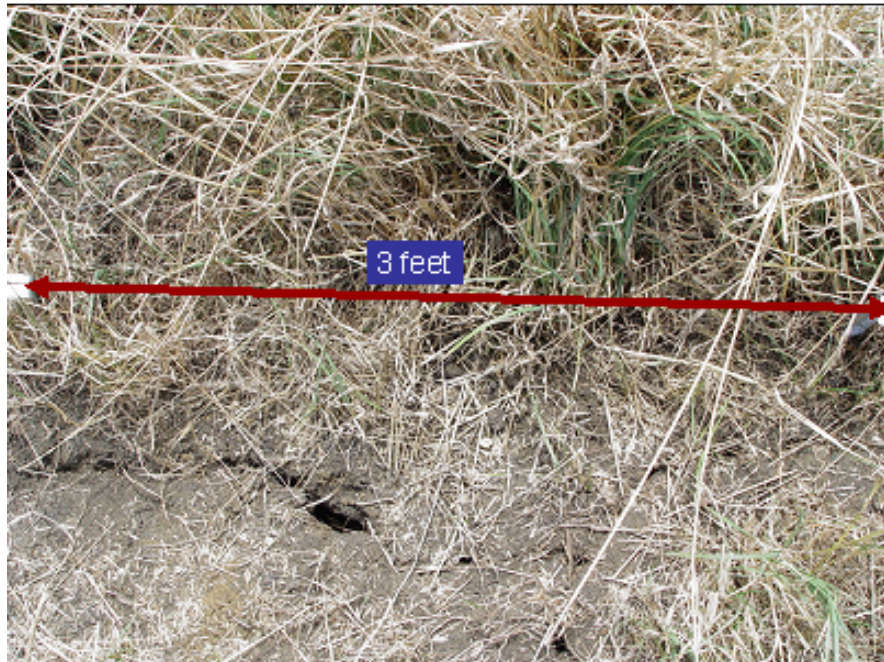
Figure 5.36 Digital image of cracked surface in control section
