PERFORMANCE OF PRESTRESSED CONCRETE CYLINDER
PIPE (PCCP) IN WATER APPLICATIONS

MASTER OF SCIENCE IN CIVIL ENGINEERING

THE UNIVERSITY OF TEXAS AT ARLINGTON

December 2012

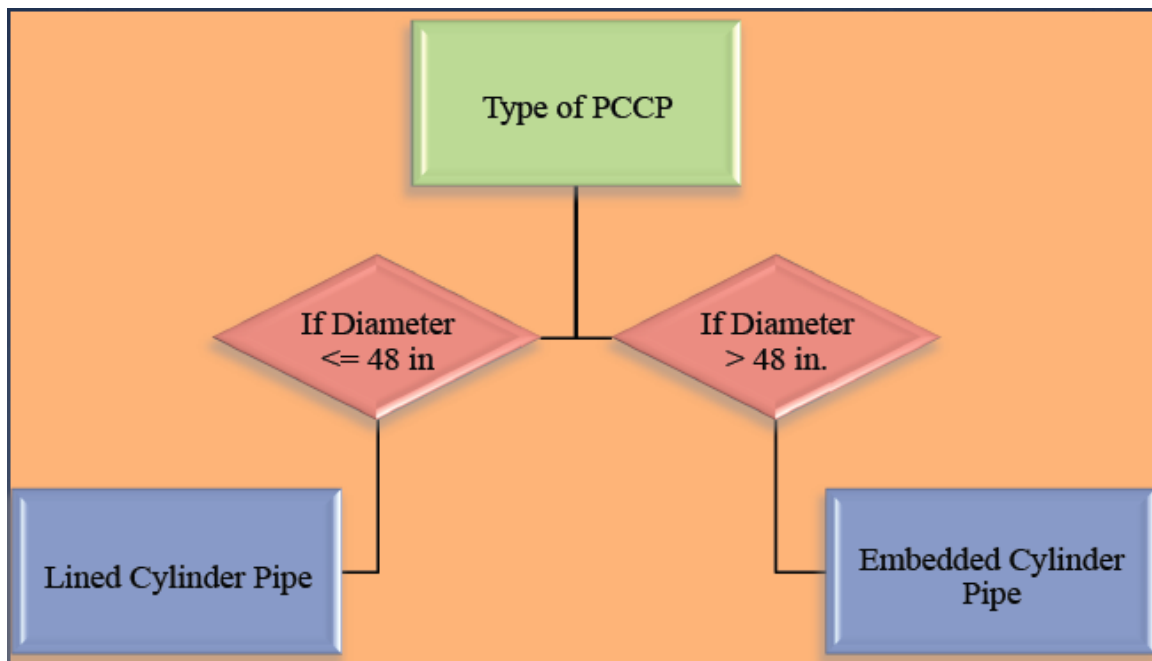
Figure 1.2 Classification of PCCP as per Diameter Size (Kola and Sinha, 2010).

There are basically two types of prestressed concrete cylinder pipes produced by manufacturers. The first one is linear concrete prestressed concrete cylinder pipe (LC-PCCP). This pipe's diameter is generally less than or equal to 48 in. The second one is embedded concrete prestressed concrete cylinder pipe (EC-PCCP), which is greater than 48 in. diameter. Figure 1.2 shows PCCP types according to diameter size.

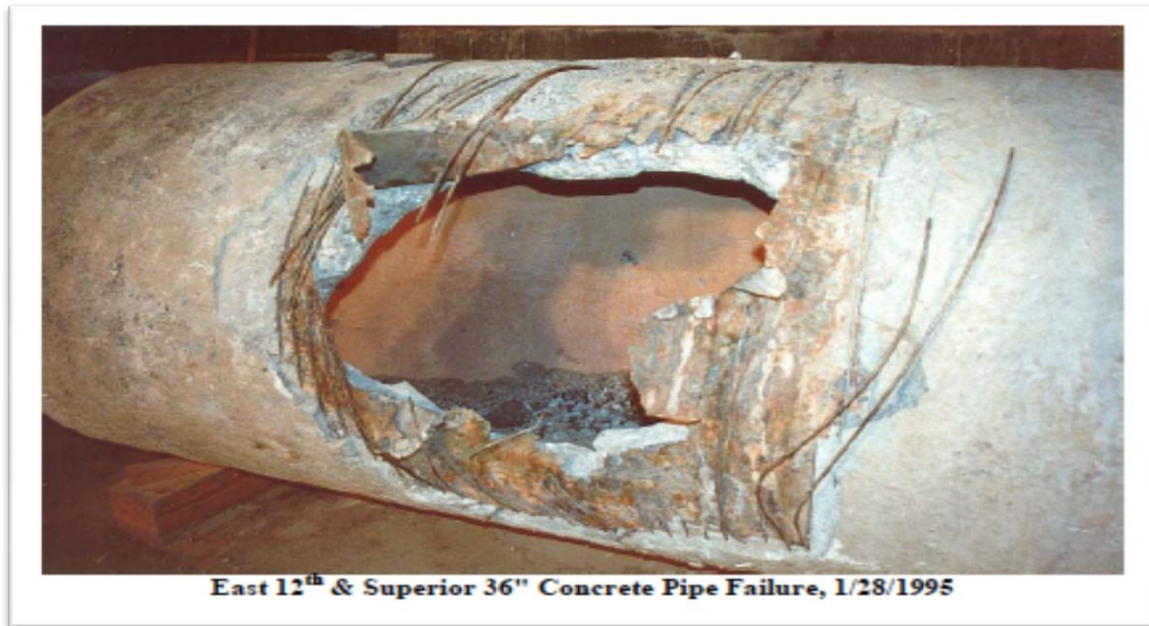
Figure 2.2 PCCP Rupture Failure due to Wire Break in 36-in. Diameter Size Pipe

As per Margevicius and Haddad, prestressed concrete cylinder pipe fails because of the failure in prestressed reinforcing wires. Defective prestressing wire, carbonation of the concrete core, incomplete encasement of the prestressing wire with Portland cement slurry and mortar coating are may be some primary reasons for wire breaks (Margevicius and Haddad, 2002; Holley and Rittenhouse, 2008). Figure 2.2 shows wire breakage in 36-in. and larger PCCP diameters due to corrosion of prestressing wire.

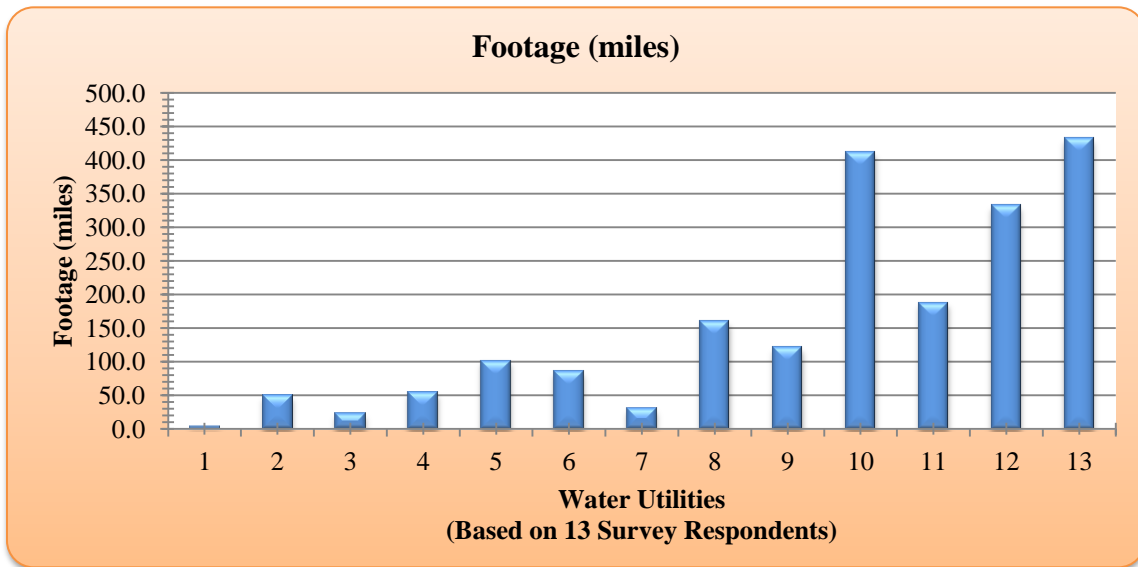
Figure 4.2 Footage of 24 in. and Larger Pipe in Water Utilities.

One of the questions in the survey was to provide the total footage of 24 in. and larger pipes in their water utility but some water utilities gave total pipe length they serve including less than 24 in. Those water utilities were contacted again to update their survey results. The total footage of 24 in. and larger pipes (including PCCP and others as shown in Figure 4.2) reported by survey respondents is 1,987 miles. Figure 4.2 shows the total pipe length of 24 in. and larger for every individual in their water utilities system. The highest footage is 432 miles for Water Utility 13, and the lowest footage is served by Water Utility 1, which is 3 miles.

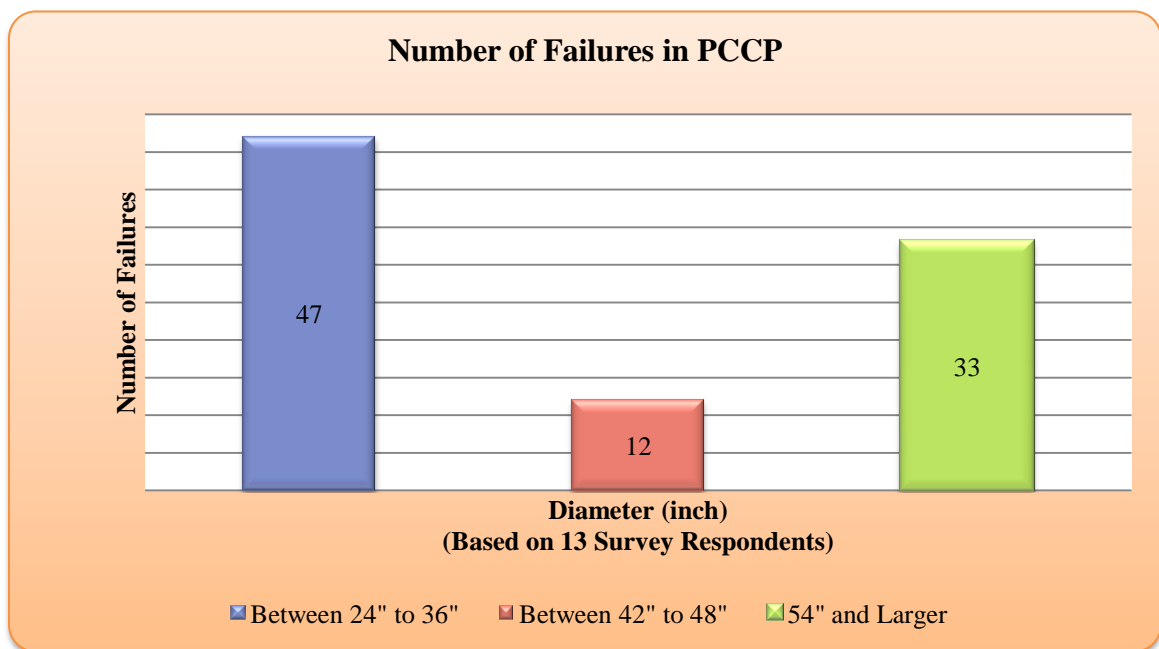
Figure 4.5 Numbers of Failure by the Water Utilities.

This section discusses failures reported by the surveyed water utilities. Figure 4.5 (a) shows the failures by diameter range. There were a total of 13 water utilities that reported a total of 92 failures in which there were 47 failures in the pipe diameter range between 24 in. and 36 in., 12 failures in the pipe diameter range between 42 in. and 48 in., and 33 failures in the pipe diameter range of 54 in. and larger. No failures were reported for other PCCP diameter ranges.

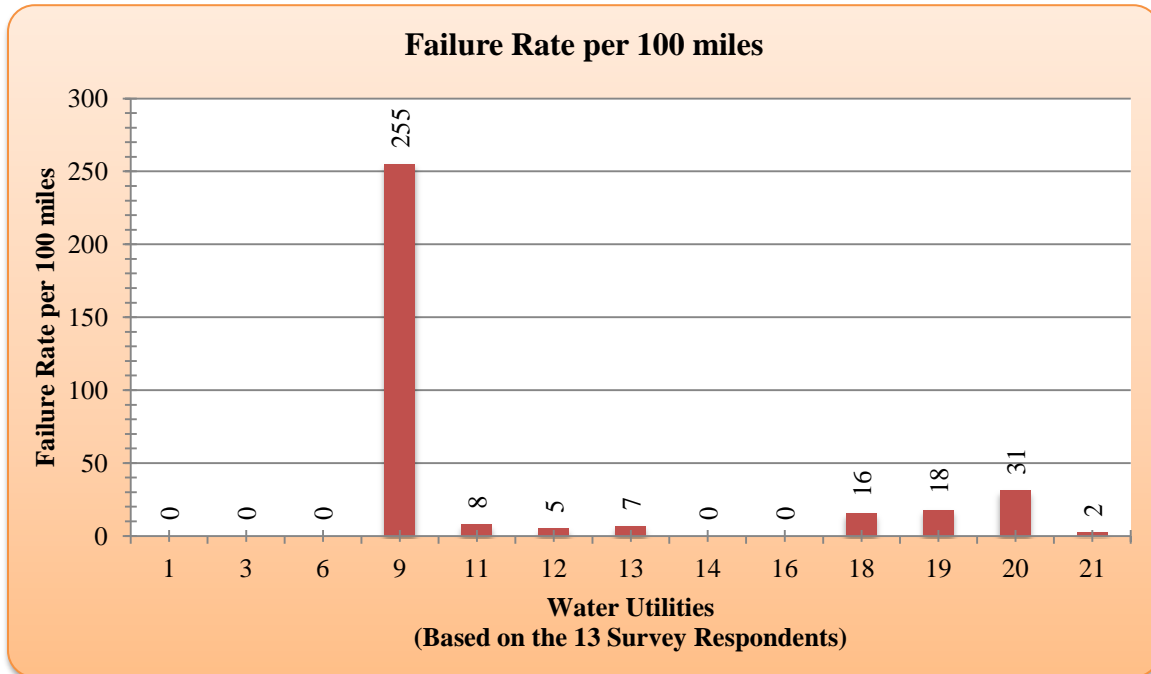
Figure 4.6 Failure Rates per 100 Miles Reported by Survey Respondents

As per survey results, the total number of failures in PCCP was 92, and the total length of PCCP was 632 miles. The total failure rate for PCCP, therefore, is 15 per 100 mile. Figure 4.6 presents the failure rates per hundred miles for each individual water utility. It should be noted that this failure rate is only valid for the PCCP inventory of survey respondents, and cannot be regarded as expected as an overall PCCP failure rate.

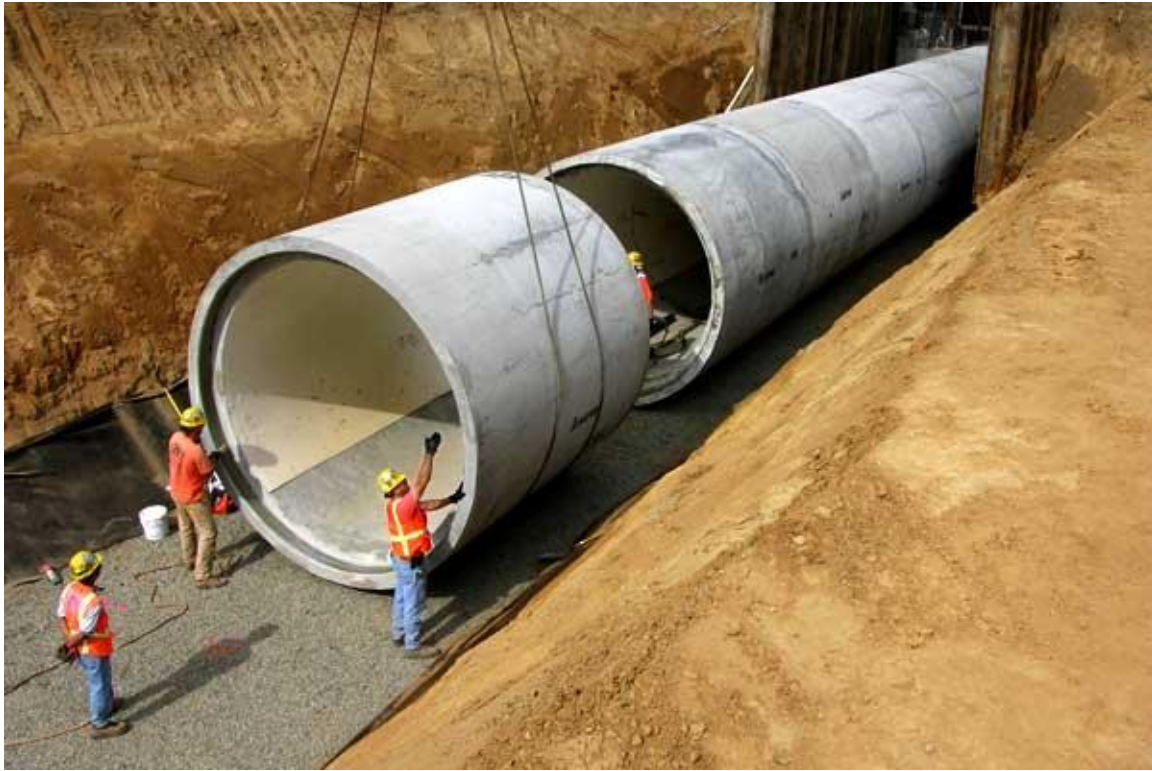
Ten miles of 96-inch diameter prestressed concrete cylinder pipe, part of the San Diego Aqueduct, will transport potable water to large metropolitan area (Ameron International).

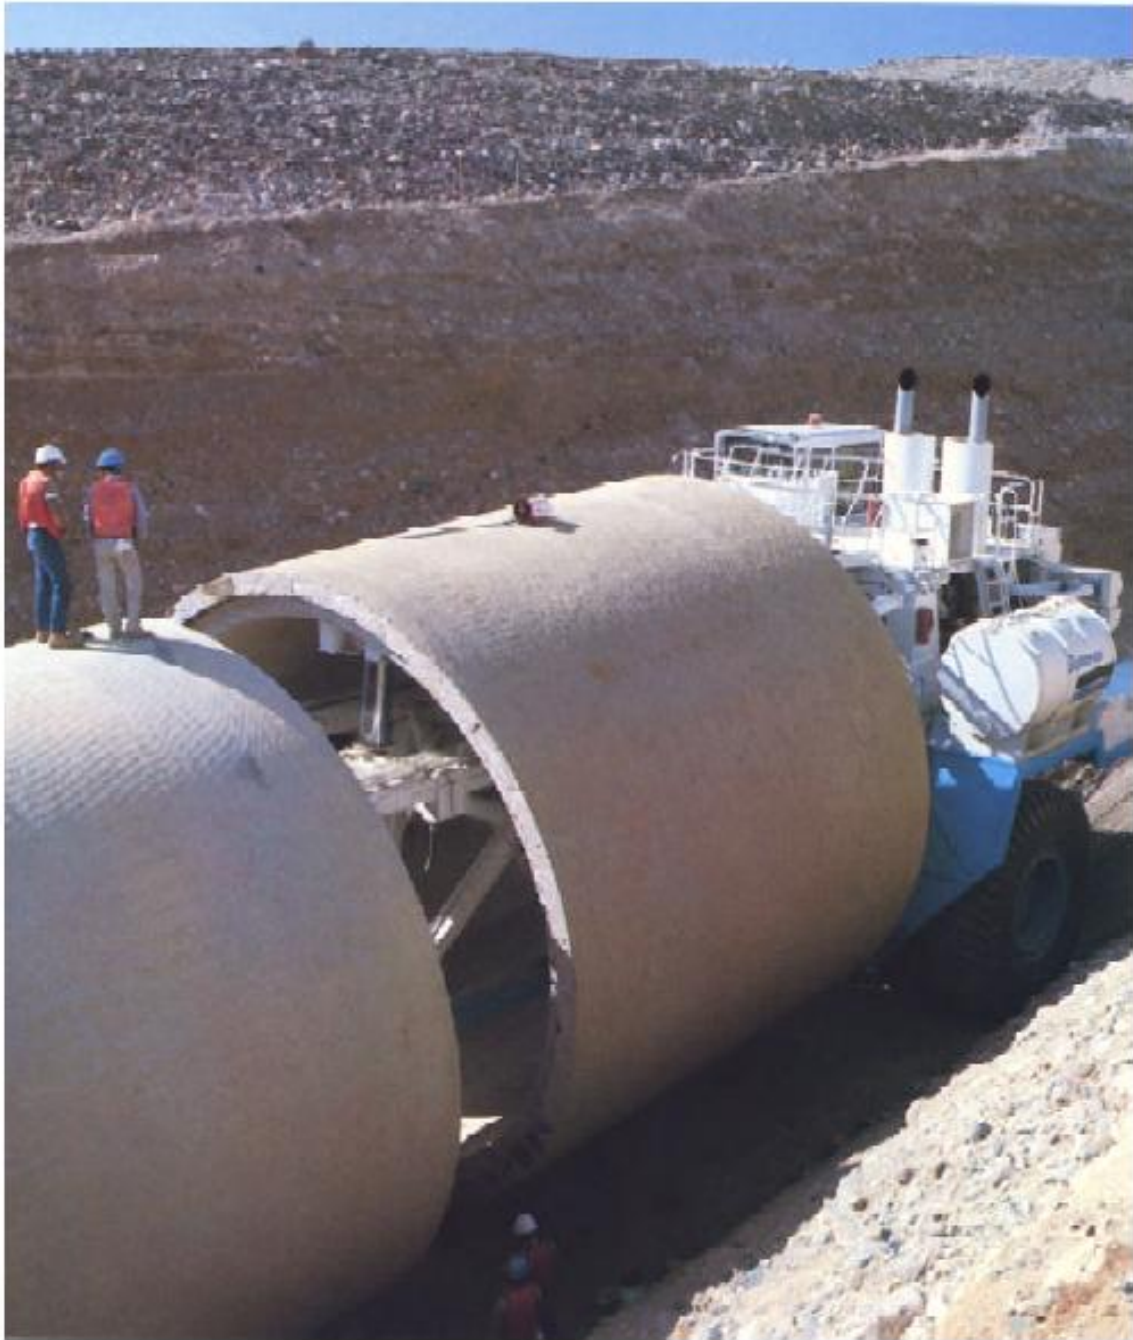
In trench, the pipe mobile's forward wheels enter the preceding pipe action and move forward to make joint. Joining of large diameter pipe sections is accomplished with controls that can maneuver the pipe in 1/16 inch increments. (Ameron International).

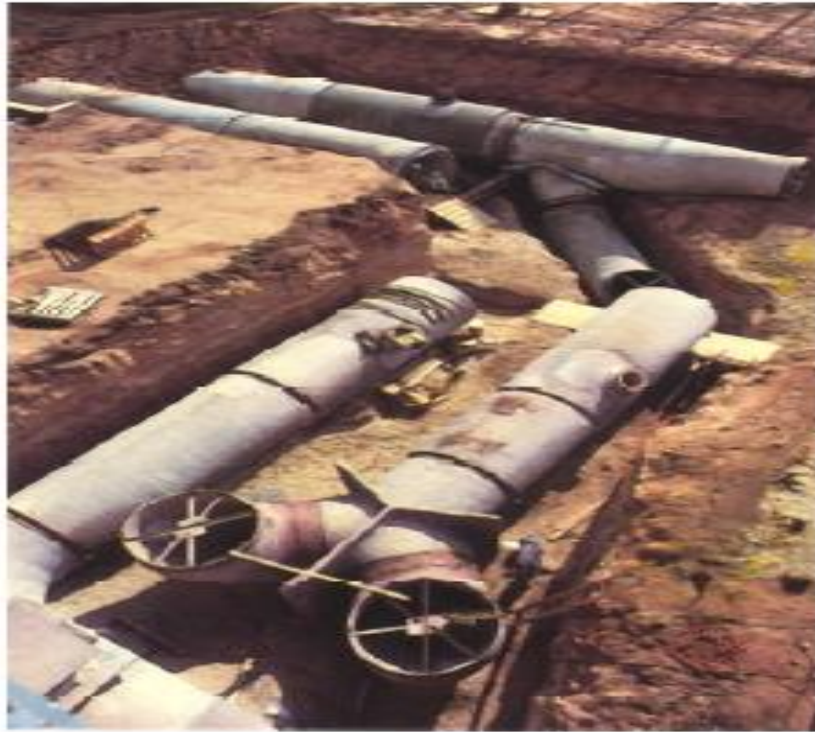
Special pipe sections and custom fittings are part of prestressing concrete cylinder pipe system at a power station (Ameron International).
