THE STUDY OF THE EFFECT OF SMART METER
RF TRANSMISSIONS ON GROUND FAULT
CIRCUIT INTERRUPTERS

Presented to the Faculty of the Graduate School of
The University of Texas at Arlington in Partial Fulfillment
of the Requirements
for the Degree of

MASTER OF SCIENCE IN ELECTRICAL ENGINEERING

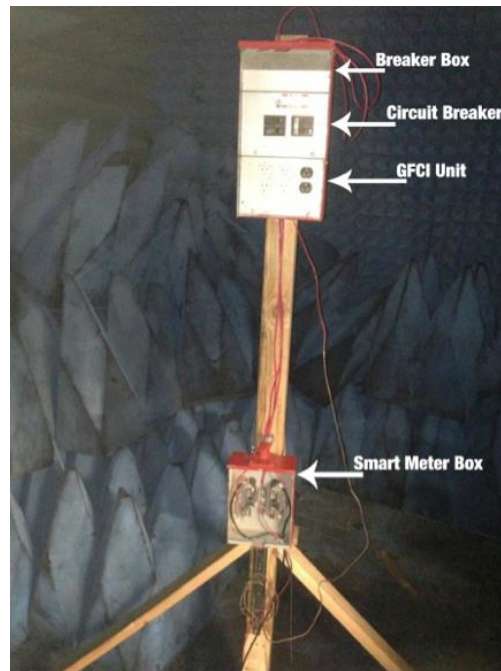
Figure 1-1 Laboratory setup representing a construction pole with GFCI electrical panel and vertically adjustable Smart Meter inside an anechoic chamber.

These devices have been widely implemented in residential and commercial buildings for decades. Typically, GFCIs are required in any electrical installation where water may interfere with electronics, such as kitchens and bathrooms. One such installation includes the construction poles, which are exposed to the elements, used by workers while constructing a building on site, like the one shown in Figure 1.

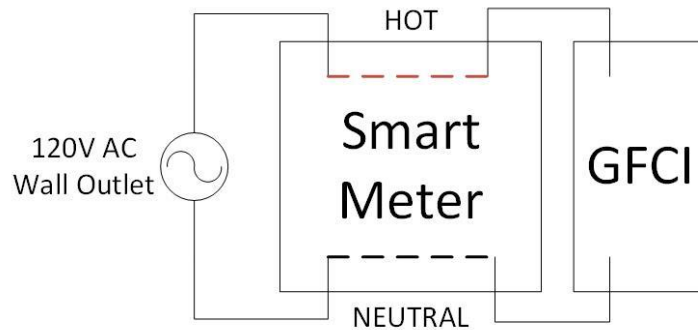
Figure 1-2 A simplified schematic of the test stand setup found in Figure 1-1. This depicts the operational scenario of a Smart Meter being powered from a 120V AC wall outlet, and then a GFCI being powered off of the hot and neutral AC bus of the Smart Meter's compartment box. Earth ground is not depicted here, but there is an earth ground bus within the Smart Meter box.

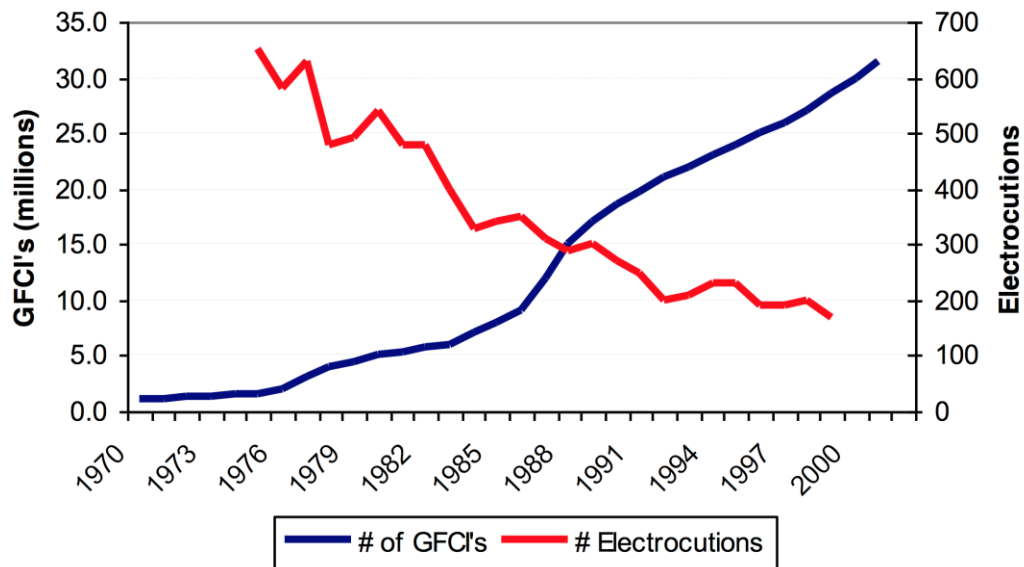
Figure 1-3 Number of deaths per year in the United States compared with the number of GFCI's installed in homes.

In 1961, a man named Charles F. Dalzeil developed a transistor version of the magamp. This is when the name Ground Fault Circuit Interrupter – or GFCI for short – was coined. Since then the device has improved over time with more regulations being applied, such as requirements for them to be installed in houses in any place where a water source is available. Deaths per year in electrocution began to decline as GFCI’s use became more widespread. The graphic in Figure 1-3 represents the number of deaths per year by electrocution compared to the number of GFCIs installed in households. Number of deaths began to be recorded in 1976 with roughly 650 deaths per year with just around 2 million GFCIs installed. By the year 2000, deaths per year were down to roughly 180.

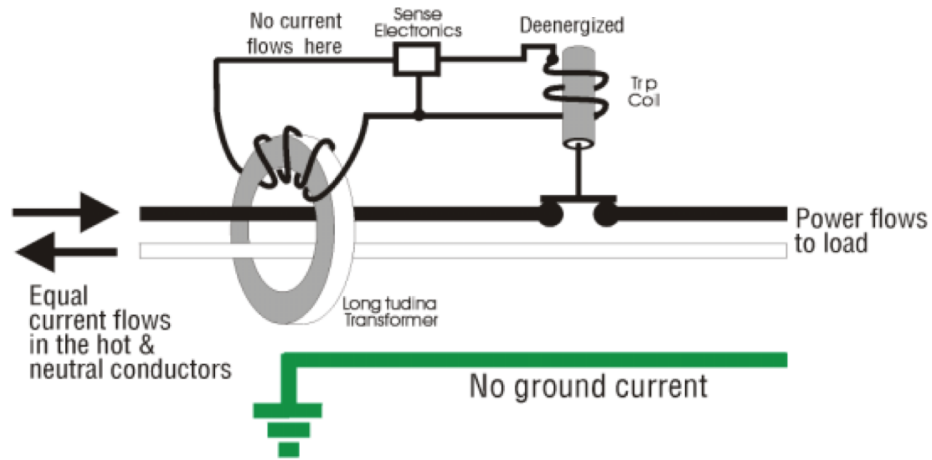
Figure 2-1 Basic GFCI operation with no fault current detected and equal current flowing through the forward path, into the connected load, and then back through the return path.

When a GFCI device is operating normally, there is no "fault" present in the system. This means that the same amount of current flowing through the transformer on the hot line to the load is also flowing back on the neutral line. In other words, the circuit is being completed with no foreign loads, or "faults", appearing and causing a tripping event. As can be seen in Figure 2-1, it states that equal current is flowing in and out of the transformer, and thus the "trip coil" remains deenergized. The trip coil is simply a solenoid controlled by an integrated circuit that receives an input from the transformer. When the signal is received from the transformer, the electronics will apply some current to the solenoid, disconnecting the forward path to the load and inhibiting any power flowing.

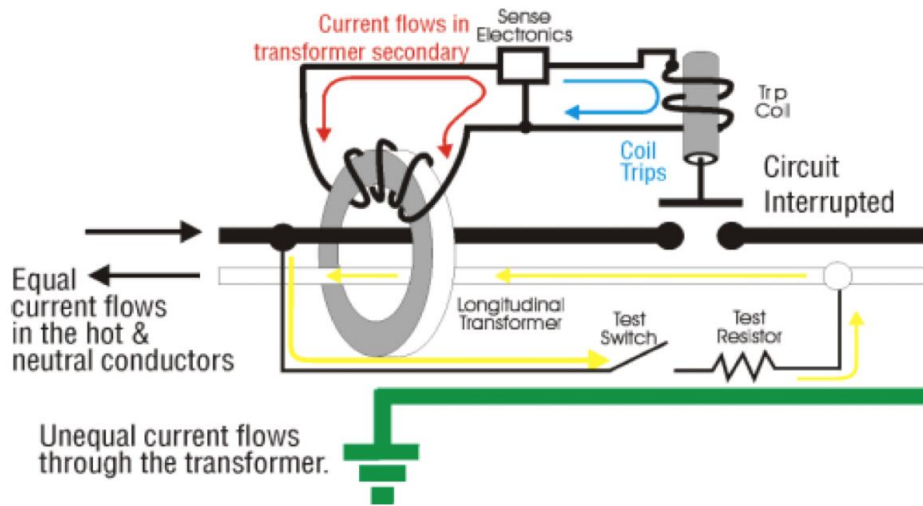
Figure 2-2 Test button operation of a GFCI unit. In this scenario, the test button of a GFCI has been pressed. This introduces a “test resistor” to the circuit between the hot and neutral lines. Since the current is no longer equally flowing in and out of the transformer, the transformer will send an input to the sense electronics which will then disconnect the hot line.

Each GFCI has a built in test button. The test button is something required by UL923 in order to allow for consumers to test their own devices for proper functionality. When the test button is pushed, a “ground fault” occurs and the GFCI disconnects any connected loads. The test button creates this fault by creating a connection and effectively applying a resistor between the hot and neutral lines. Because this connection is done before the transformer is introduced on the forward path (hot line) and before reaching the transformer on the return path (neutral line), a change in current is sensed. In short, a resistor affects the amount of current, the GFCI senses a current leak and the device trips. This scenario can be seen in Figure 2-2 for reference.

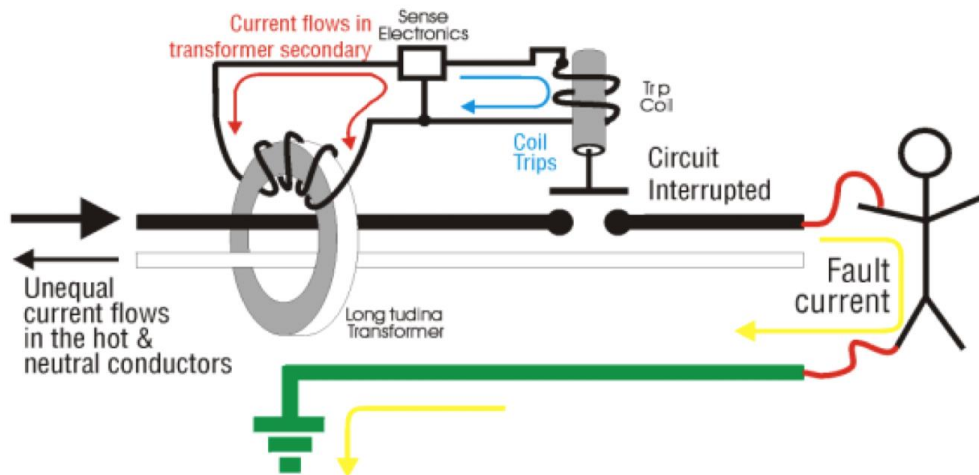
Figure 2-3 A scenario in which a GFCI has experienced a tripping event. A foreign load has been introduced between the hot line and earth ground. Instead of current flowing through the neutral line return path, the current now flows to ground. When this occurs, the amount of current flowing in and out of the transformer is not equal, causing it to send an input to the sense electronics, which then disconnect the load.

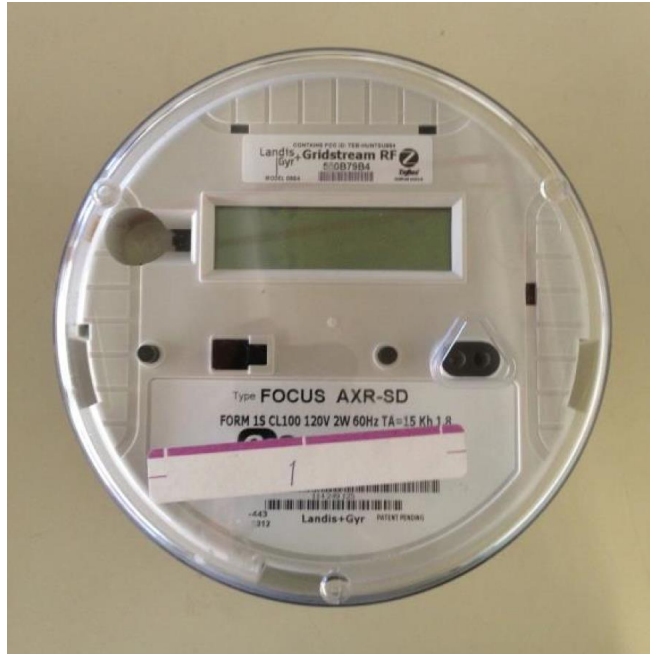
Figure 2-5 A Landis+Gyr FOCUS AXR-SD 120V Smart Meter, used in all tests throughout this study.

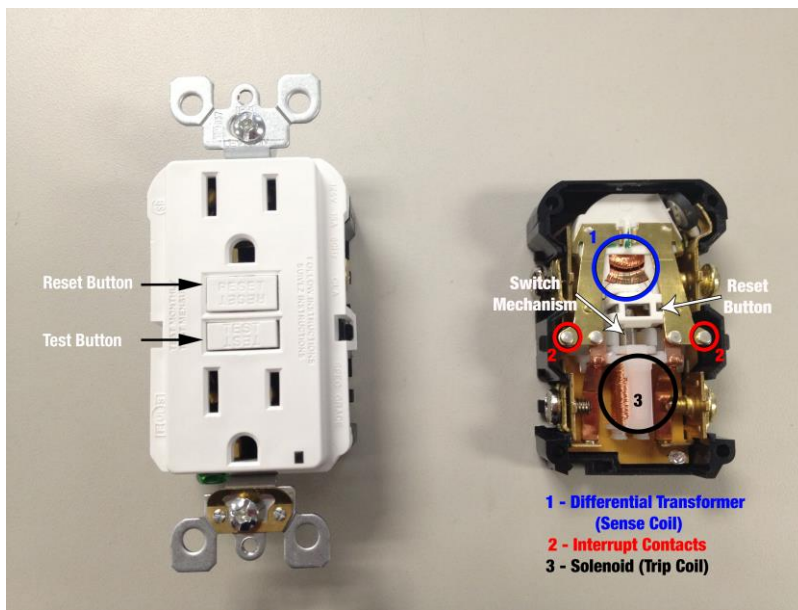
Figure 2-6 The basic internal components of a GFCI unit. The Switch Mechanism armature can be seen protruding itself from the solenoid, the Interrupt Contacts are the actual contacts that are physically disconnect in the event of a trip, and the differential transformers including the sense coil and the ground-neutral coil.

in which μ is the magnetic permeability of the medium, n is the number of turns per unit length in the solenoid, and I is the conduction current which together result in B - the magnetic field. In this equation, the permeability and number of turns are always constant, so if the magnetic field is being manipulated then the current must be increasing. By changing the magnetic field within the transformer, it can affect the circuit in the same way as a normal current imbalance would. Also, this same concept can be applied to the armature solenoid which physically disconnects the load from the GFCI receptacle, as can be seen in Figure 2-5.

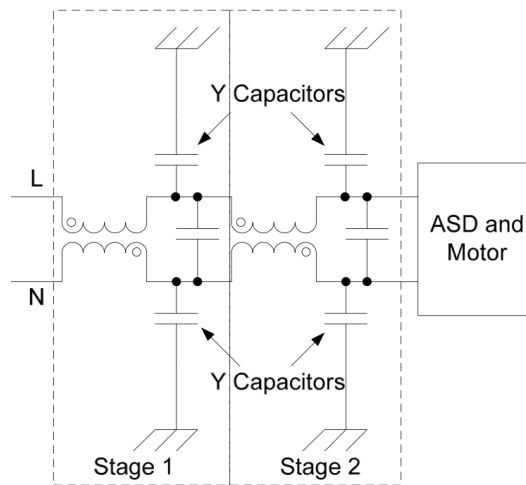
Figure 2-7 The two-stage filter found on adjustable speed drives used in hot tubs for mechanical regulation of their pumps. This is what is typically found within ASDs to prevent GFCI devices from tripping at the frequencies they generate.

While the Smart Meter and GFCI device interaction is not well understood, there is a similar problem that is still common in homes today. In this case, the culprit is when a GFCI is paired with a hot tub. An adjustable-speed drive (ASD) is a device used in hot tubs or spas which varies the speed of the pump machinery used. In the study "Compatibility Between GFCI Breakers and Household Adjustable Speed Drives" by Kimball *et al.* the frequency response of a GFCI is compared to that of an ASD commonly found in hot tubs. [17] This device is classified by the FCC to be a class B digital device, meaning it's for use in a residential environment, and is an unintentional radiator. Within the ASD is a two-stage EMI filter, which can be seen in Figure 2-6. It was mentioned that

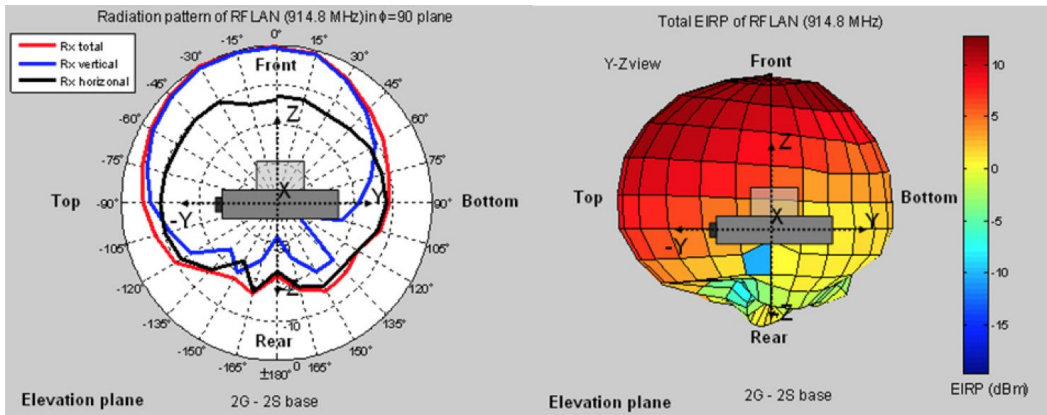
Figure 2-8 Three-dimensional field of Smart Meter RF transmissions created by EPRI.

This gave some insight supporting the suspicion that there could be a “hot spot” in the emission pattern. EPRI’s three-dimensional map can be seen in Figure 2-8 and a slight protrusion of the field is noted around the negative 45-degree mark.

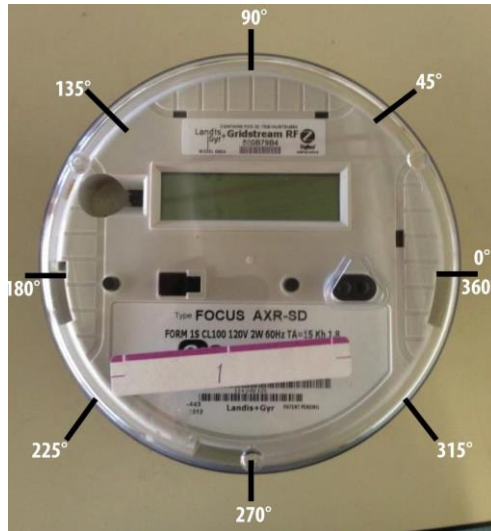
Figure 3-1 Angles marked on the Smart Meter for reference as to where measurements were taken in relation to position on the rotary table.

Angles in 45-degree intervals were marked on to the rotary table, along with a reference point for the Smart Meter to be placed upon. For reference, the angle placement in relation to the Smart Meter can be found in Figure 3-1 above. If the Smart Meter were a circle on an x and y-axis, then the reference point would be the 0-degree mark on the right hand x-axis. This allowed for the Smart Meter to be rotated and measurements to be taken at the various angles reliably and repeatedly. Both spectrum analyzers utilized a GPIB to USB connection, allowing them to interface with a National Instruments LabVIEW measurement program.

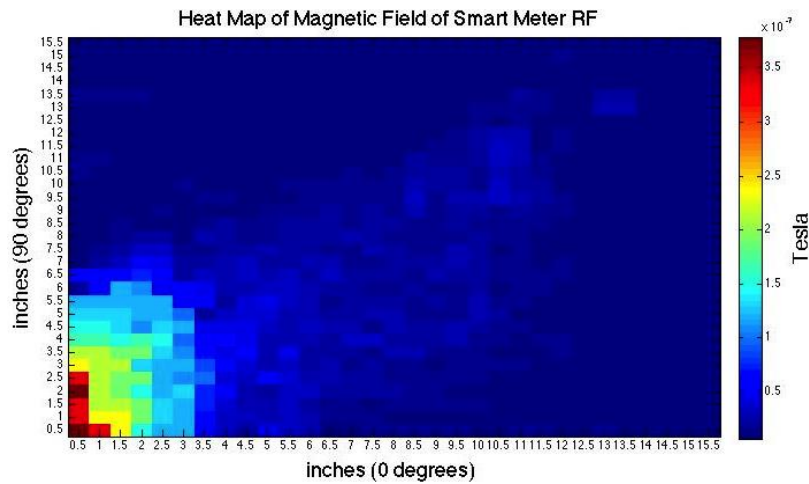
Figure 3-2 B-field measured axially for varying distances between 0 and 90 degrees.

A custom LabVIEW Visual Instrument (VI) was created for data capture across the 900 to 930MHz spectrum. The field's strengths were recorded for two minutes at each 1.25 cm distance interval. During that time, the program captures data upon a trigger of -40 dBm. This is due to the minimum RF transmission power from the maximum distance tested being, on average, -40 dBm. It is worth noting that the Smart Meter's RF emission strength varies as it tries to connect with a communication HUB, which is not located within communications length of the meter. This caused variation in the measurements over the two-minute period. The highest intensity pulse recorded over the two-minute test period was used in the mapping of the magnetic field (B) and electric field (E) from 0 to 90 degrees relative to the reference point. Those plots are shown in Figures 3 and 4 respectively. Note that these measurements are subject to the time in which they were taken and may vary, though multiple readings were taken to minimize potential error. It can be seen in both figures that there is a 'hot spot' observed around the 45-

degree angle of the Smart Meter. The intensity of the field remains relatively constant up until 4.7 cm, at which point it changes by roughly 10 dBm. It may trip more often when subject to the “hot spot” of the fields. A map of the B-field can be found in Figure 3-2 and the E-field in Figure 3-3. The results show that the orientation of the Smart Meter with respect to the GFCI may impact the coupling of RF into the GFCI's electronics. It may suggest that orientation of the meter on the construction stand could prevent any tripping from occurring.

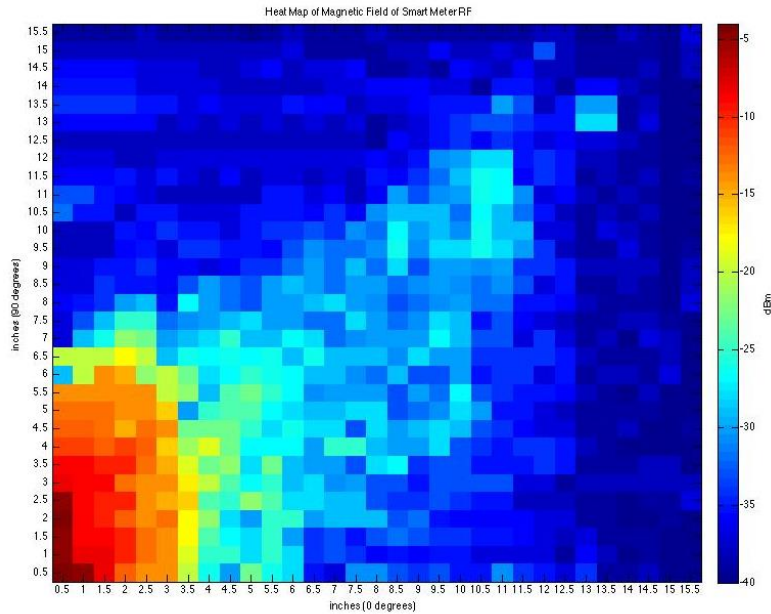
Figure 3-4 B-field measured axially in terms of dBm for varying distances between 0 and 90 degrees. This representation more clearly depicts the field’s “hotspot” being emitted by the Smart Meter at roughly the 45-degree mark.

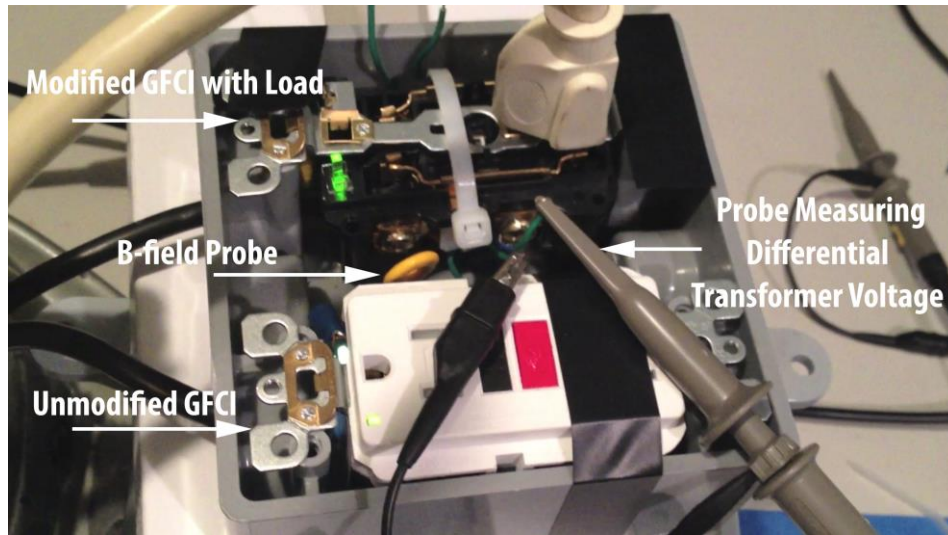
Figure 3-5 Experimental setup with both modified and unmodified control GFCI. The load is plugged into the modified GFCI in order to measure the differential transformer voltage without tripping, and a B-field probe is placed directly next to the transformer located in each device.

The experimental setup for this test can be found in Figure 3-5, which depicts both a modified and unmodified GFCI of the same model. The modified GFCI has leads soldered on the terminals of both the neutral and sense coils (both differential transformers), and there is a B-field probe placed directly beside the location of said transformers, between both GFCIs. In this case, Measurements were done off of the sense transformer, which detects faults between hot and neutral.

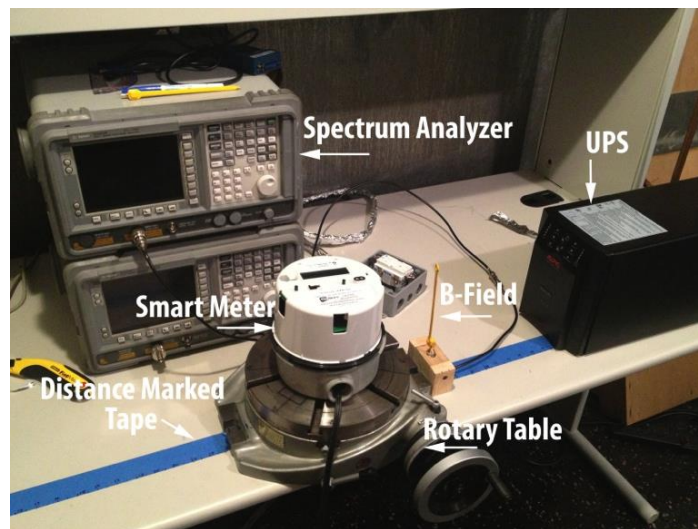
Figure 3-5 Experimental setup consisting of a 120V Smart Meter, B-field and E-field probes, UPS, two spectrum analyzers, and GFCI outlet box.

One hypothesis to explain the unexpected tripping events is that the shared power line conducts the RF signal from the meter into the GFCI electronics. In order to test the validity of this hypothesis, the two circuits must be electrically isolated as much as possible while still leaving them in normal operating modes. In the laboratory, two similar GFCIs, made by different manufacturers, and a single 120 VAC Smart Meter were each powered using a separate AC power source.

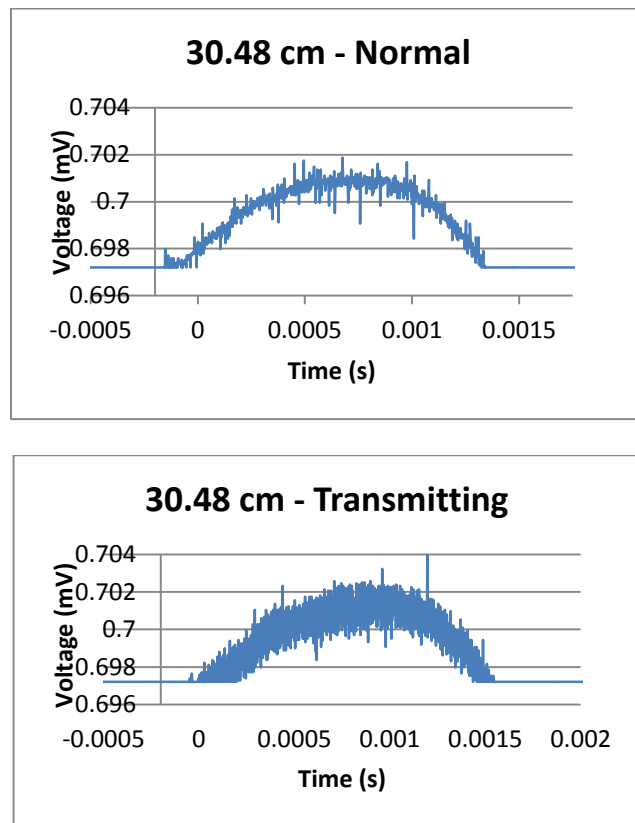
Figure 4-1 These are the peaks of the load being applied (100W light bulb) to the modified GFCI at 30.48 cm (12 inches) during regular operation and during a trip while the Smart Meter was transmitting.

From here, testing was done in intervals of 2.54 cm, or 1 inch. A 100W light bulb was used as a load in these tests, allowing for a comparison of the waveform both during normal operation and during an RF transmission from the Smart Meter. In Figure 4-1, it can be seen that a large amount of interference is induced on the coil and measured during a trip at the same time as a Smart Meter RF transmission occurs. The peak of the waveform during transmission is approximately 0.702 V (though there is a moment when 0.704 V is recorded) and the peak during normal operation is approximately 0.701 V. This resulted in an approximate 0.0013 V differential.

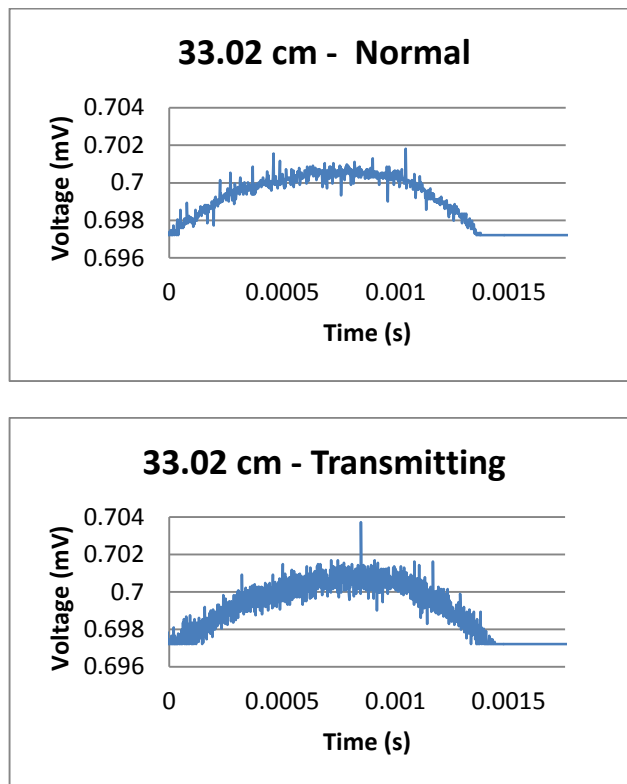
Figure 4-2 These are the peaks of the load being applied (100W light bulb) to the modified GFCI at 33.02 cm (13 inches) during regular operation and during a trip while the Smart Meter was transmitting.

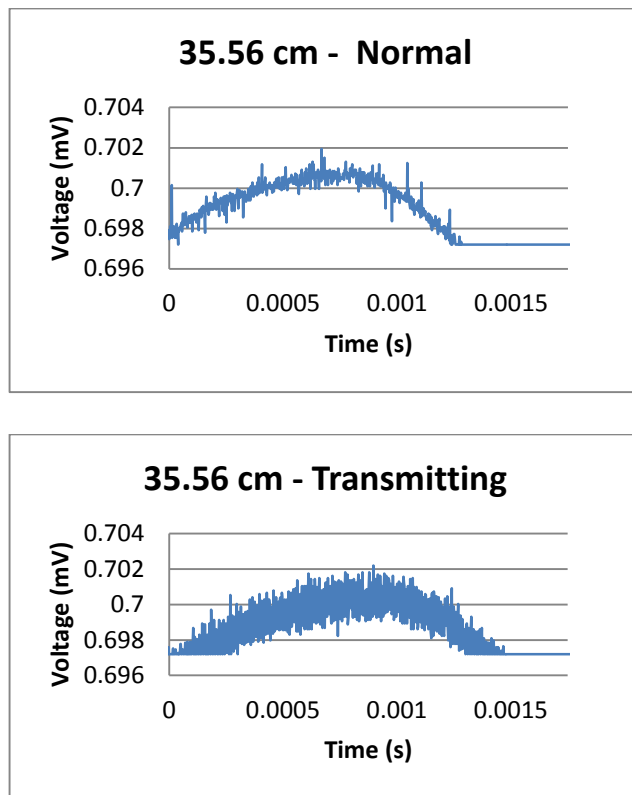
Figure 4-3 Peaks of the waveform of the load being applied (100W light bulb) to the modified GFCI at 35.56 cm (14 inches) during regular operation and during a trip while the Smart Meter was transmitting.

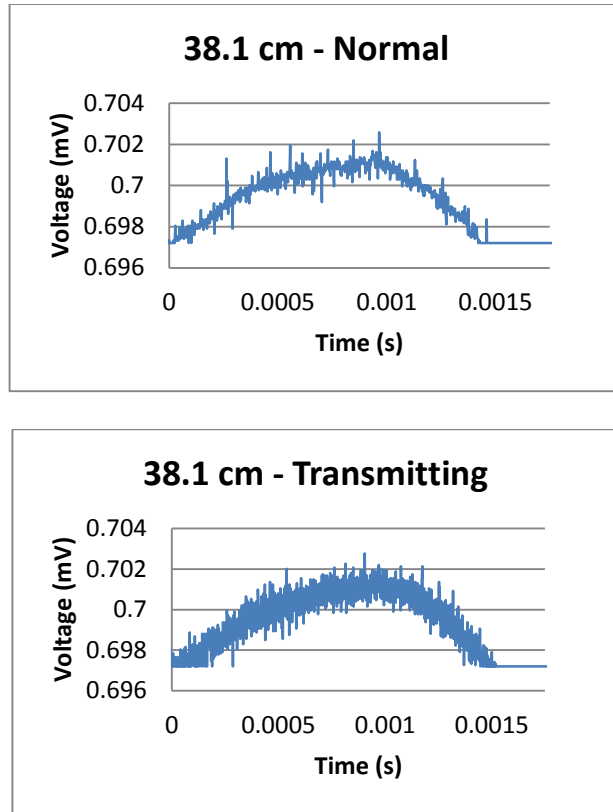
Figure 4-4 These are the peaks of the load being applied (100W light bulb) to the modified GFCI at 38.10 cm (15 inches) during regular operation and during a trip while the Smart Meter was transmitting.

Distance testing at 38.1 cm resulted in an approximate transmitting peak of 0.7017 V, an approximate normal operating peak of 0.7011 V, and a differential of 0.00064 V. Compared to the other tests, this was slightly lower than the previous two tests and more than half the differential of the initial 30.48 cm test. Results can be seen in Figure 4-4 below. A summary table containing the approximate transmitting and normal operating peaks of each distance, as well as the differential, can be found in Table 1.

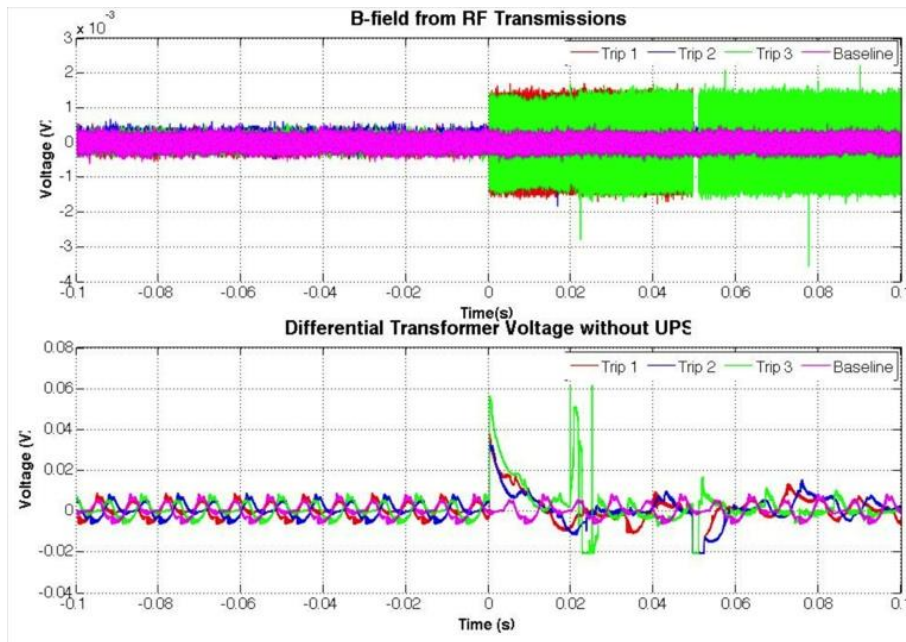
Figure 4-1 Tripping event measured across the differential transformer. Top: B-field measured from RF transmissions of the Smart Meter, Bottom: differential transformer voltage measured across the same time span as the RF transmissions. Each color of the RF transmissions corresponds with the differential voltage waveform colors.

is recorded, and at that same moment the GFCI tripped. This is definitive evidence of RF transmissions affecting GFCIs. The same occurrence happens with the ground-neutral transformer in Figure 4-2.

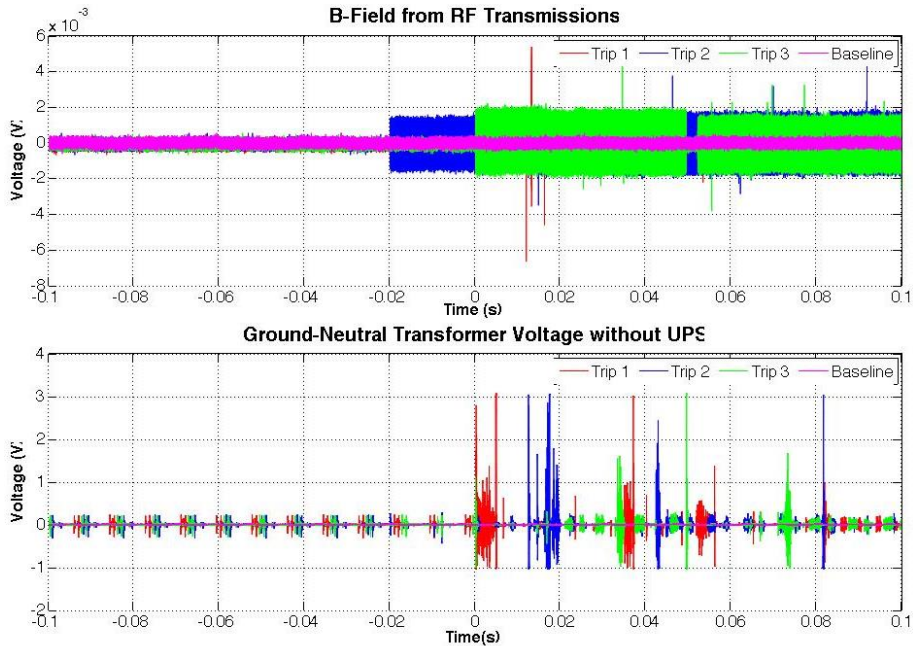
Figure 4-2 Tripping event of ground-neutral transformer. Top: b-field created from RF transmissions of Smart Meter, Bottom: ground-neutral transformer voltage during the same time span as the RF transmissions. Each color of the RF transmissions corresponds with the ground-neutral voltage waveforms of the same color.

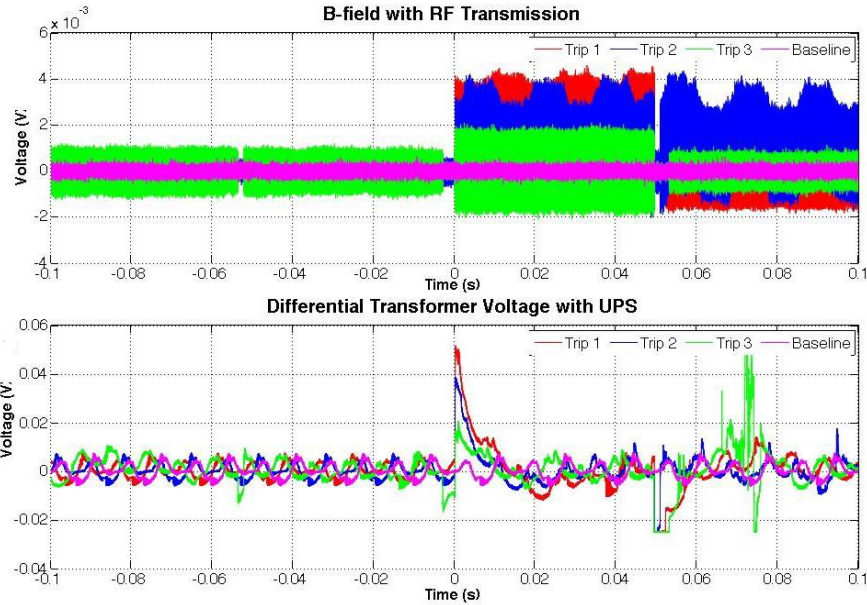
Figure 4-3 Tripping event of differential transformer while GFCI is powered from UPS.

Again, each of these tests had three tripping events recorded and a baseline to show the difference in voltage during RF transmissions of the Smart Meter. The differential transformer and ground-neutral transformer were both tested independently of each other. The waveforms measured across the differential transformer can be found in Figure 4-3, and those measured across the ground-neutral transformer can be seen in Figure 4-4. As seen in these figures, tripping events occurred similar to those seen earlier.

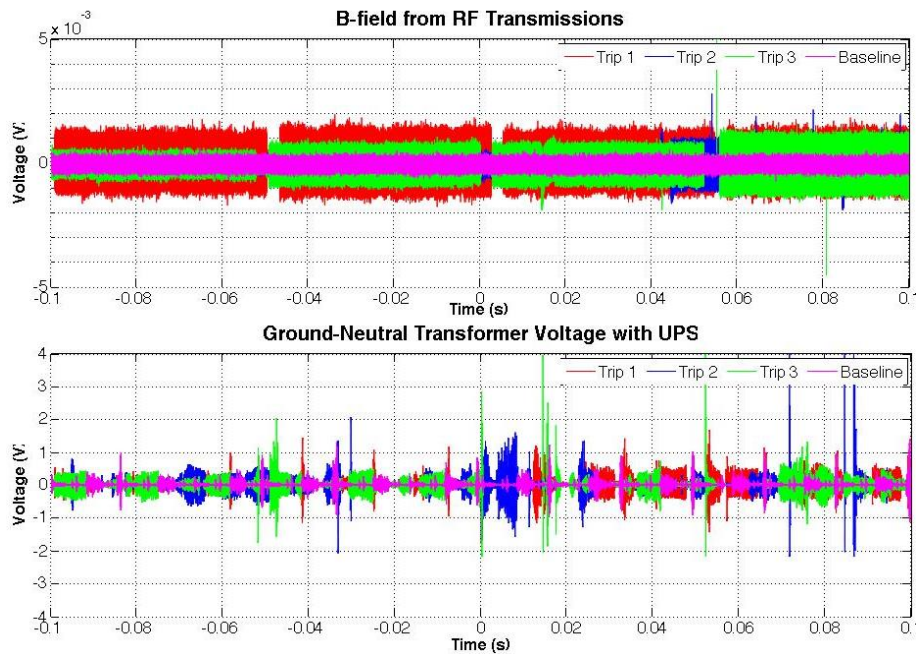
Figure 4-4 Tripping event of ground-neutral transformer while GFCI is powered from UPS. Top: B-field created from RF transmissions of Smart Meter, Bottom: ground-neutral transformer voltage during the same time span as the RF transmissions. Each color of the RF transmissions corresponds with the ground-neutral voltage waveforms of the same color.

One interesting note is the rapid occurrence of transmissions occurring when the voltages were measured across the ground-neutral coil. During that test, they were occurring so rapidly and since the scope was manually triggered during measurement of the ground-neutral coil, many spikes are observed before the trigger event occurs.

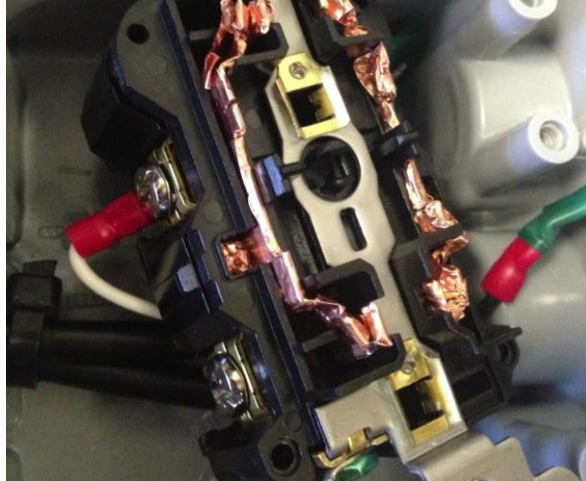
Figure 5-1 A GFCI with copper tape wrapped around the hot and neutral brass conductors. This successfully prevented any tripping from occurring.

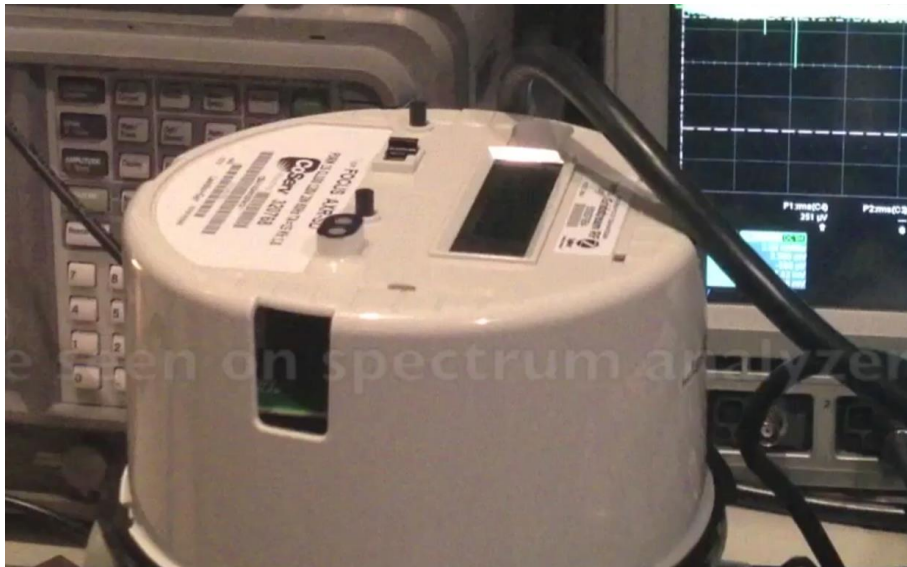
Figure 5-2 A screen capture from a video recording of evidence of GFCI tripping due to RF interference of a Smart Meter. Here, it can be seen that the wires being used to power the GFCI off of the Smart Meter are put in a circular fashion. It was found that this increased tripping events, and is possibly acting as an antenna.

It was noticed that when the power line being shared between the Smart Meter and the GFCI was moved during testing that this would sometime induce tripping. Literally moving the wire a few inches would immediately cause tripping to occur. After some testing, it was found that placing the wire in a looped fashion that it would begin to trip more often than before. At this time it was known that interference being experienced by the GFCI was a combination of both radiative and conductive types, but the possibility that the shared power line acted as an antenna had yet to be considered. It was assumed that the components affected by radiative interference must be the ones affected by magnetic fields (such as the differential transformers and the solenoid found in the GFCIs).

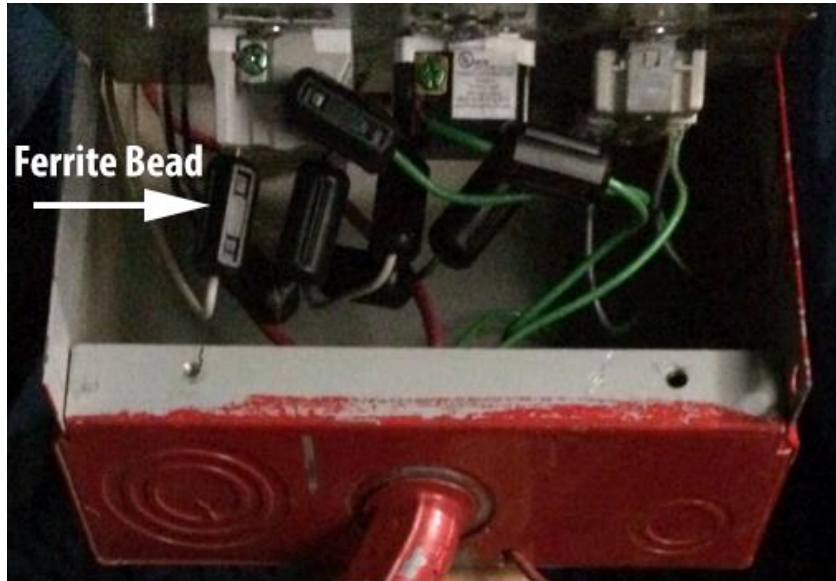
Figure 6-1 Ferrite beads placed on the hot, neutral, and earth ground lines of two brands of GFCIs. Note, the two ferrites on the hot line, though this proved to be unnecessary.

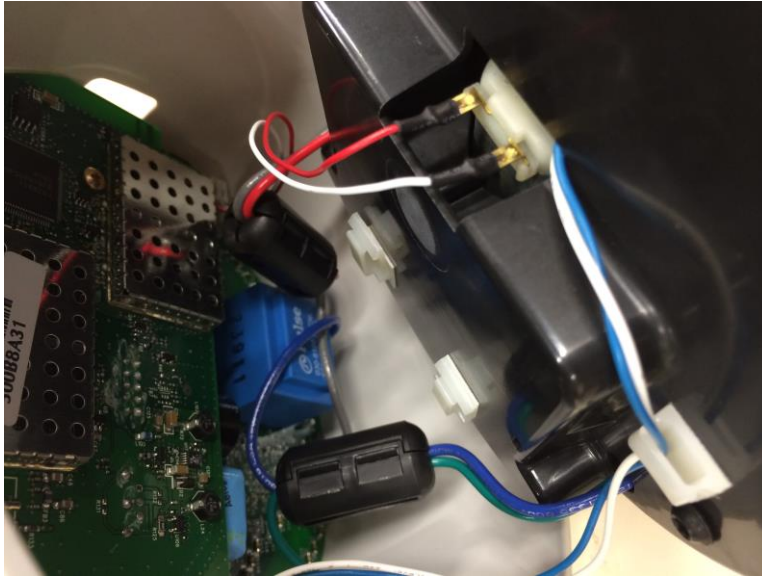
Figure 6-2 Ferrite applied from within the Smart Meter, one on the red and white wires, and one on the blue and green wires. These locations were provided by the contracting company and were claimed to be preventing any tripping from occurring.

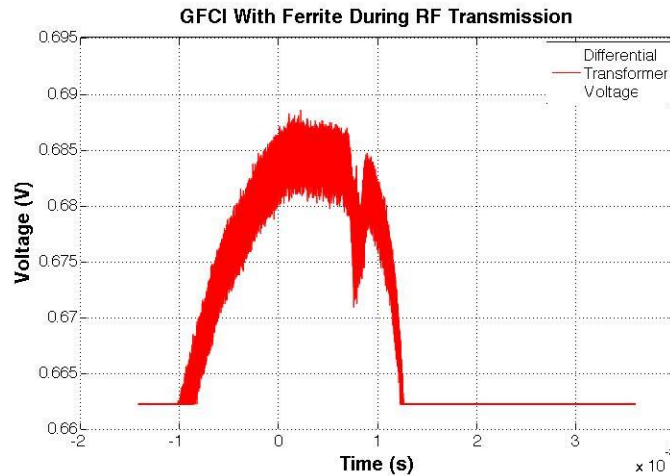
Figure 6-3 Voltage measurements of the differential transformer of a modified GFCI while ferrite beads are applied to its hot, neutral, and earth ground wires, and during RF transmission of the Smart Meter. It's clear that there is much less noise than during the distance testing with the modified GFCI previously (Figures 4-1 through 4-4). The extra spike is an anomaly that couldn't be identified (a new light bulb was used as the other one burnt out), but didn't hinder any performance of the load.

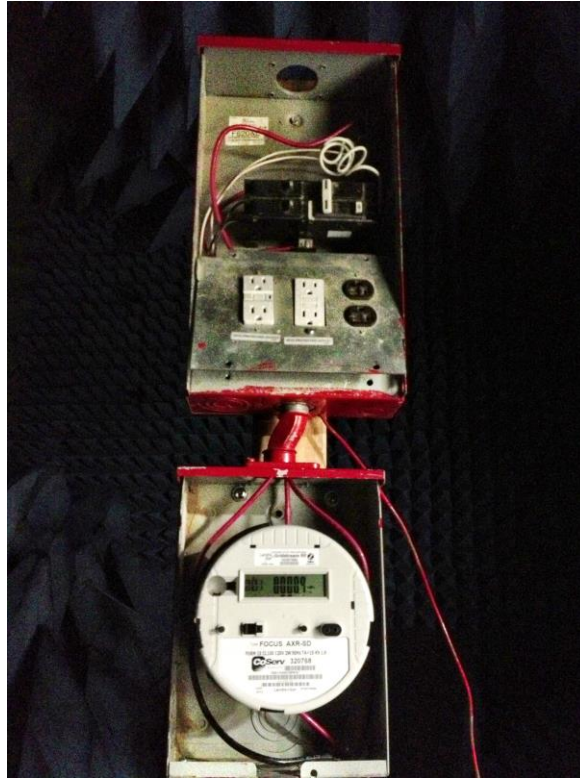
Figure 6-4 The construction stand used for testing the Smart Meter and GFCIs. Note that the fronts of the metal compartments are missing, but during tests were placed back on in attempt to replicate as closely as possible the scenario found on construction sites.

an antenna for the RF transmissions, as well as realizing that the distance between the GFCI and Smart Meter didn't matter in this configuration, the wires were cut down. This was also done to configure the stand as closely as possible to what was found in actual construction sites. After this was done the amount of tripping drastically decreased. If construction sites are having trouble with tripping and the wires used to power the GFCI were not cut down and simply shoved inside the metal box then this could potentially be the problem.

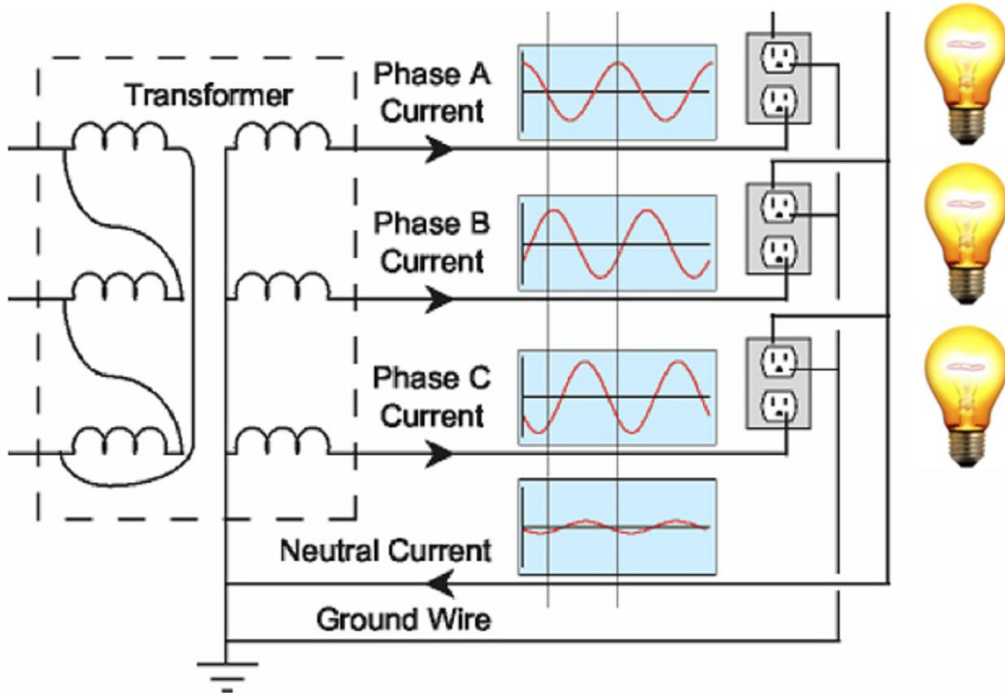
Figure 6-5 An example of how power phase, and thus current phase, of inductive loads can trick GFCIs into seeing a differential of current moving through them and causing trips. This could be a potential cause of trips for construction sites if they use certain power tools.

Any device that has an inductive load, specifically an inductive load that changes, can trip a GFCI. This is the same reason that refrigerators are not supposed to be plugged into GFCIs, as the coils used may move the power out of phase. An example of this can be seen in Figure 6-5. While most handheld tools are generally okay to use, if something like a table saw were to be plugged in to a GFCI more than likely it would cause a trip. It was never specified what was actually being plugged into the GFCIs on the construction stand, but it was assumed that a construction site would most likely know that it's bad practice to use inductive loads with their GFCIs.
