Experimental Study On Seismic Performance Of Reinforced Concrete Coupling Beams  
And Rectangular Squat Walls With Innovative Reinforcement Configurations

POORYA HAJYALIKHANI

THE UNIVERSITY OF TEXAS AT ARLINGTON

December 2015

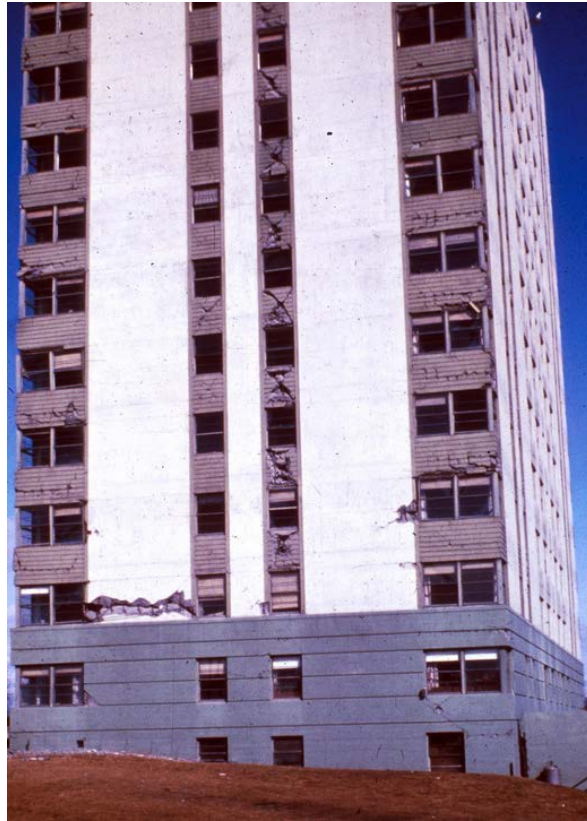
Figure 1-3 Diagram showing failure of conventional coupling beam during Alaska Earthquake (United States Geological Survey (1964))

In 1964, the earthquake in Alaska caused significant damage throughout the Anchorage Alaska area. Conventionally detailed coupling beams in the perimeter walls of the Mount McKinley Hotel were severely damaged during this earthquake, shown in Figure 1.3. This event and subsequent experimental research after the earthquake showed that coupling beams with conventional reinforcement consisting of longitudinal bars and stirrups are vulnerable when subjected large load reversals (Paulay, 1971).

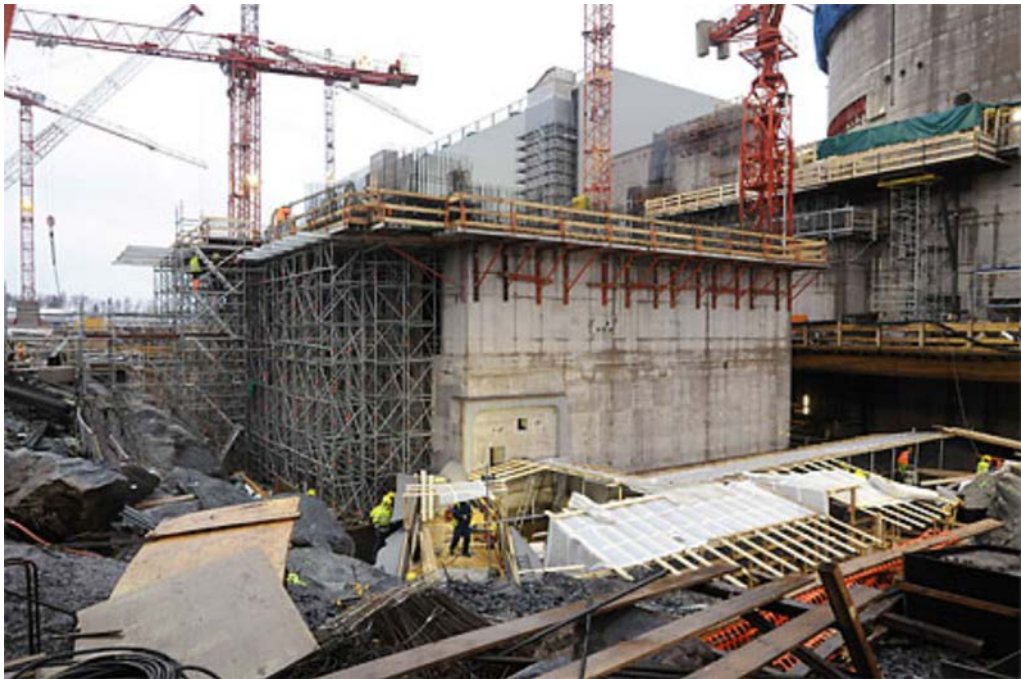
Figure 1-6 Shear wall in a nuclear reactor, Olkiluoto, Finland

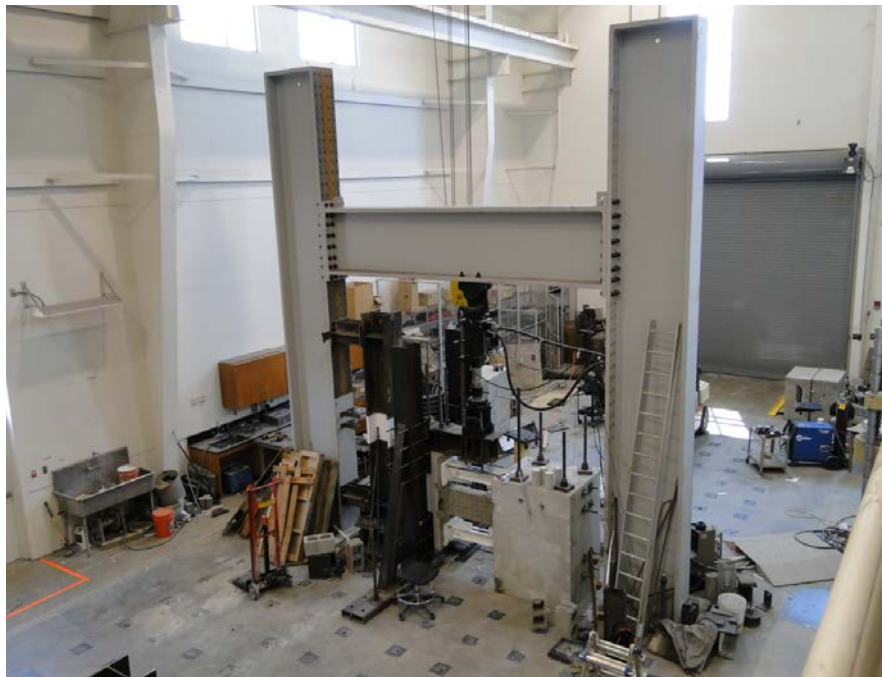
Figure 3.11 Test setup for the coupling beam experiments

For the squat wall test, the cyclic load was applied with the vertical actuator, which placed on the top of the loading block directly to produce maximum moment near the footing block and approximately zero moment at the other end of the wall, near the loading block. All of the test specimens were also braced laterally to prevent out-of-plane movements and twisting.

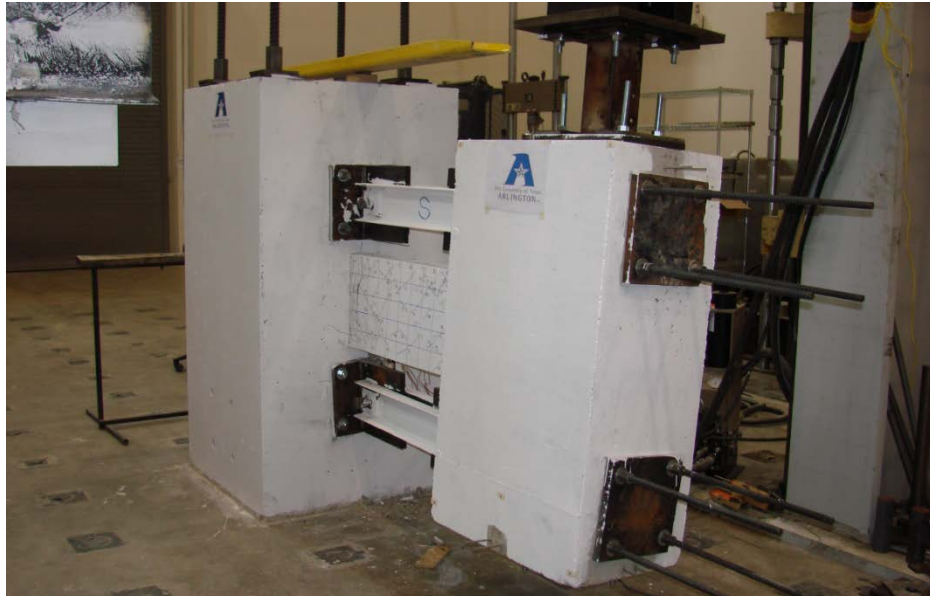
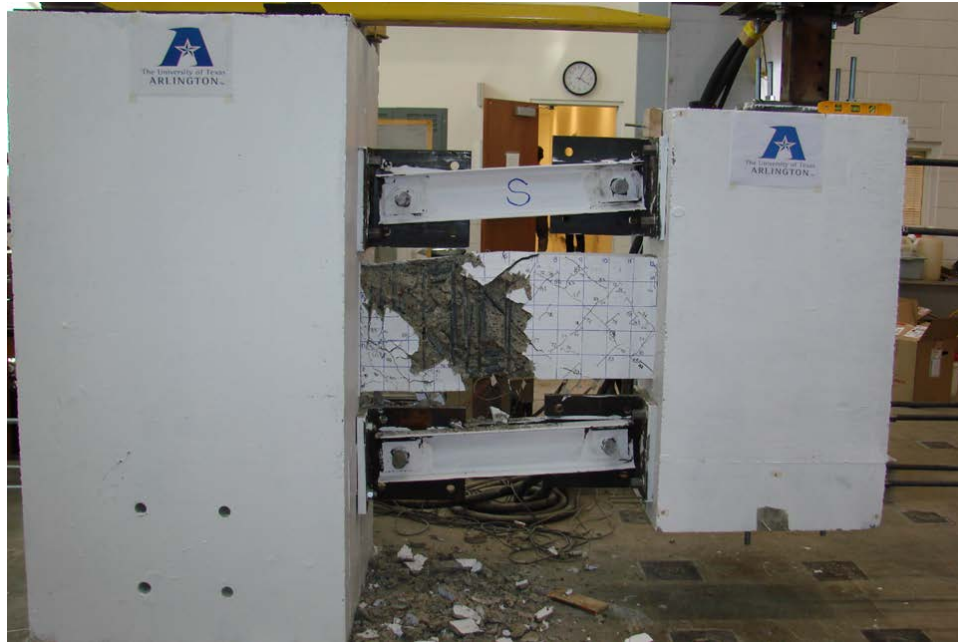
Figure 4-2 Torsion failures for CB-1

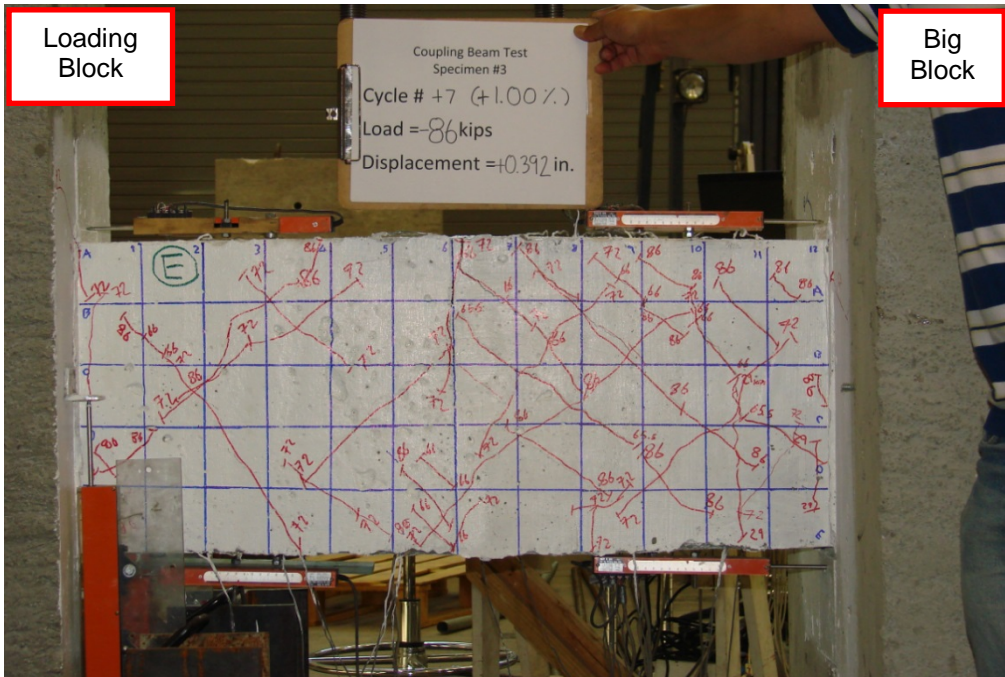
Figure 4-9 Sliding shear failures for CB-3

The shear force/stress versus drift response of Specimen CB-3, is demonstrated in Figure 4.8. Links on the top and bottom of the coupling beam did not use during the test for this specimen. Therefore, could not impose the state of double curvature on the coupling beam completely based on the rotation of the loading block and also, could not prevent the elongation of the beam due to the cracks. LVDT's used to calculate the vertical displacement of the big block did not install, thus, the accurate drift could not be achieved. The maximum load imposed on this specimen was approximately 99 kips at 1.66% drift, which was equivalent to an average shear stress of  $13.2\sqrt{f'_c}$  (psi). The first observed cracks were flexural cracks near the big block that developed at 0.25% drift and approximately 29 kip. As specimen was pushed to 0.75% drift, first diagonal cracks were observed. The critical flexural crack was formed at the mid-length of the beam where the beam did not have the longitudinal bars. Therefore, after few cycles the diagonal crack and flexural crack opened wider and also, the diagonal bars were yielded, thus leading to a less effective aggregate interlocking resistance along the open cracks. On the other hand, the dowel action resistance was equal to zero at the mid-length of the beam due to no longitudinal bars at that location, thus sliding developed along a plane parallel to the transverse reinforcement due to the wide cracks and no reinforcement resistance which leads to loss of beam stiffness and strength, as shown in Figure 4.9.

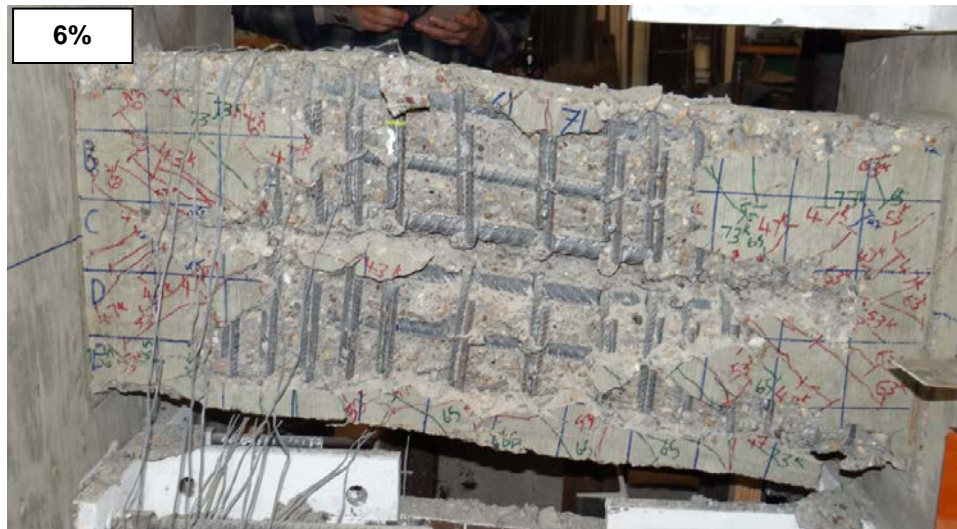
Figure 4.17 Crack pattern and damage progress of DBCBs with 1" gap width

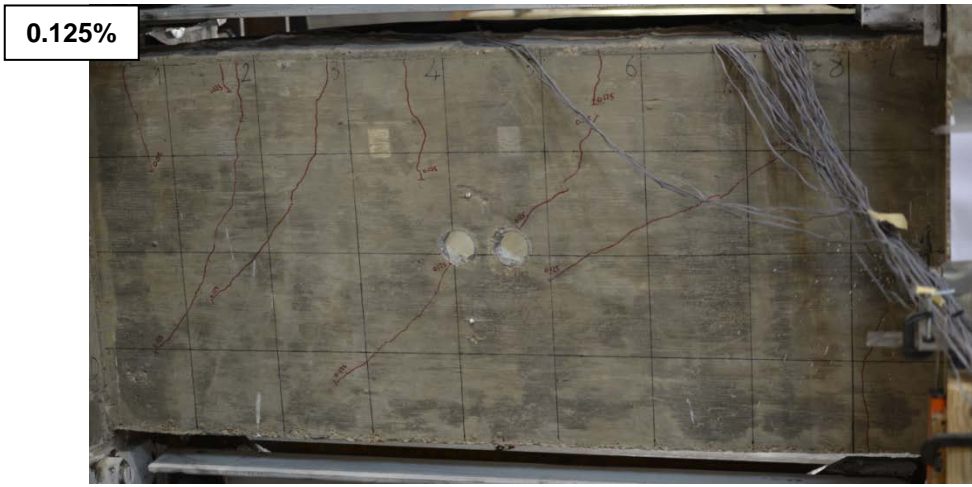
Figure 4.19 Crack pattern and damage progress of full scale DBCBs with 1.5" gap
