HYDROCARBON POOL FIRE PERFORMANCE OF FIBER REINFORCED POLYMER  
(FRP) STRENGTHENED AND THERMALLY INSULATED BRIDGE GIRDERS

Presented to the Faculty of the Graduate School of  
The University of Texas at Arlington in Partial Fulfillment  
of the Requirements  
for the Degree of

DECEMBER 2016

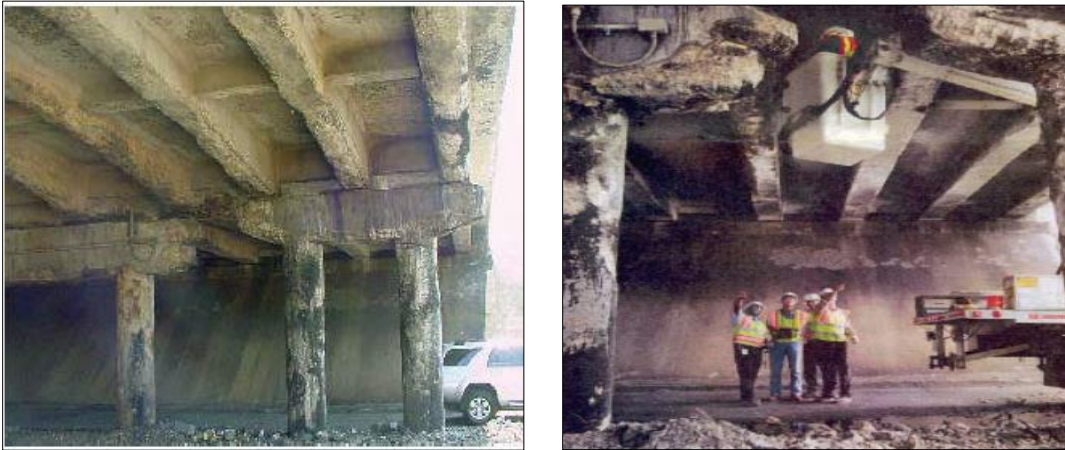
Figure 1-4 Hydrocarbon fire damaged SH183 bridge over MacArthur Boulevard (Sika Corporation 2006)

On the morning of Saturday, May 28, 2005, a 3000-gallon fuel tanker heading east on State Highway 183, Irving, TX, barreled through a guardrail and spiraled off a bridge at about 6:30 am before landing upside down and exploding on MacArthur Boulevard (Sika Corporation 2006). The fire severely burned and cracked the bridge, as shown in Figure 1-4. It took firefighters 30 minutes to extinguish the blaze. After the accident, TXDOT engineers conducted a thorough evaluation and concluded that the damage was extensive and recommended repair. The repair process involved removal of 1000 ft<sup>3</sup> (14.2 m<sup>3</sup>) of delaminated concrete, applying wet spray-applied fiber reinforced mortar and finally strengthening with CFRP. Figure 1-5 shows the bridge after repair.

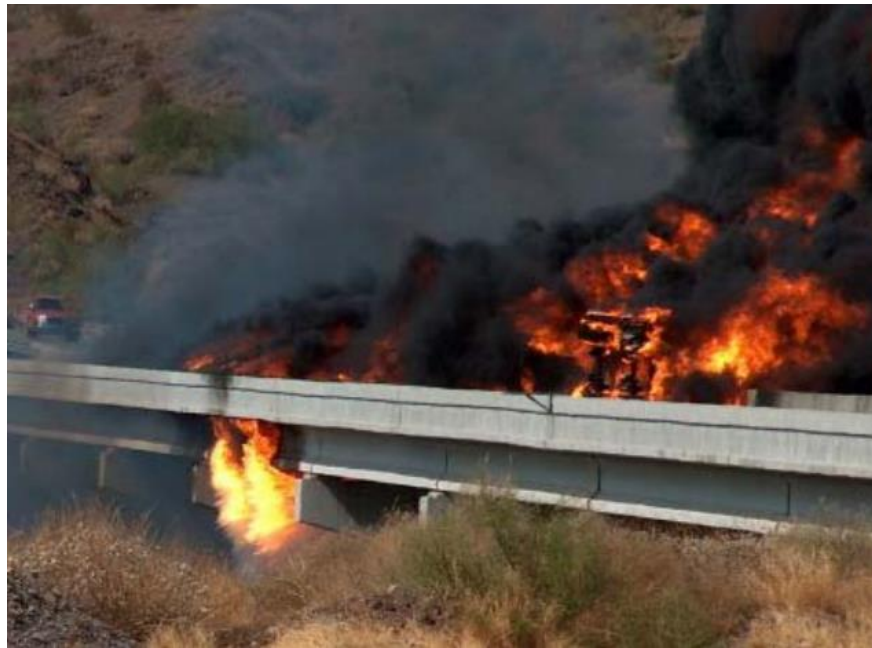
exterior girders and the deck overhangs were the sections with the most severe localized damage (Kodur et al. 2010).

Figure 2-3 Bill Williams River Bridge fire (Marth et al. 2007)

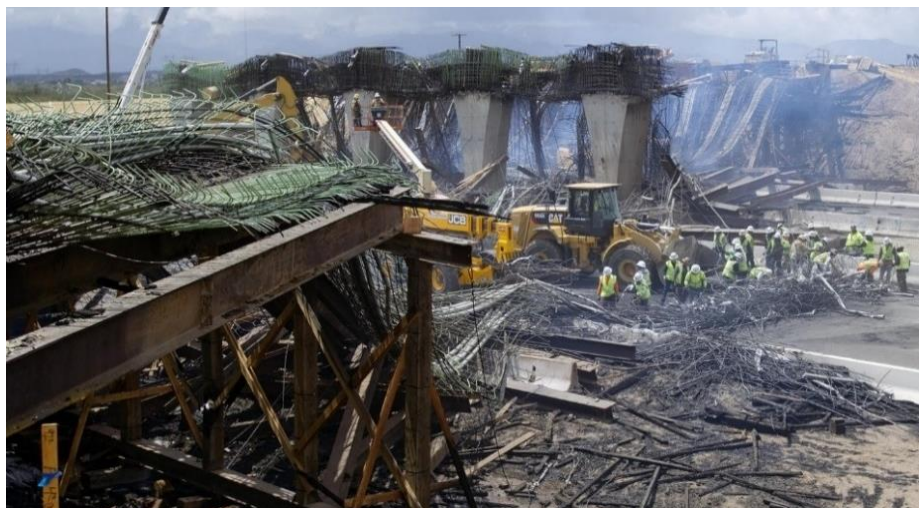
Figure 2-4 The collapse of the under-construction Rancho Road Bridge due to accidental fire (Vives et al. 2014)

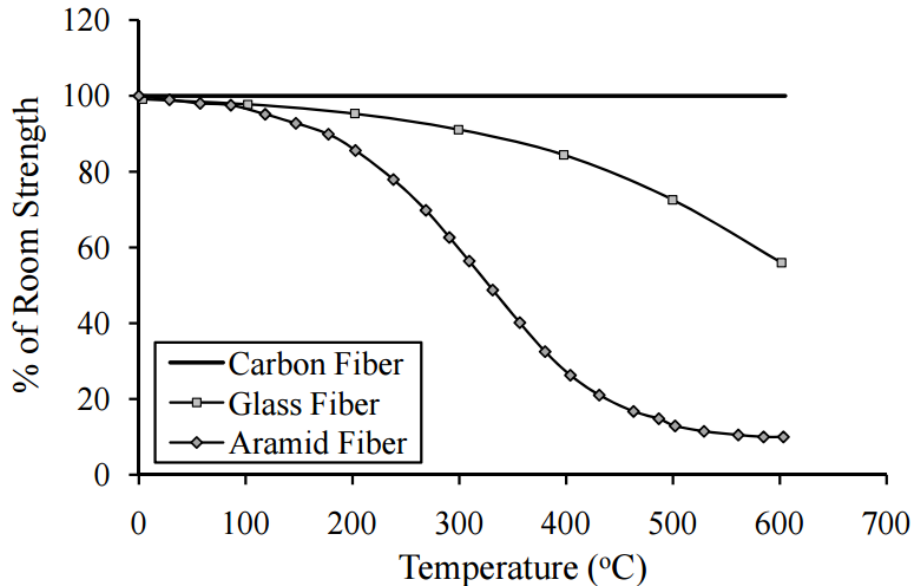
Figure 2-7 Variation of tensile strength of carbon, glass and aramid fibers with temperature (Ahmed 2010)

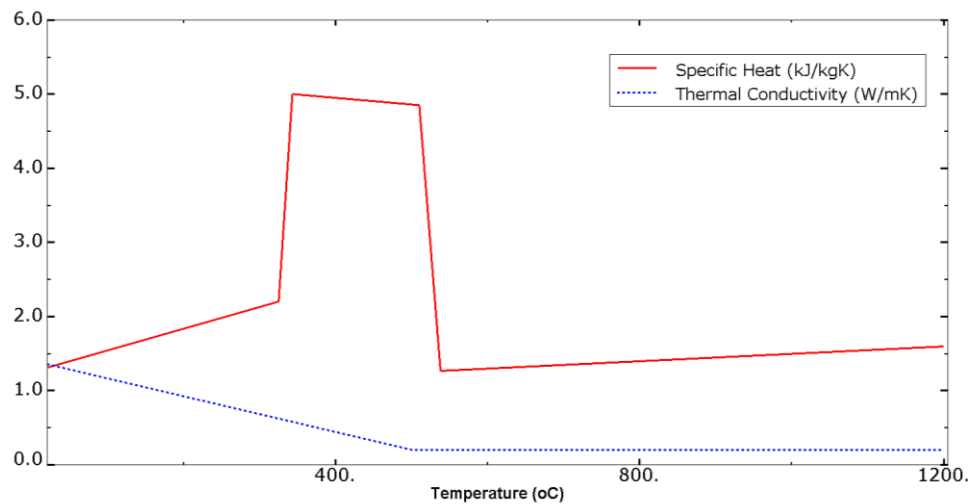
Figure 2-8 Variation of thermal conductivity and specific heat as a function of temperature for CFRP laminate (Griffis et al. 1981)

plateau. The specific heat increase steadily at a slower rate up to a temperature of 325°C followed by a spike which then plateaus up to 511°C before it plunges down. It then follows a steady increase at a slower rate with increase in temperature. The plateau observed shows a consumption of additional heat because of thermal degradation of resin.

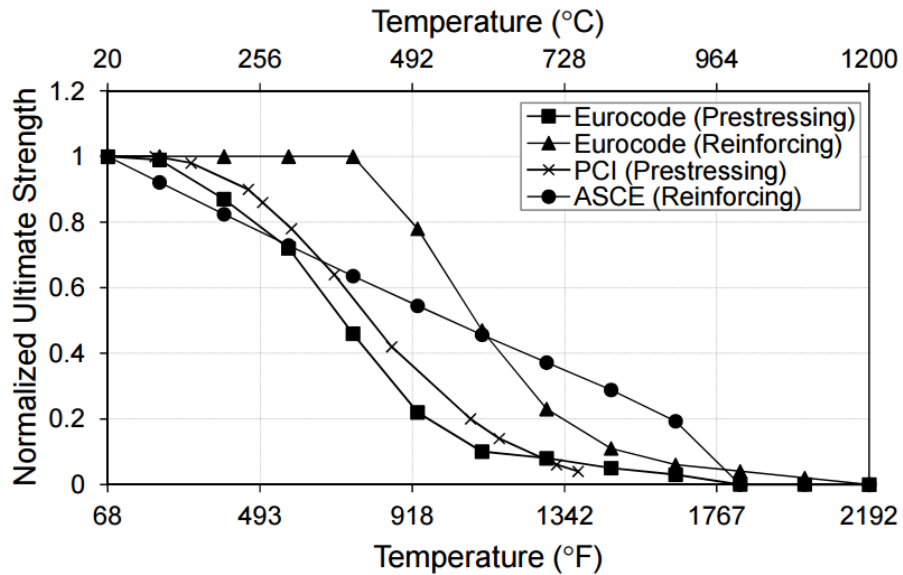
Figure 2-26 Variation of ultimate strength with temperature for mild reinforcement and prestressing steel (Eurocode 3, 2005; ASCE 1992 and PCI 2004)

Figure 2-26 depicts the variation of ultimate strength of prestressing steel and mild reinforcement with temperature as per the provision of Eurocode-3 (2004), ASCE (1992) and PCI (2004). Except for the ASCE model, all the curves show an S-shaped ultimate strength degradation curve. According to Eurocode, prestressing steels begin to lose strength at 100°C, whereas mild reinforcements do at 400°C. As per the ASCE model, mild reinforcing steel immediately begins to lose strength linearly until it reaches approximately 20 % of its strength at 900°C and completely degrades once 1000°C is reached. A strong correlation is observed between the ASCE and PCI model.

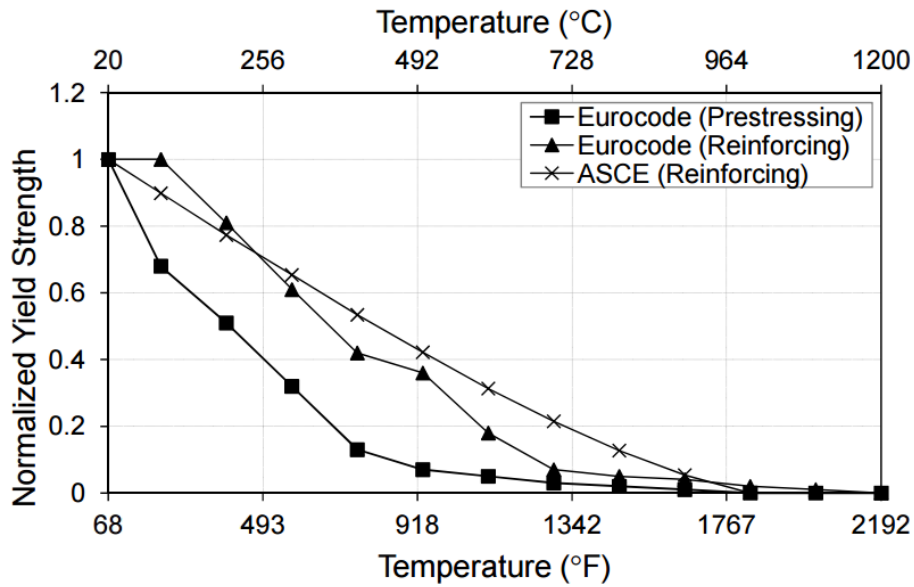
Figure 2-27 Variation of mild reinforcement and prestressing steel yield strength with temperature (Eurocode 3, 2005; ASCE 1992 and PCI 2004)

with increase in temperature. The Eurocode model for mild steel shows a decrease in yield strength above 100°C, to the contrary the ASCE model shows a decrease as soon as the temperature goes above ambient temperature.

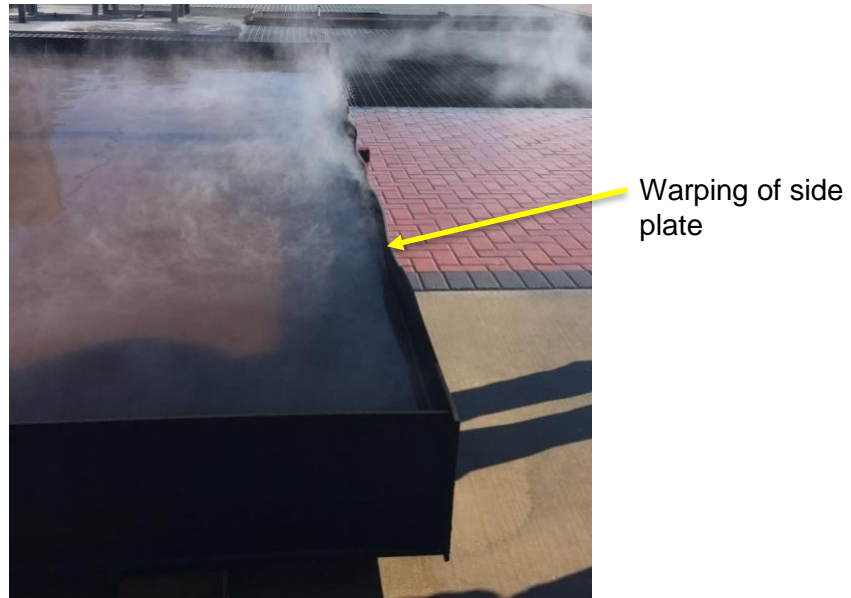
Figure 5-5 Warping of side of the pan

down. The fire was then started and observation was made for 5 minutes by varying the fuel flow rate. It was found out that 20 gallons per minute were the optimum flow rate. After putting off the fire, the pan showed warping, as shown in Figure 5-5. As a remedy, more stiffeners were welded as shown in Figure 5-6.

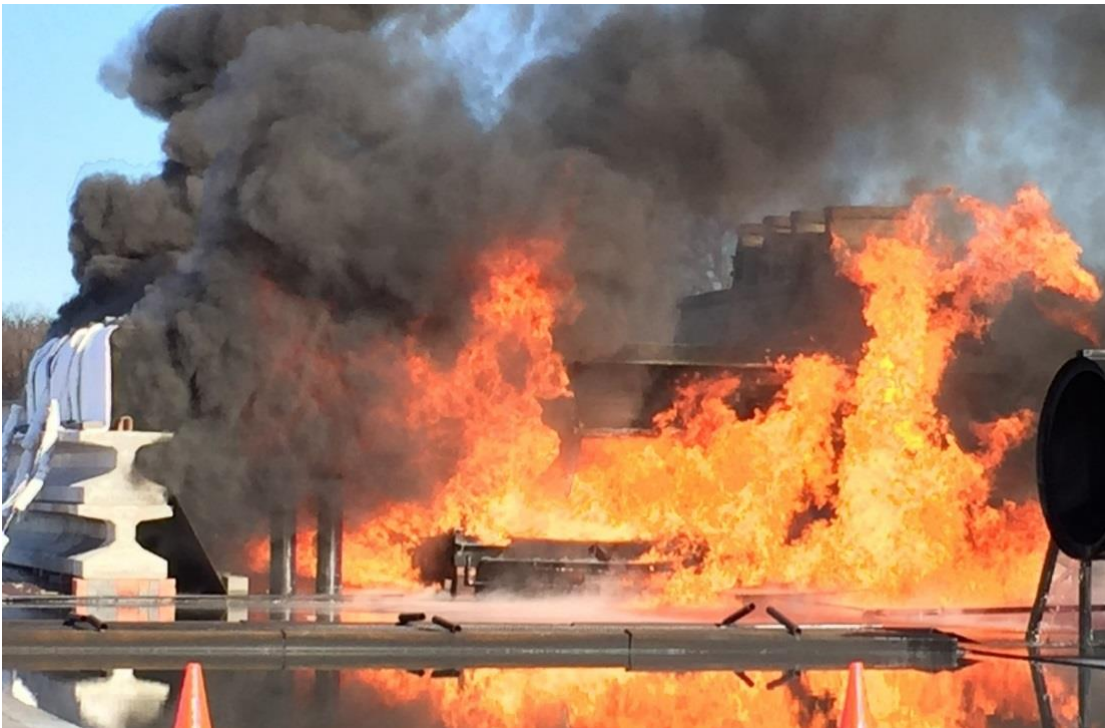
Figure 5-14 Fire test

It was a calm and a non-windy at the beginning of the test as it can be observed from the even distribution of the flame shown in Figure 5-14. But few minutes past the start of the fire, a southeast wind came and disrupted the even distribution of the fire as shown in Figure 5-15. The wind persisted until the end of the test. The test was conducted for an hour burning 4.32 m<sup>3</sup> (1140 gallons) of E-III fuel.

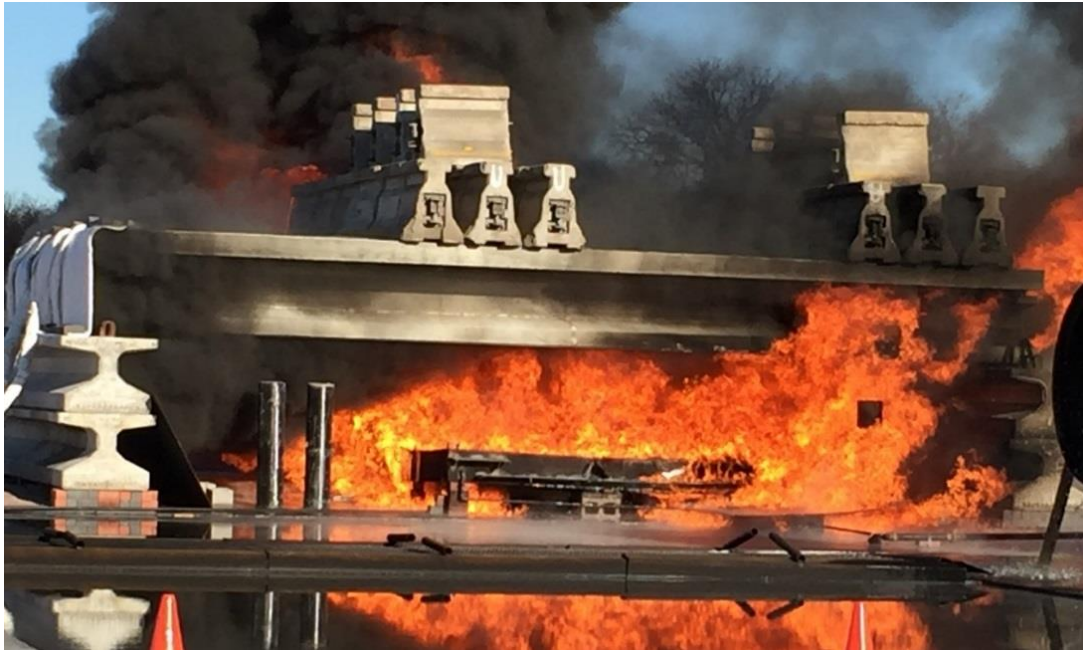
Figure 5-15 Uneven distribution of fire due to the wind

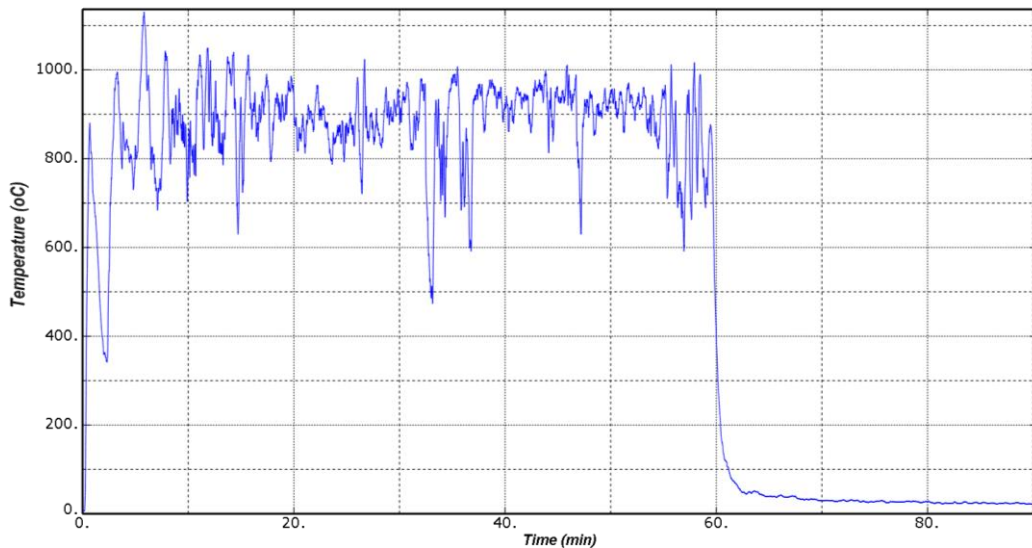
Figure 5-17 Temperature vs. time curve measured by thermocouple-1BO

as 1131°C. During the growth phase, the fire peaked to a temperature of 876°C within 41 secs after starting the test. The temperature plunged down by 800°C in three minutes during the decay phase. The temperature from the fire goes up and down erratically due to the prevalent wind. A temperature difference of up to 640°C was observed among temperature reading taken within a 1-minute interval. This sudden rise and falling, as well as, the erratic variations of temperature caused thermal shock which eventually contributed to cracking and spalling of concrete.

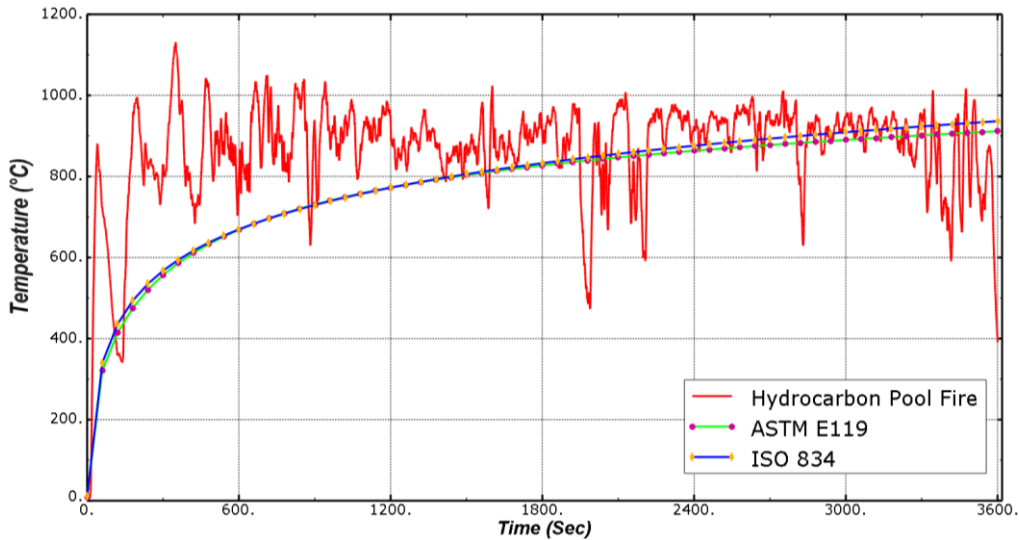
controlled condition. The temperature readings from the pool fire are more than the standard fire curves for most of the duration.

Figure 5-18 Fire curves from pool fire versus standard fire

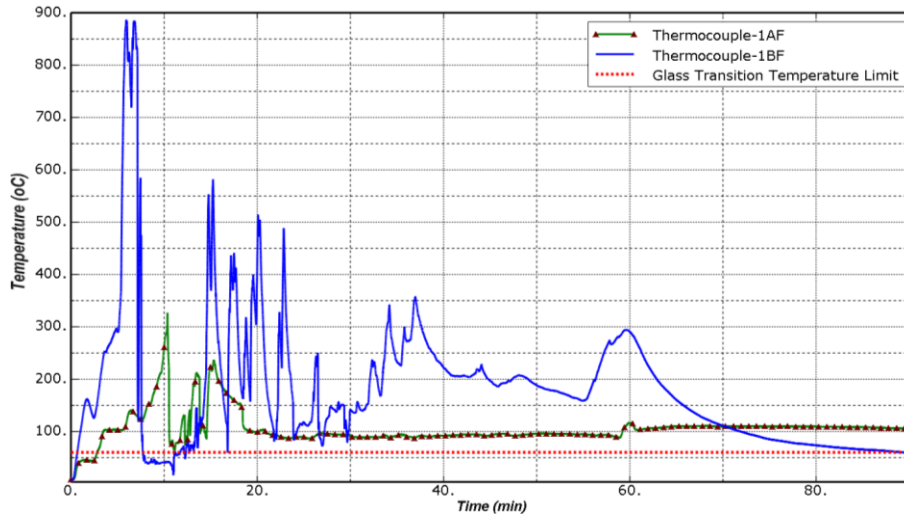
Figure 5-19 Measured temperature at FRP-concrete interface by the rmocouple 1AF & 1BF

After the test had been completed, both thermocouple-1AF and thermocouple-1BF were found on the ground under a pile of spalled concrete as shown in Figure 5-20. In addition to the wind, this resulted in a series of spike followed by falling of temperature reading for both thermocouples as observed in Figure 5-19.

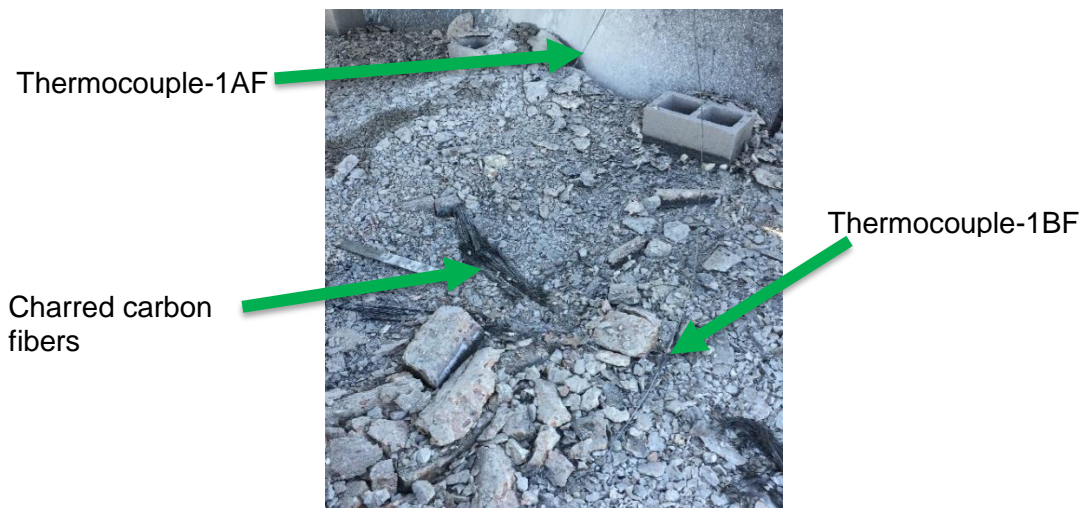
Figure 5-20 Thermocouples under a pile of spalled concrete and charred carbon fibers

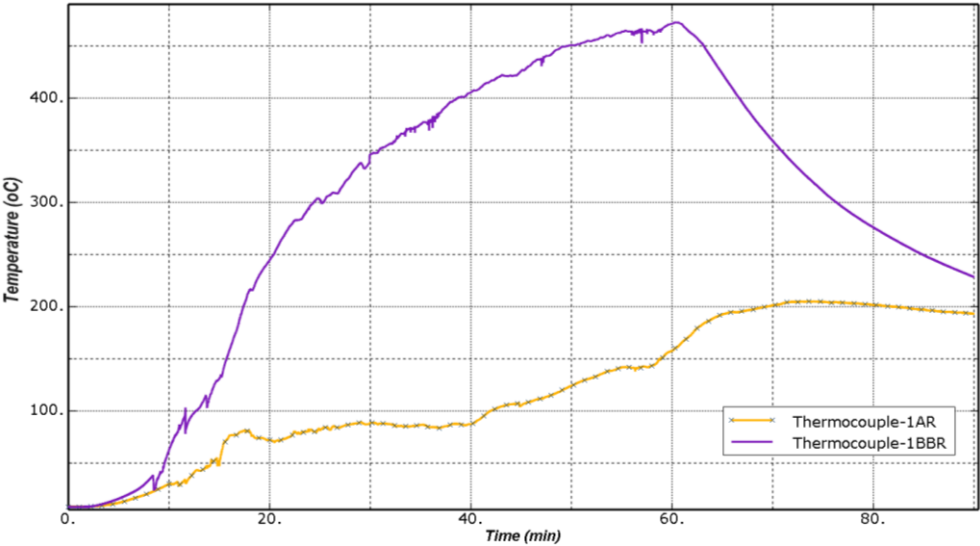
Figure 5-21 shows the temperature versus time curve for the prestressed strands. The temperature reading from thermocouple-1AR is lower than the reading from thermocouple-1BBR since the former was exposed to less fire. It is also observed from the graph that the temperature reading from thermocouple-1AR kept on increasing for approximately 20 minutes after the fire was extinguished. This is due to conduction of heat from the hot region. On the contrary, the temperature reading from thermocouple-1BBR went down as soon as the fire was extinguished since it was located in the high-temperature region. The temperature reached as high as 205°C and 473°C for thermocouple-1AR and thermocouple-1BBR, respectively. At a temperature of 473°C, prestressing strands are known to lose approximately 70 % of their strength (Eurocode-2, 2004).

Figure 5-21 Measured temperature at the prestressing strands for Girder-1 (1AR and 1BBR)

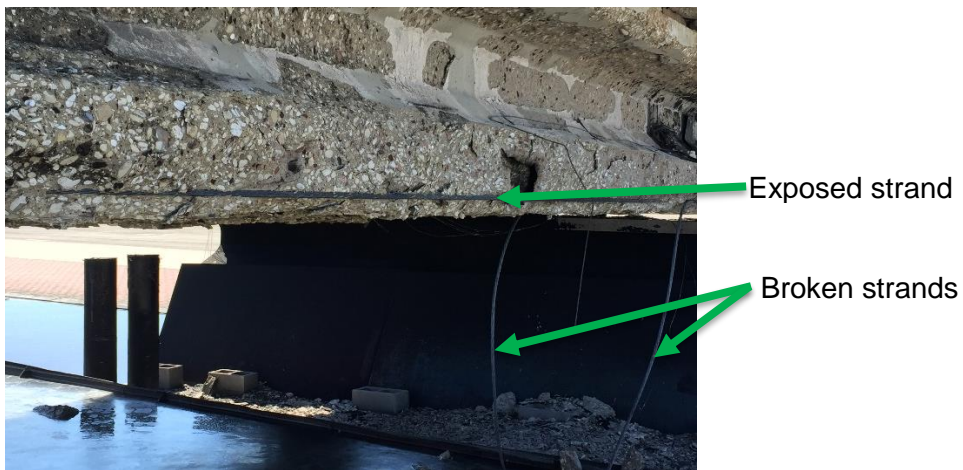
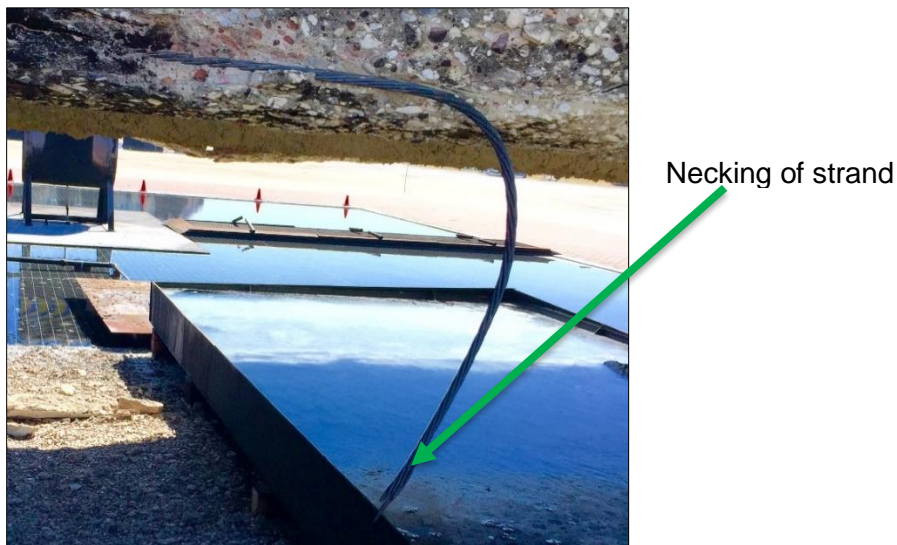
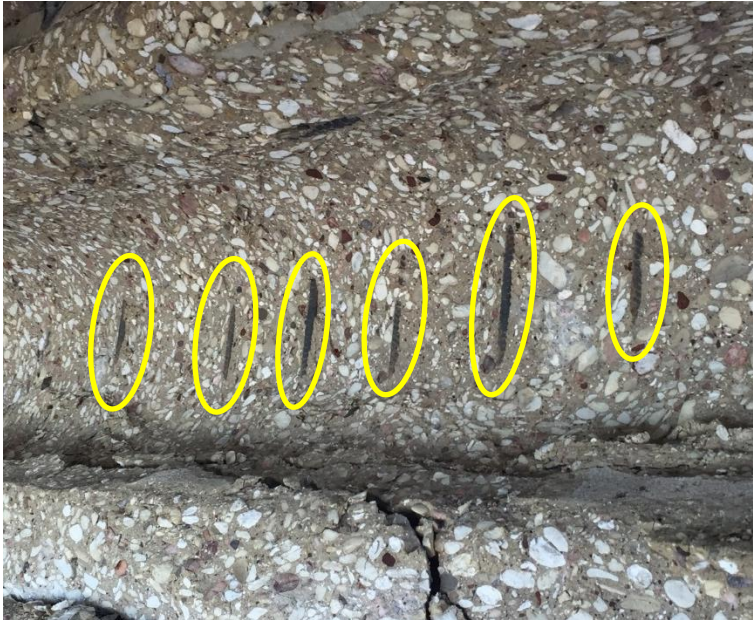
It was visually observed that two prestressing strands were broken at 3.63 m (11.9') and 3.99 m (13.1') from support-2 as shown in Figure 5-22 (a). One of the strands lost the concrete cover for approximately 3.35 m (11') of its length (Figure 5-22 (a)). The remaining strands had concrete which barely covers them. Six of the shear reinforcements, which were placed at a distance of 2.957 m (9.7ft.) from support-2, had a partial loss of concrete cover as shown in Figure 5-22 (c).

(a) Broken and exposed prestressing strands

(b) Necking of prestressing strand

(c) Exposed shear reinforcements

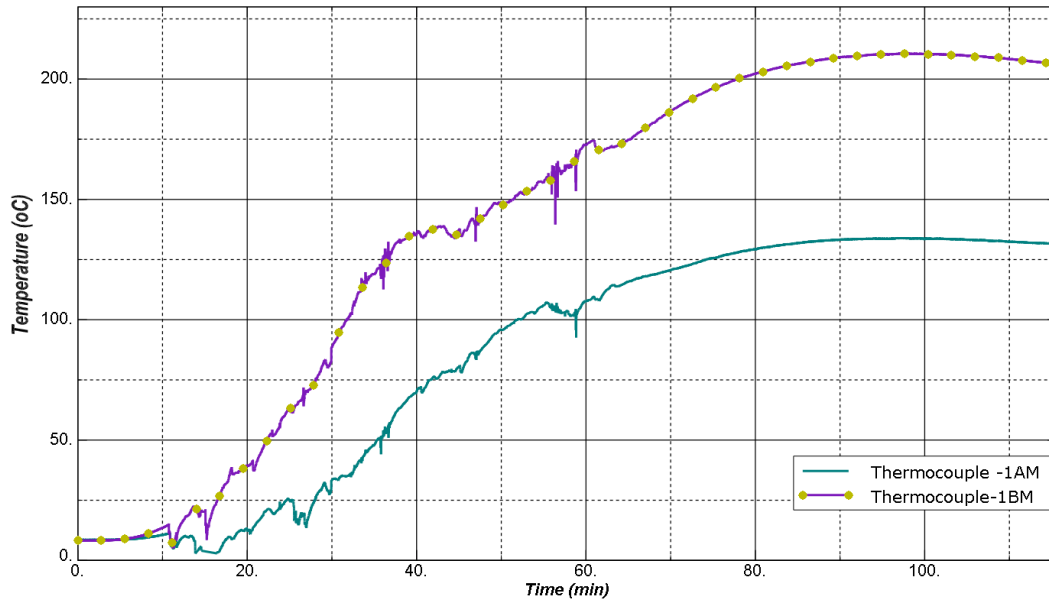
Figure 5-23 show the temperature measured as a function of time by thermocouples-1AM and thermocouple-1BM inside the web of Girder-1. As expected, the temperature measured by later was higher than the former for most of the duration of the fire. Compared to the other thermocouple installed on Girder-1, these two thermocouples took a longer time to cool down after the fire was extinguished. Temperature readings from thermocouple-1AM and thermocouple-1BM kept on increasing for approximately 55 min and 44 min respectively after extinguishing the fire, before starting to go down.

Figure 5-23 Temperature vs. time readings of thermocouple-1AM and thermocouple-1BM

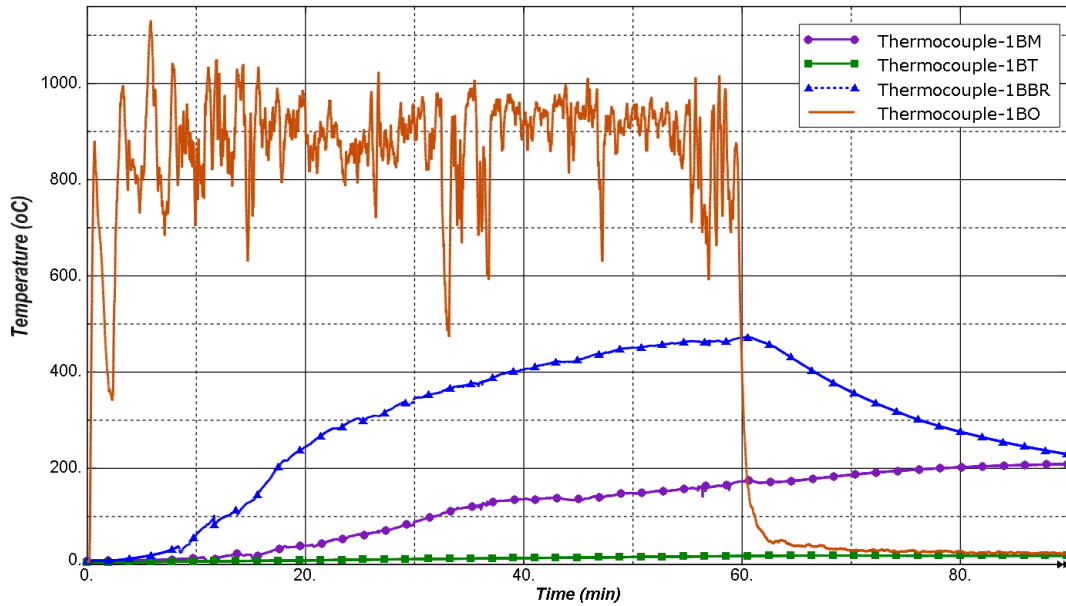
Figure 5-24 shows the progression of the fire across the cross section of the girder at its mid-span. It is observed from the figure that the measured temperature in concrete decrease with increasing depth from the bottom of the surface. This is attributed to the low thermal conductivity and high thermal capacity of concrete, which plays a key role in slowing down heat penetration to the inner layers of concrete. It is a common phenomenon in standard fire tests to observe a temperature plateau at about 100°C from the readings of the thermocouples placed inside the concrete (Hou et al., 2015; Dwikat and Kodur 2009). This is due to evaporation of free water in concrete which occur around 100°C. However, no temperature plateau was observed in current study at this temperature. This could be due to spalling/cracking of the concrete in the vicinity of the thermocouples or the migration of moisture to the inner portions of concrete sections.

Figure 5-24 Mid-span temperature vs. time reading of Girder-1 at different depths

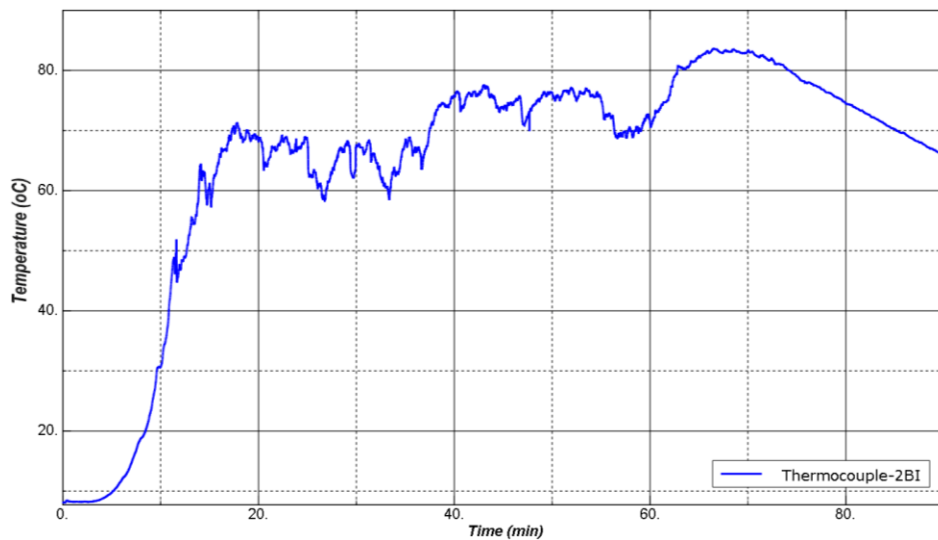
Figure 5-26 shows the temperature measured at the FRP-insulation interface. From the graph, it is observed that the temperature was constant for the first 4 minutes and then sharply increased to 71°C in approximately 13 min and stayed steadily fluctuating between 60°C and 80°C till the fire was extinguished. The sharp rise in temperature was due to the ingress of smoke through the cracks observed on the surface of the insulation. Inspection of the concrete underneath the fireproofing around the vicinity of thermocouple-2BI revealed smoke on the concrete surface (Figure 5-27).

Figure 5-26 Temperature vs time measured at the FRP-fireproofing interface of Girder-2

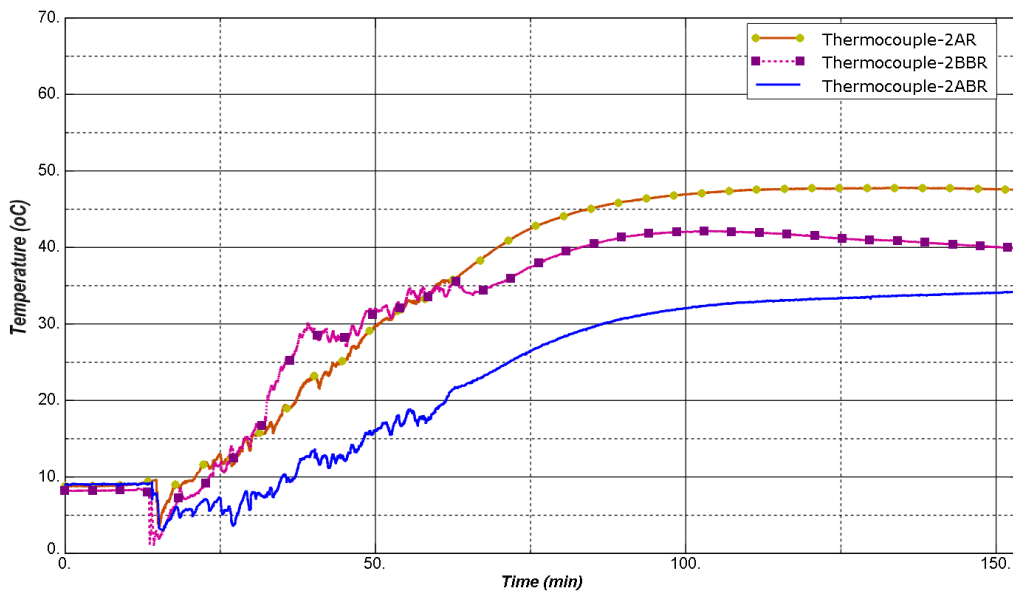
The fireproofing not only protected the FRP but it also insulated the prestressing strands and the concrete. Figure 5-31 shows the temperature vs. time measurements at three different locations of the prestressing strands of Girder-2. The maximum temperature measured was 48°C. Prestressing strand are known to retain 100 % of their strength up to a temperature of 100°C (Eurocode-2, 2004).

Figure 5-31 Measured strand temperature for Girder-2

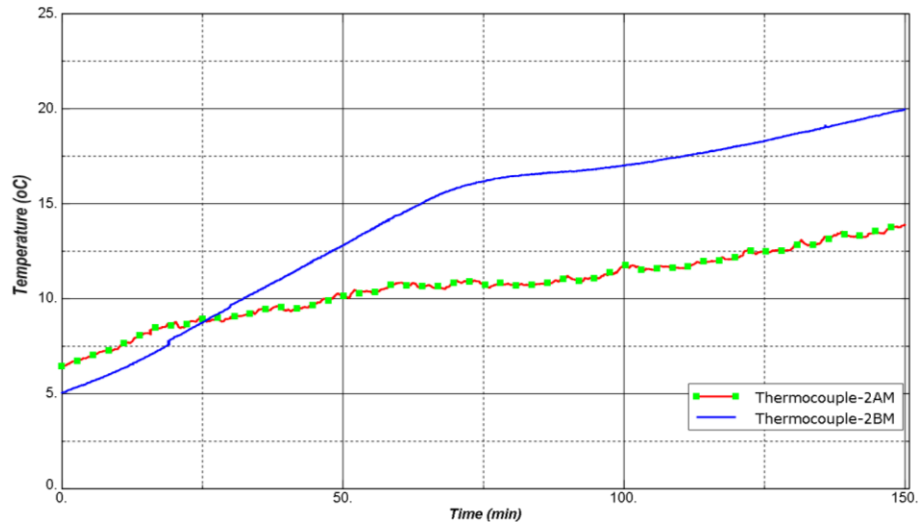
Figure 5-34 show the temperature measured as a function of time by thermocouple-2AM and thermocouple-2BM inside the web of Girder-1. The temperature readings from these thermocouples were small as well due to the insulating effect of the fireproofing. Even though it is at a slow rate, their temperature reading kept on increasing after the fire was extinguished.

Figure 5-34 Temperature vs. time reading of thermocouple-2AM and thermocouple-2BM

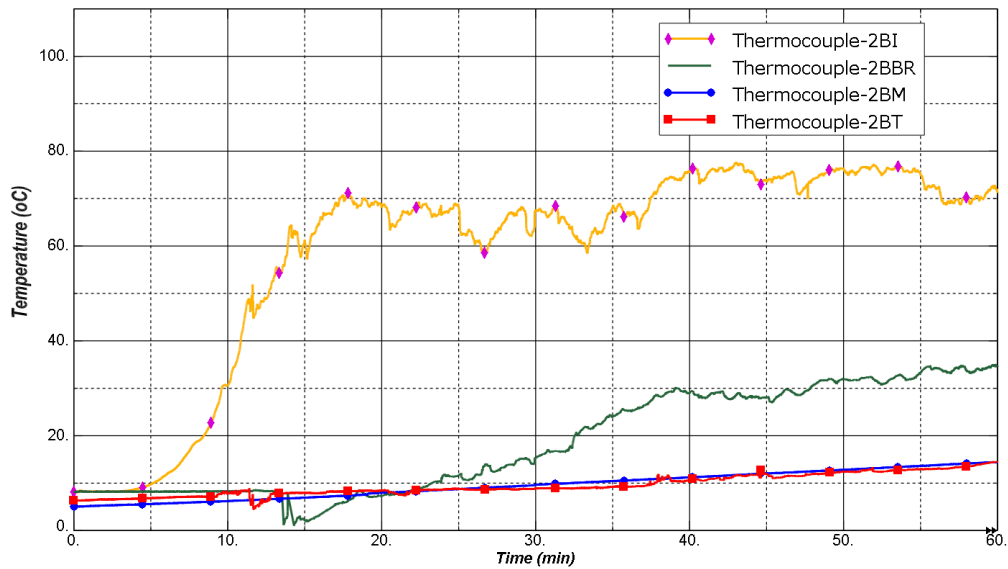
Figure 5-35 shows the progression of the fire across the cross section of the girder at its mid-span. Like Girder-1, It is observed from the figure that the measured temperature in concrete decrease with increasing depth from the bottom of the surface.

Figure 5-35 Mid-span temperature vs time reading of Girder-2 at different depth

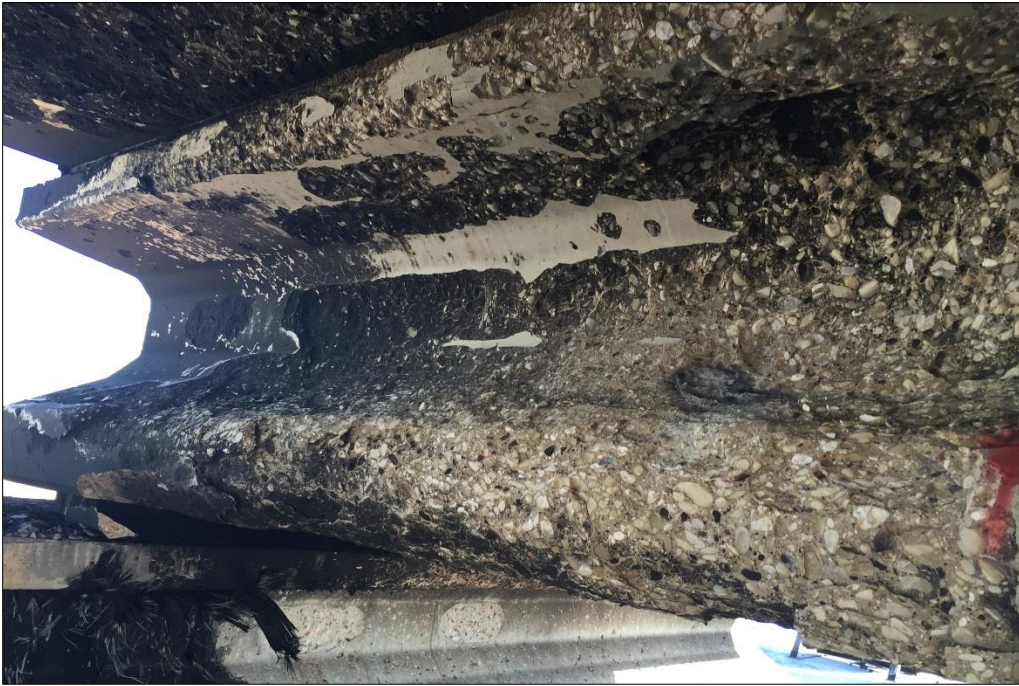
The insulation covered approximately 42% of the fire-exposed surface of Girder-2. As a result, majority of the concrete exposed to the severe fire was protected from spalling. Areas which were not protected with the fire proofing exhibited a moderate level of spalling as shown in Figure 5-36.

Figure 5-36 Spalling of concrete on Girder-2.

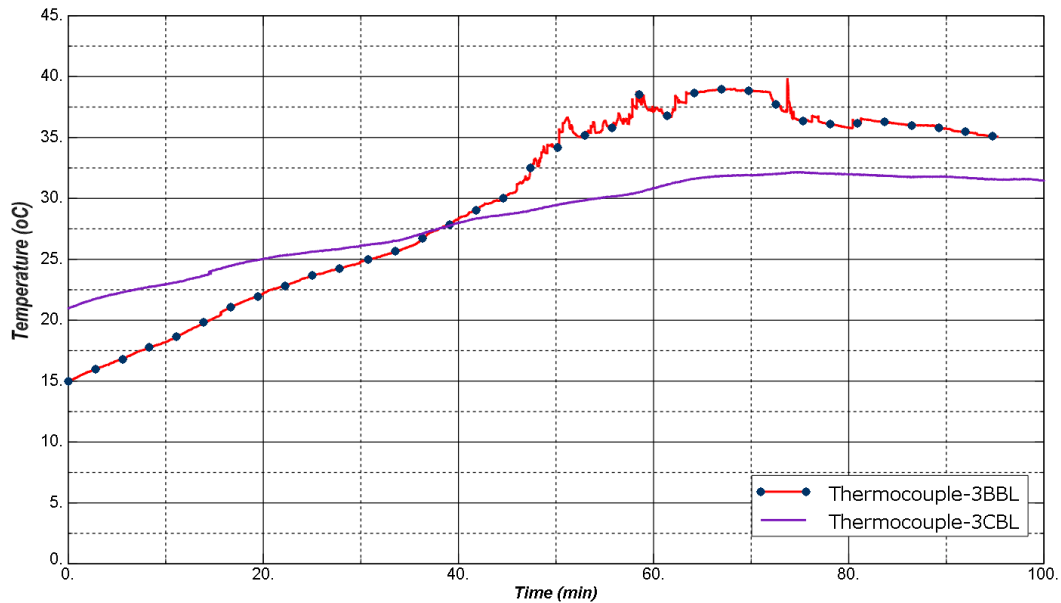
Figure 5-37 show temperature as a function of time for the prestressing strands. The maximum measured temperature was 40°C. Prestressing Strand retains 100 % of their strength at a temperature of this magnitude.

Figure 5-37 Measured strand temperature for Girder-3

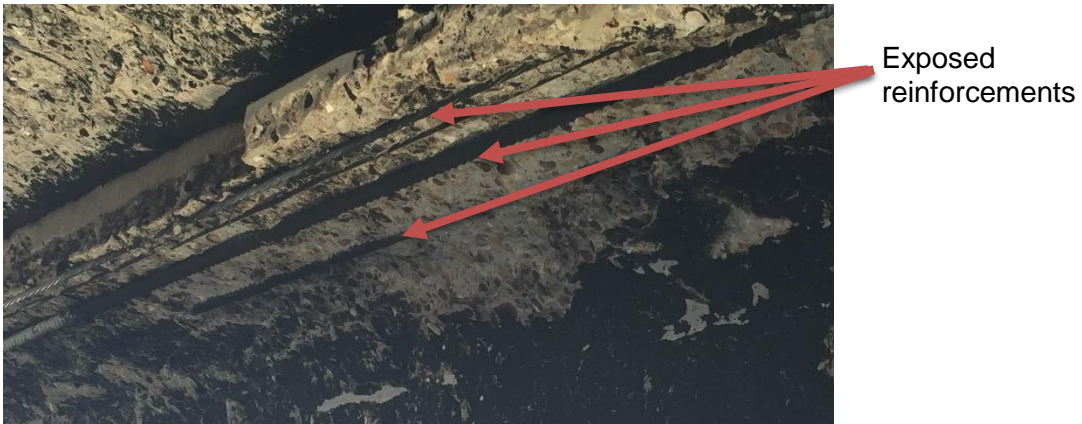
Figure 5-38 Exposed top reinforcements and strand for Girder-3

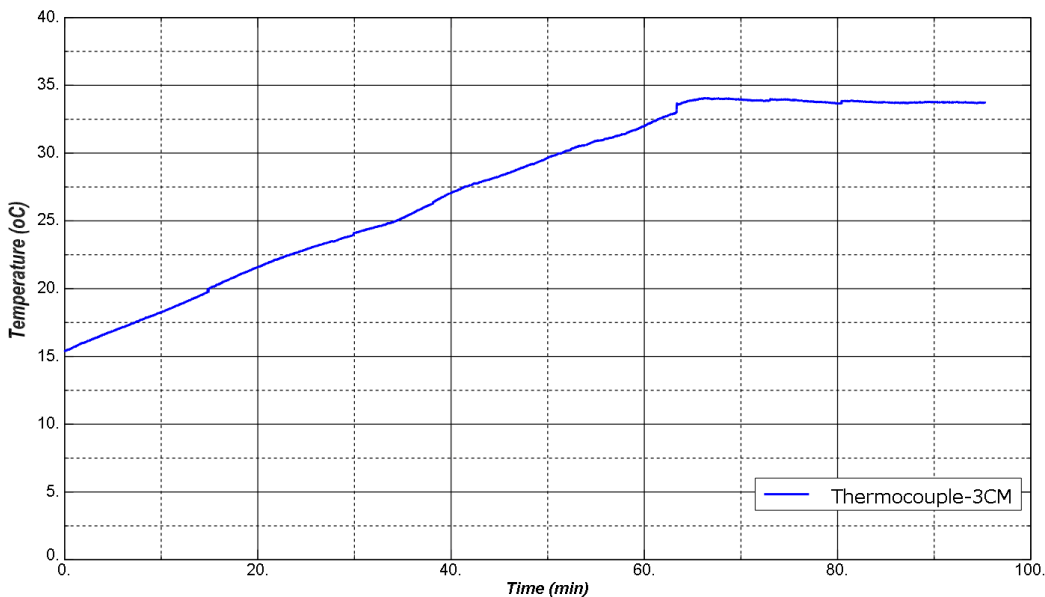
Figure 5-40 Temperature vs. time reading of thermocouple-3CM

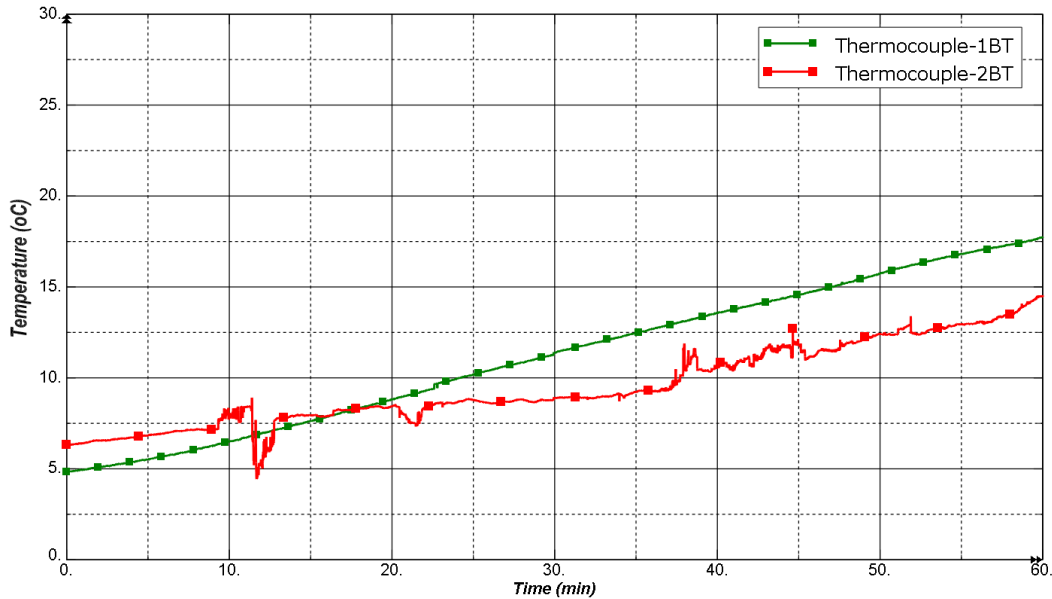
Figure 5-41 Temperature at the interface between deck and the girder

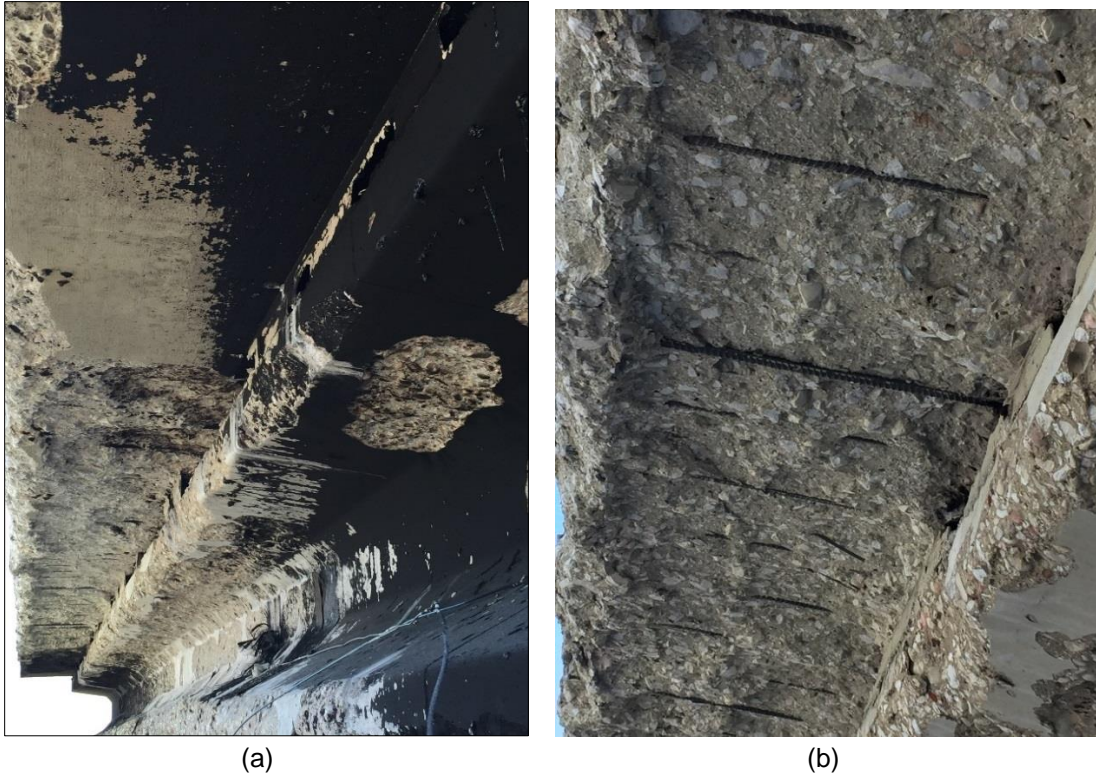
Figure 5-43 (a) Overhang portion of the deck on Girder-1 side after the fire; (b) closer look at of the spalled concrete for the overhang portion of the deck on Girder-1 side

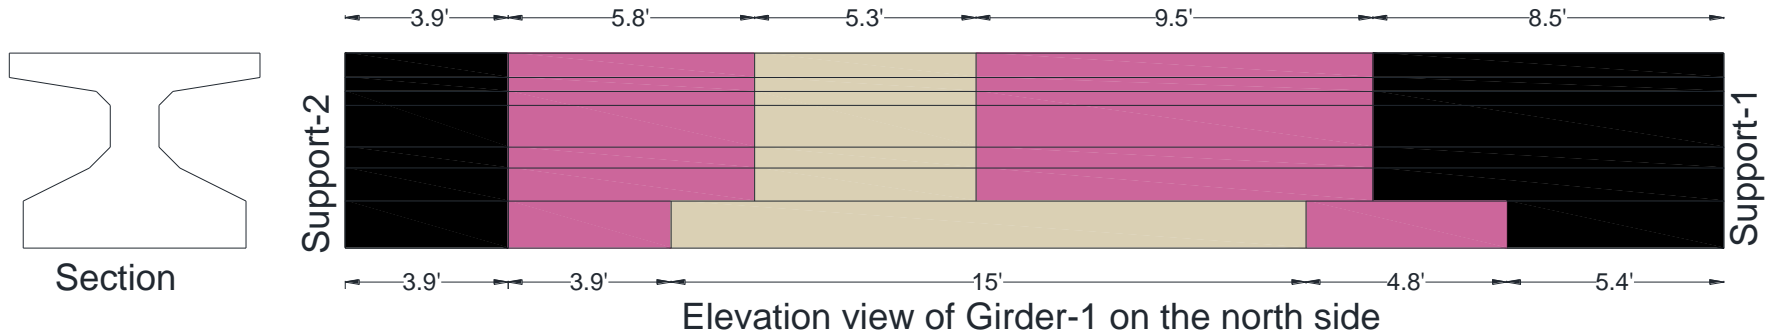
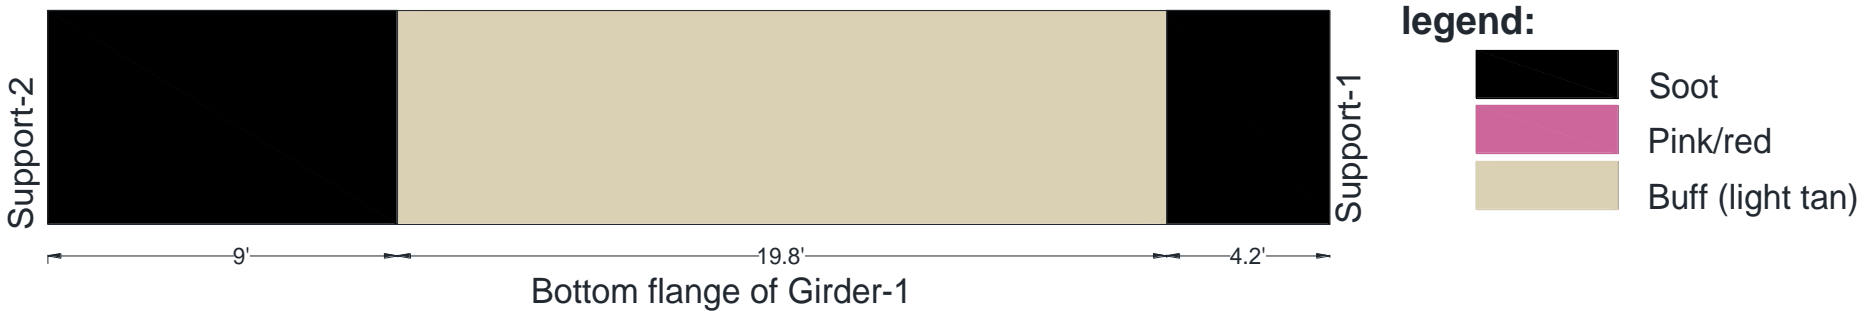
Figure 5-49 Visual inspection of Girder-1

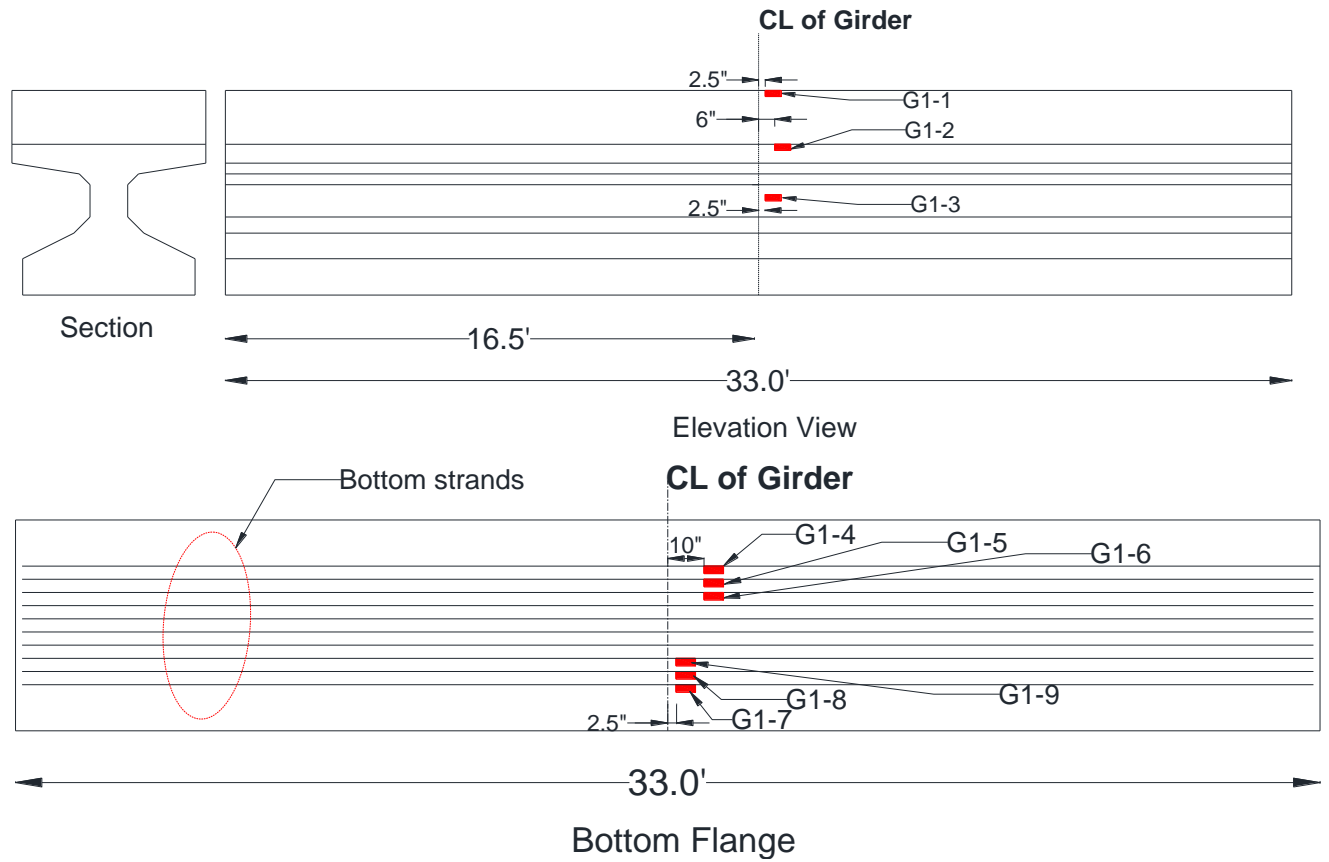
Figure 6-6 Girder-1 strain gauge layout
