HYDROCARBON POOL FIRE PERFORMANCE OF FIBER REINFORCED POLYMER  
(FRP) STRENGTHENED AND THERMALLY INSULATED BRIDGE GIRDERS

Presented to the Faculty of the Graduate School of  
The University of Texas at Arlington in Partial Fulfillment  
of the Requirements  
for the Degree of

DECEMBER 2016

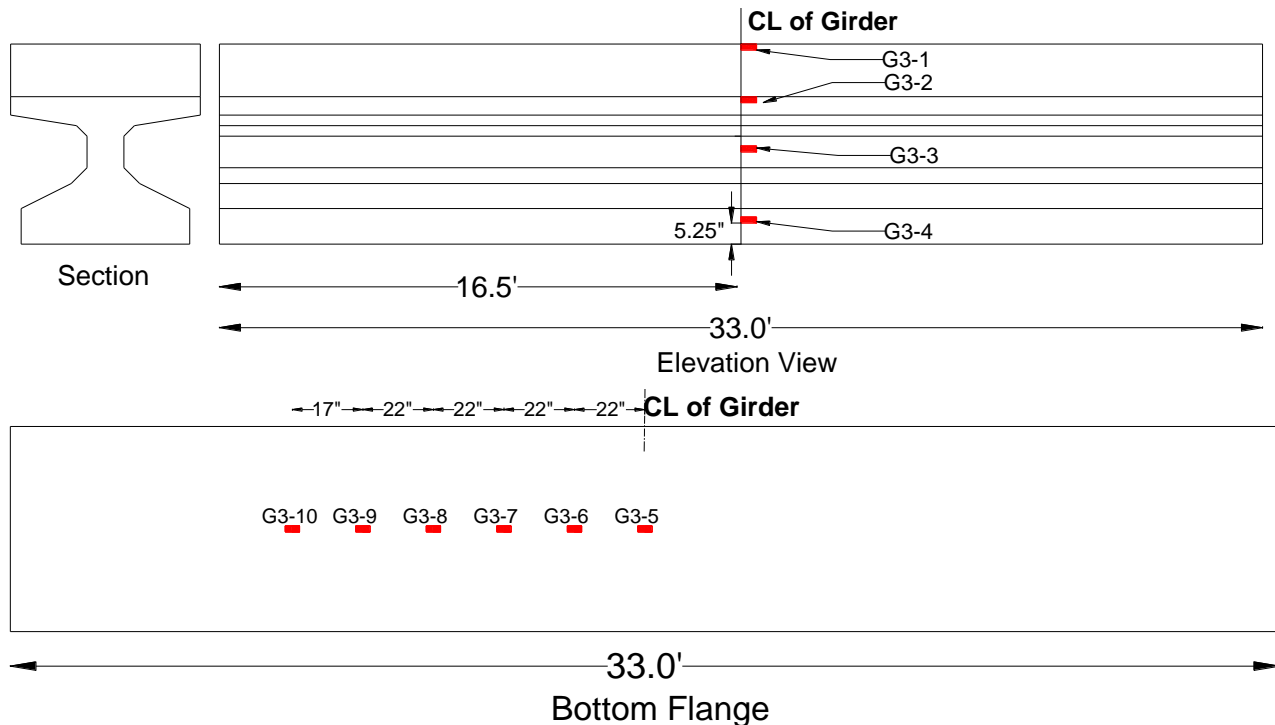
Figure 6-10 Girder-3 strain gauge layout

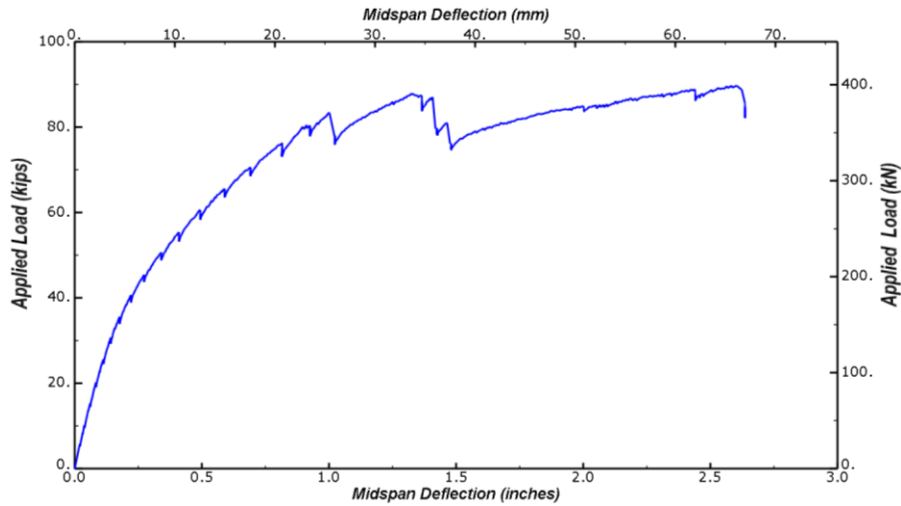
Figure 6-13 Applied load vs mid-span deflection of Girder-1

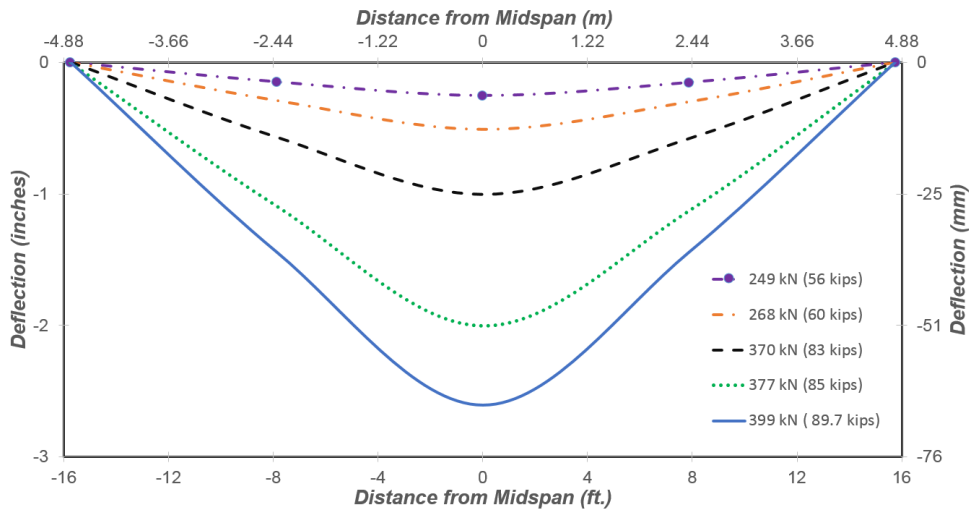
Figure 6-14 Displacement profile of Girder-1 at different load levels

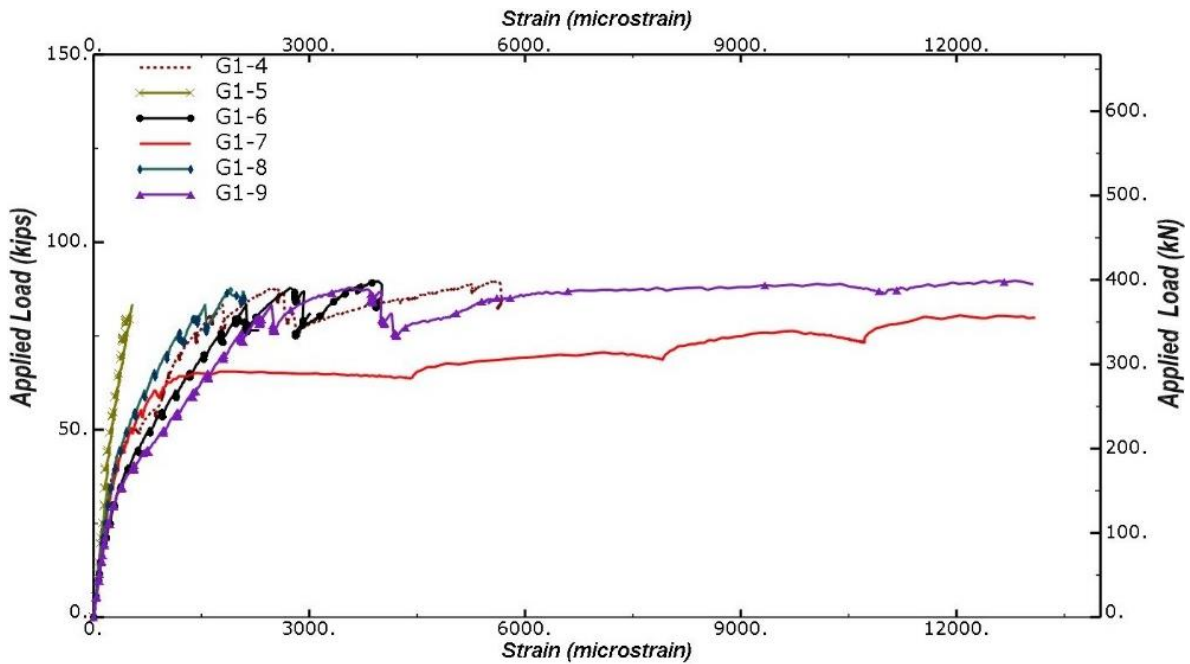
Figure 6-16 Strain on exposed prestressing strands of Girder-1

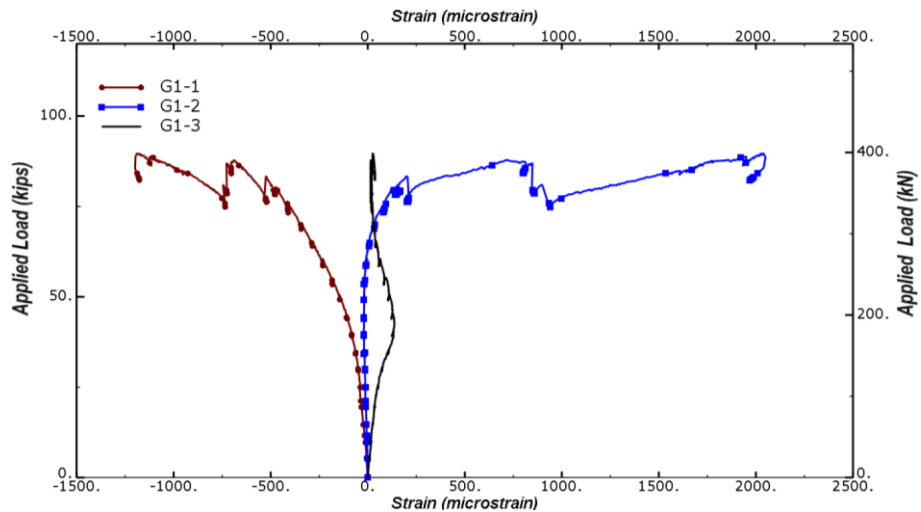
Figure 6-17 Girder-1 concrete strain profiles at different depths

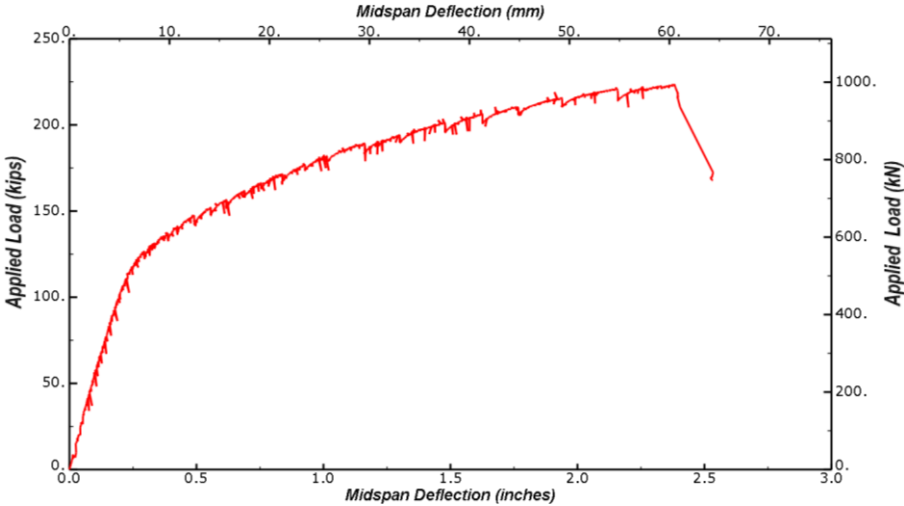
Figure 6-18 Applied load vs mid-span deflection of Girder-2

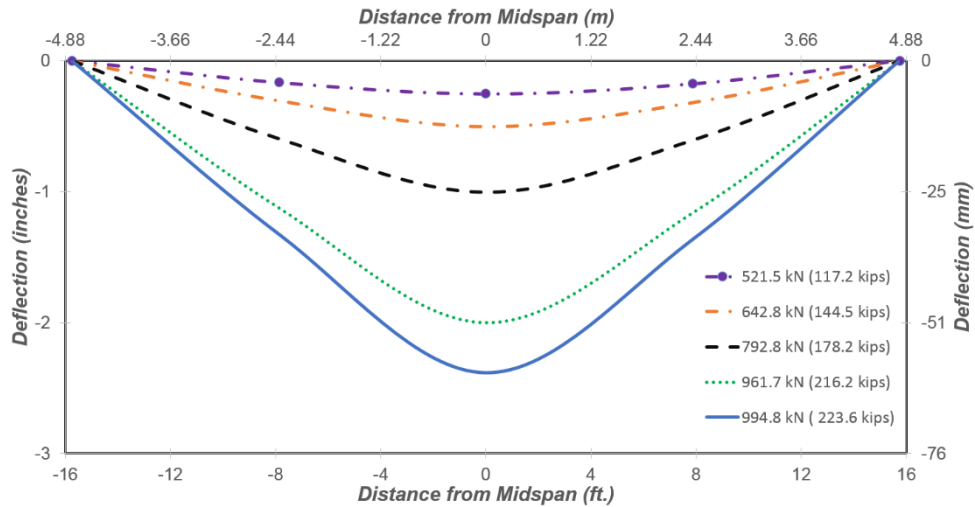
Figure 6-20 Deflection along girder length for various load increments of Girder-2

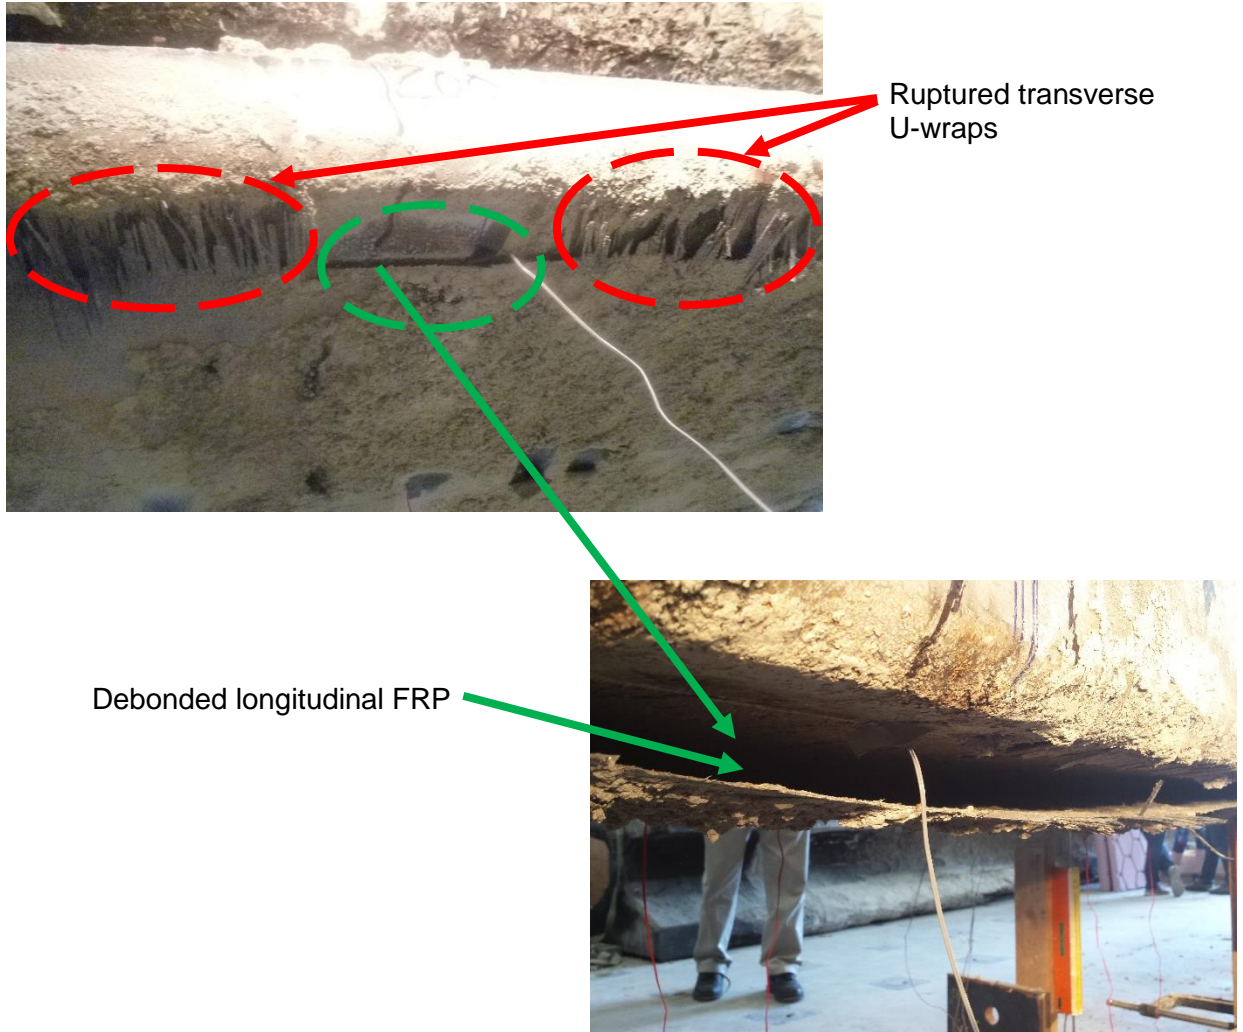
Figure 6-22 Rupture of transverse FRP and debonding of longitudinal FRP

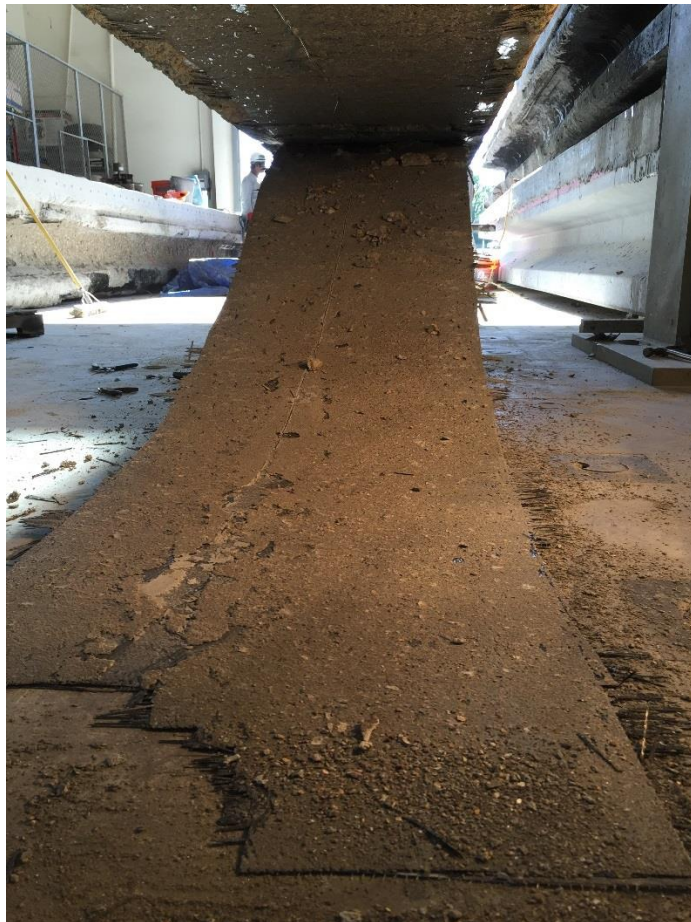
(c) Debonded longitudinal FRP

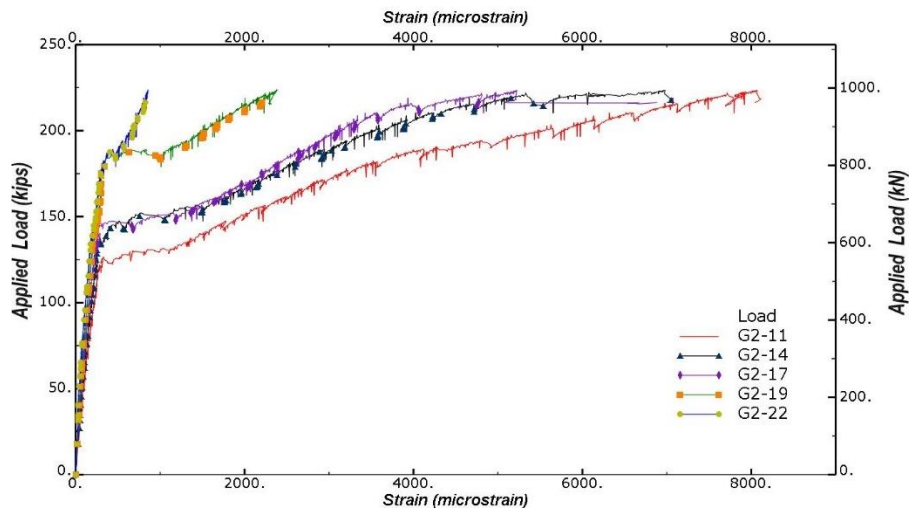
Figure 6-24 Strain versus applied load at various points on the longitudinal FRP

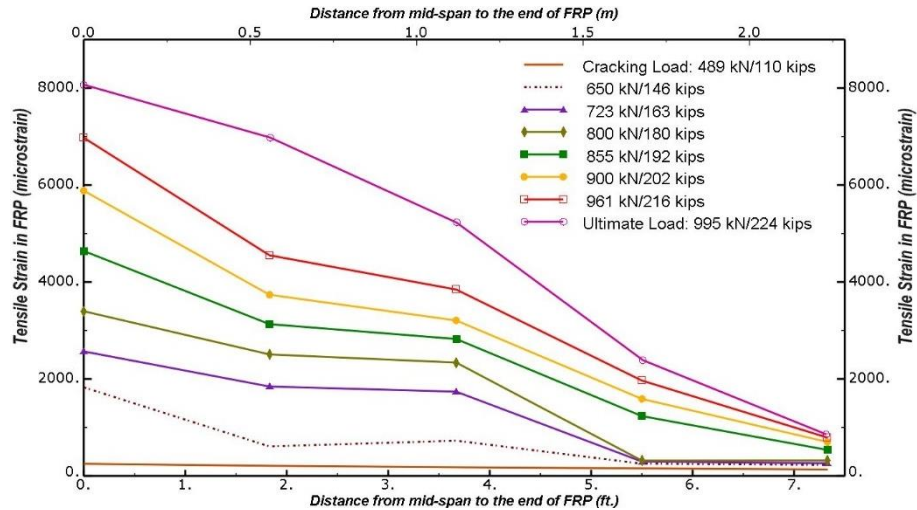
Figure 6-25 Tensile strain in FRP versus length of girder at different load increments

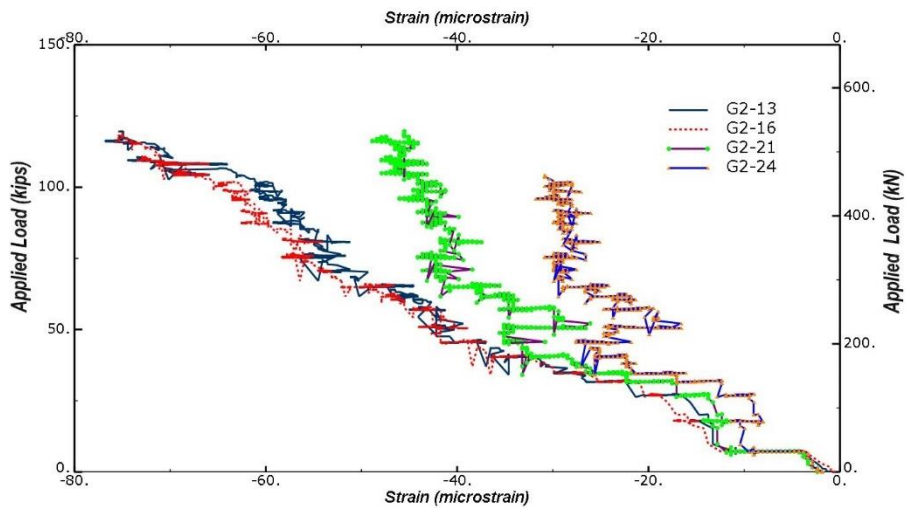
Figure 6-26 Strain versus applied load on U-wraps

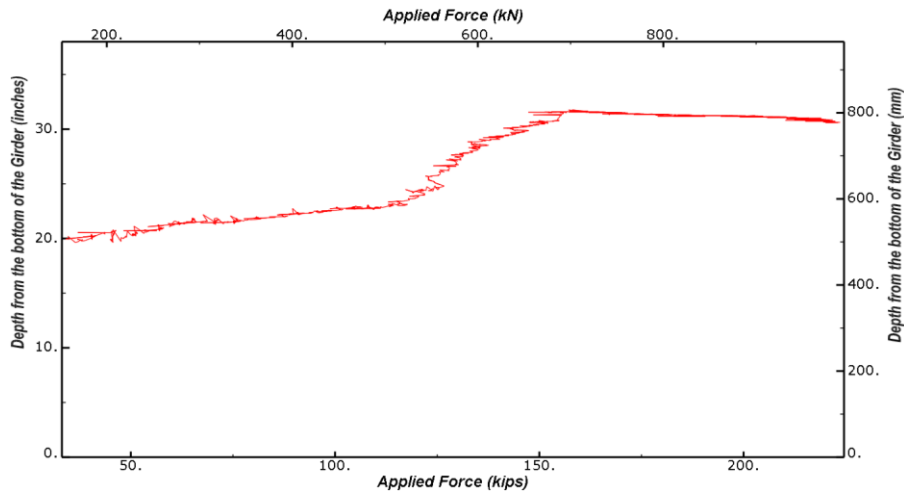
Figure 6-27 Variation of neutral axis depth with load for Girder-2

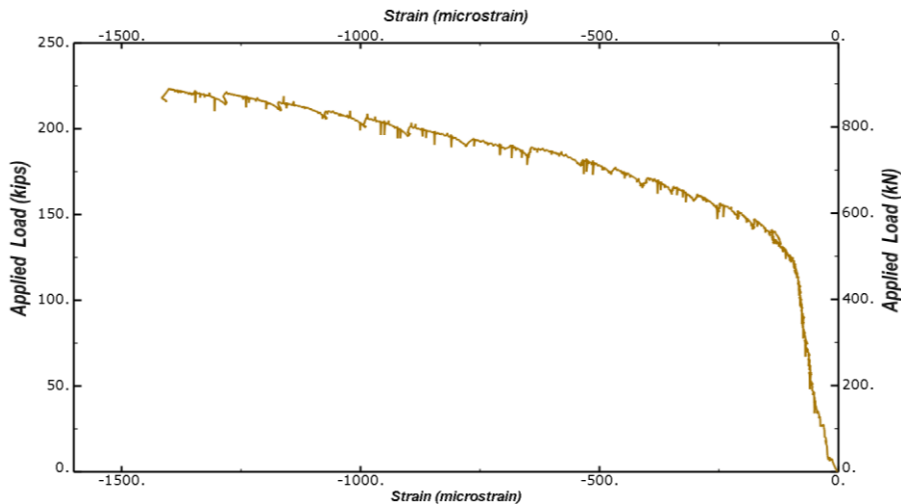
Figure 6-28 Variation of strain with applied load at the extreme concrete compression fiber for Girder-2

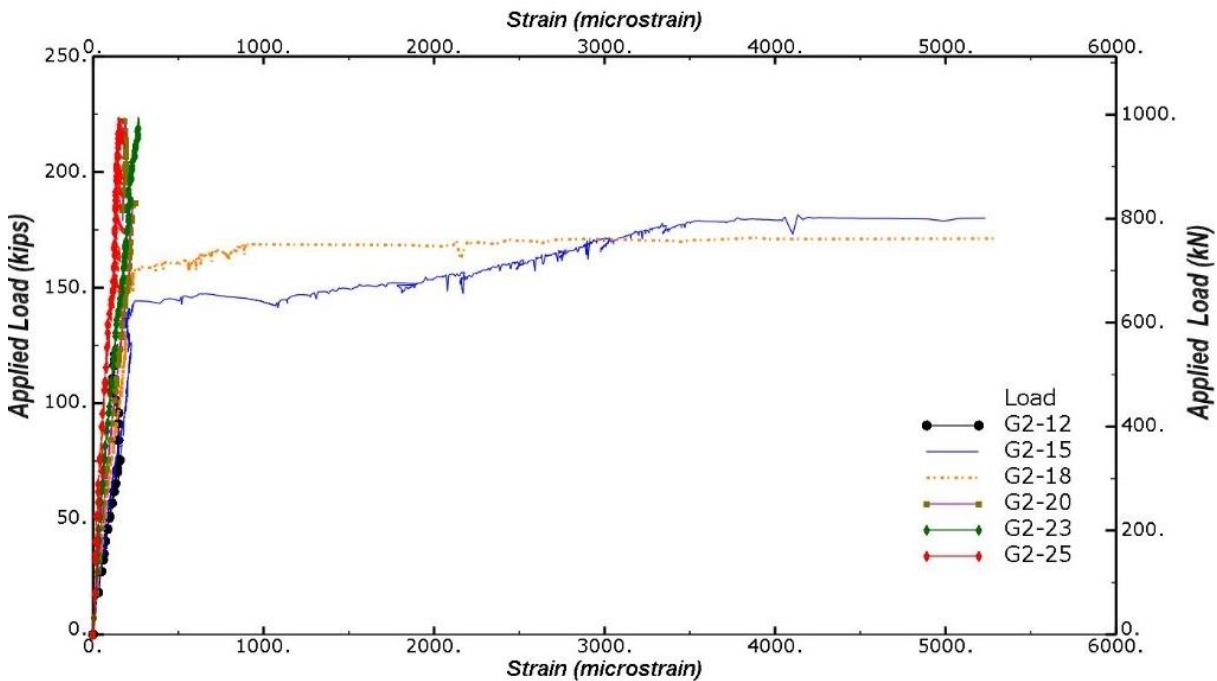
Figure 6-29 Load versus strain at various location on the concrete surface of the bottom flange

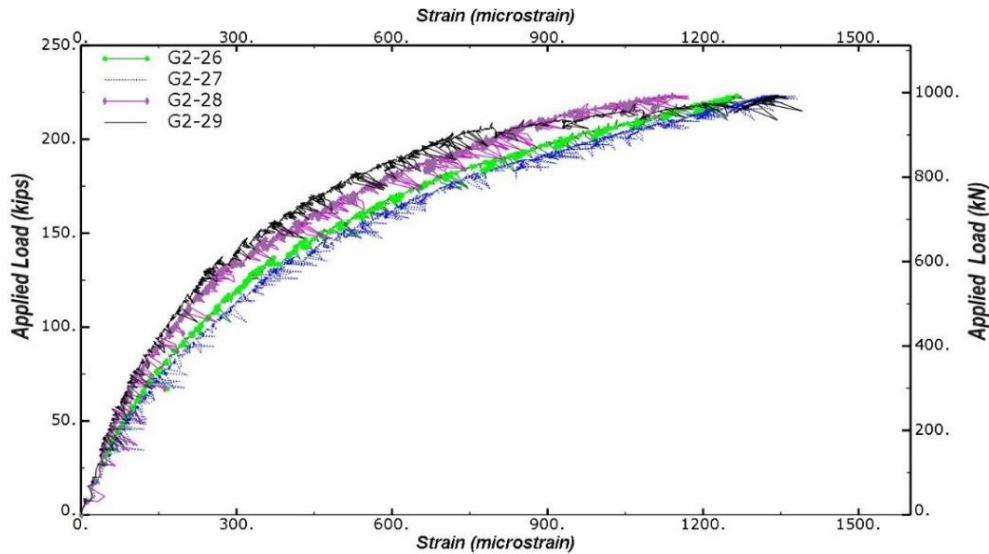
Figure 6-30 Strain on exposed prestressing strands of Girder-2

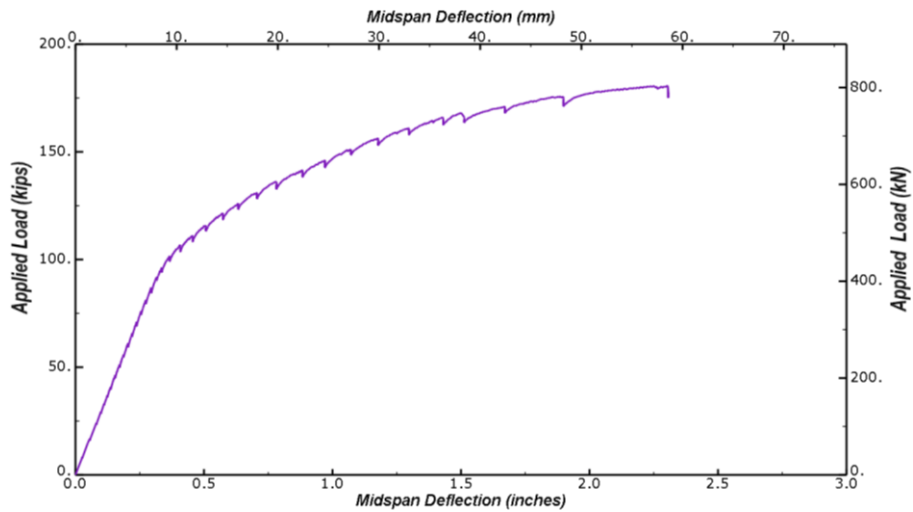
Figure 6-31 Applied load vs mid-span deflection of Girder-3

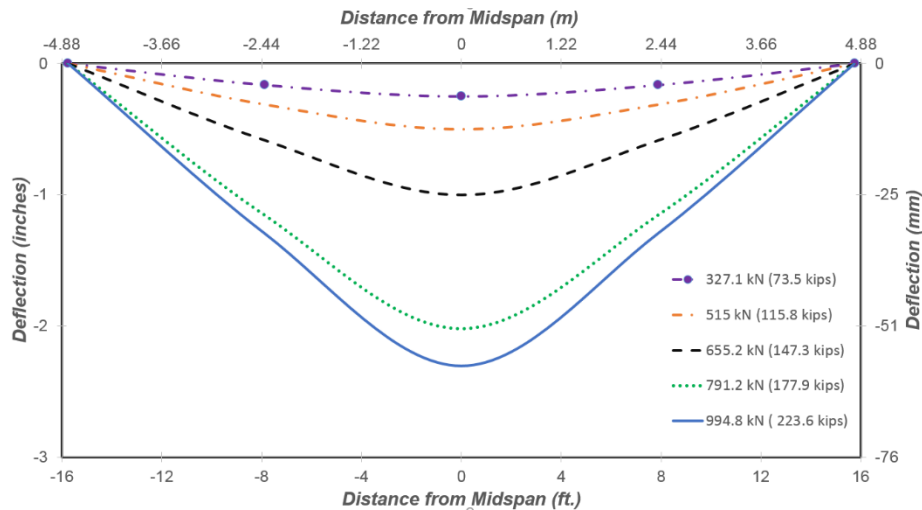
Figure 6-32 Deflection along girder length for various load increments of Girder-3

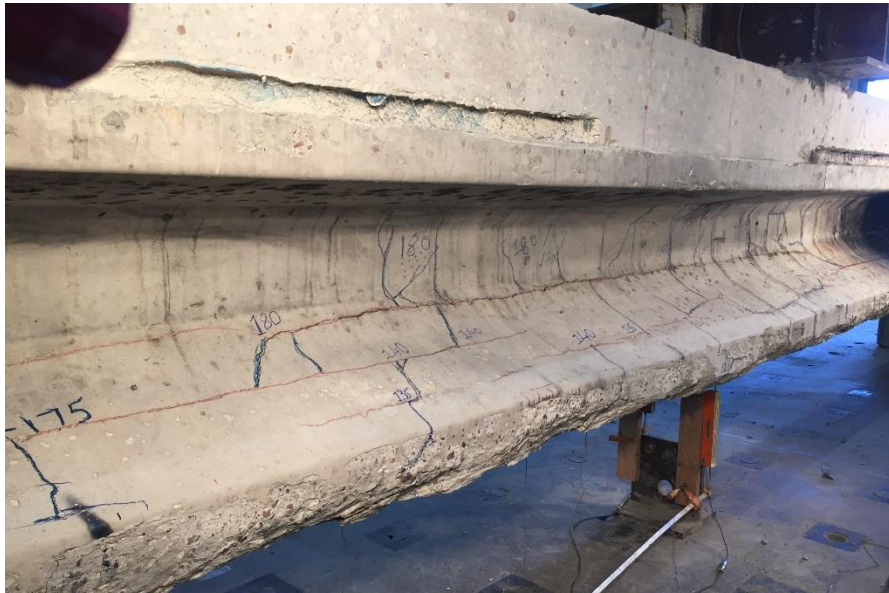
Figure 6-33 Cracks formed during fire and residual strength test

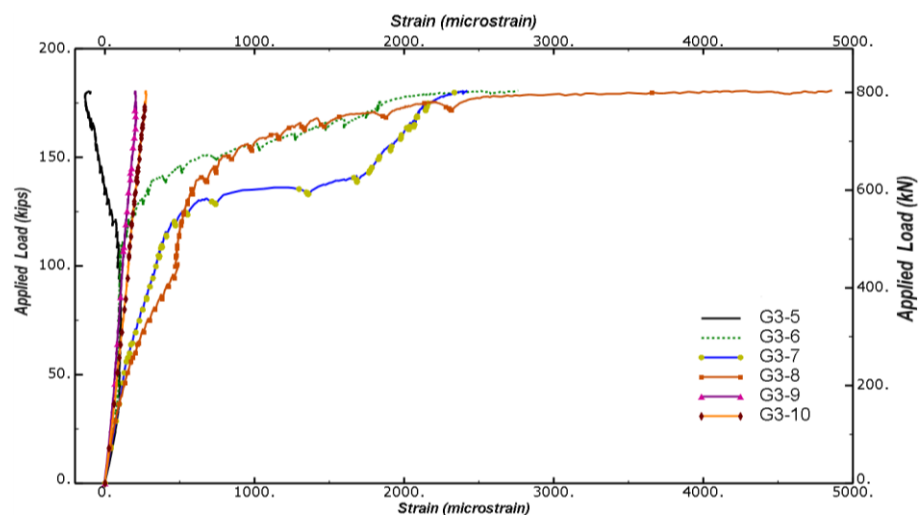
Figure 6-34 Applied load versus strain at the bottom of Girder-3

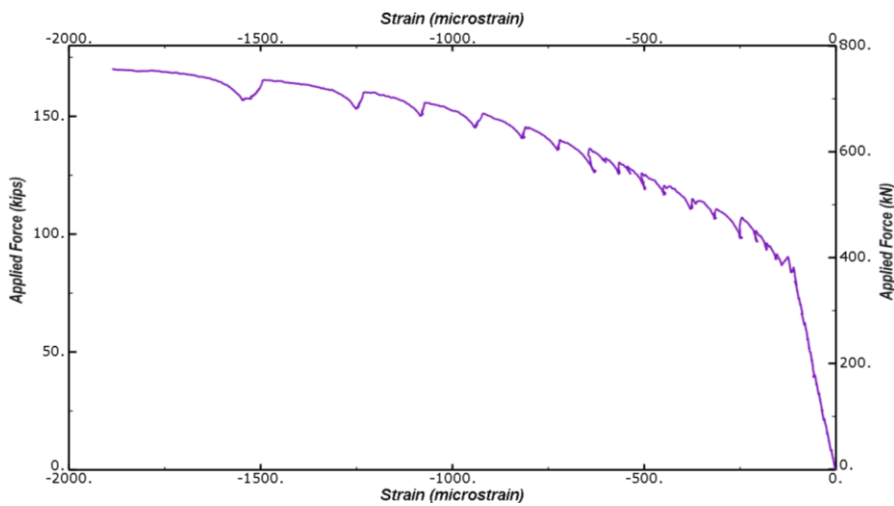
Figure 6-40 Strain versus applied load at the extreme concrete compression fiber for the control girder

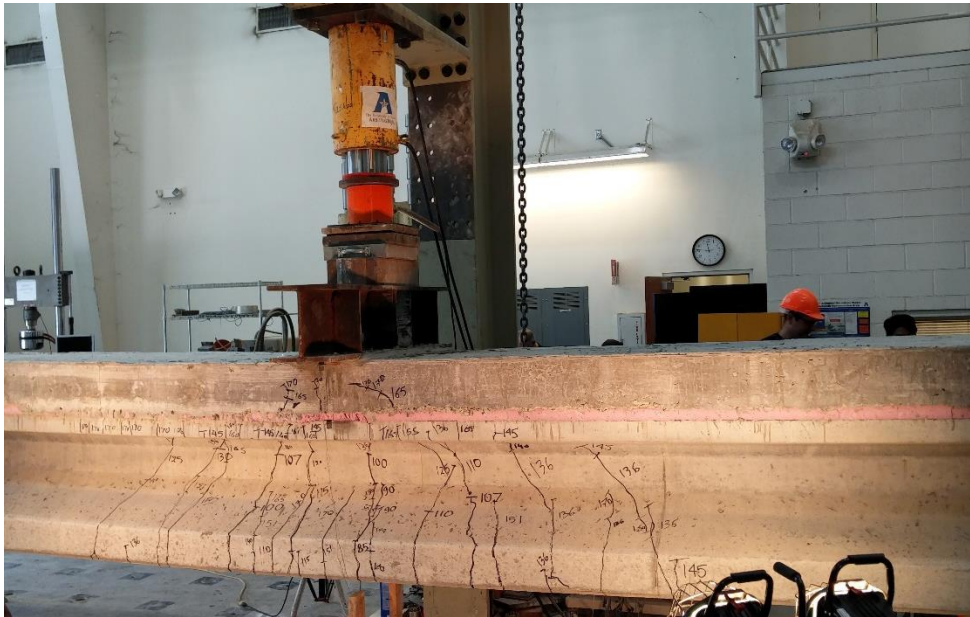
Figure 6-41 Crack pattern of control girder

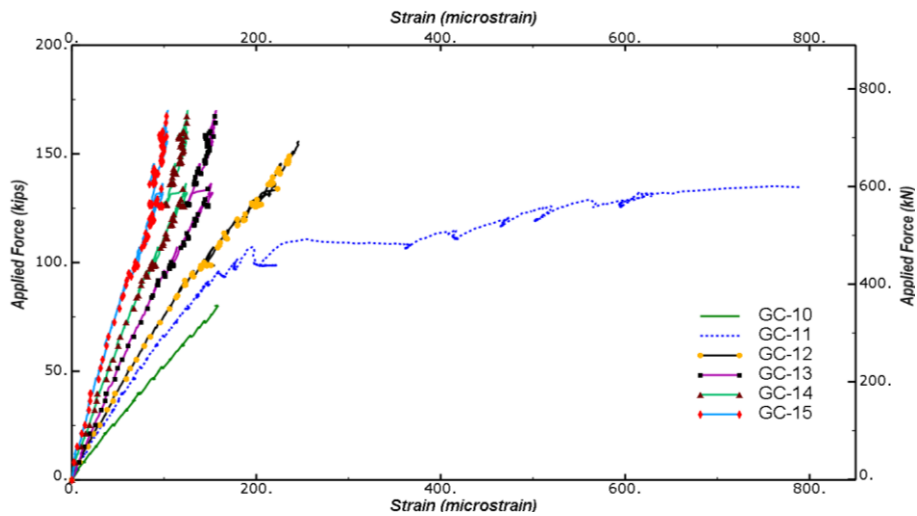
Figure 6-42 Applied load versus strain at various location on the bottom of control girder

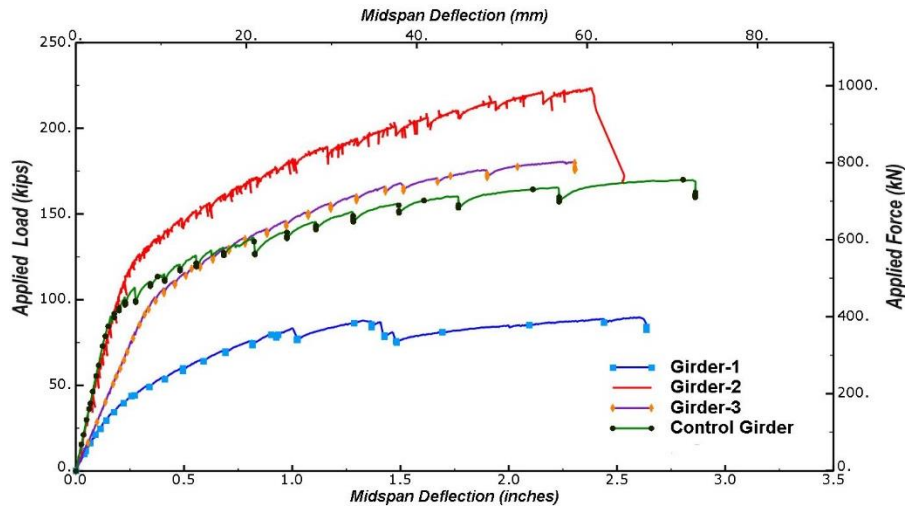
Figure 6-43 Applied load versus midspan deflection for all the tested girders

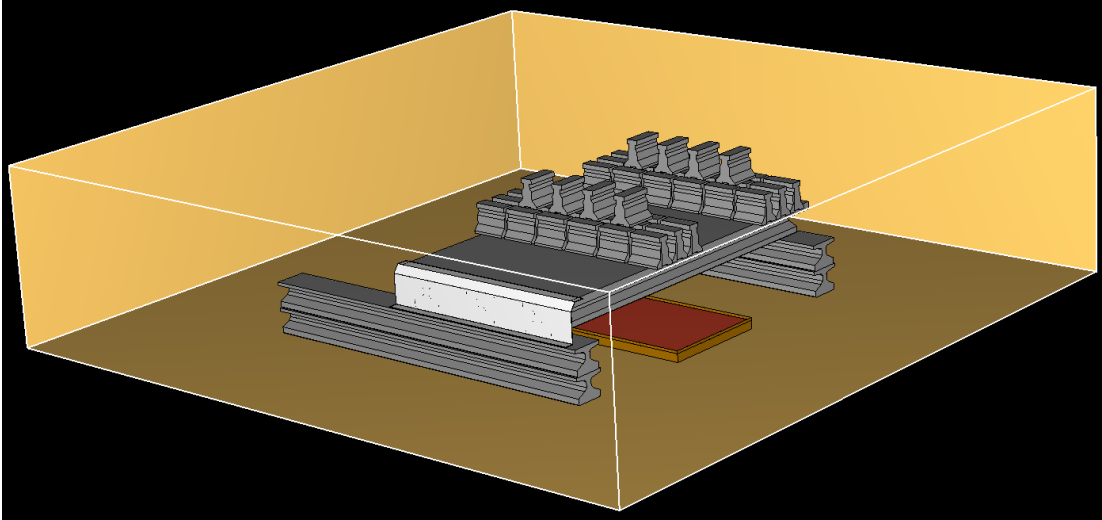
Figure 7-1 Fire tested bridge Pyrosim model

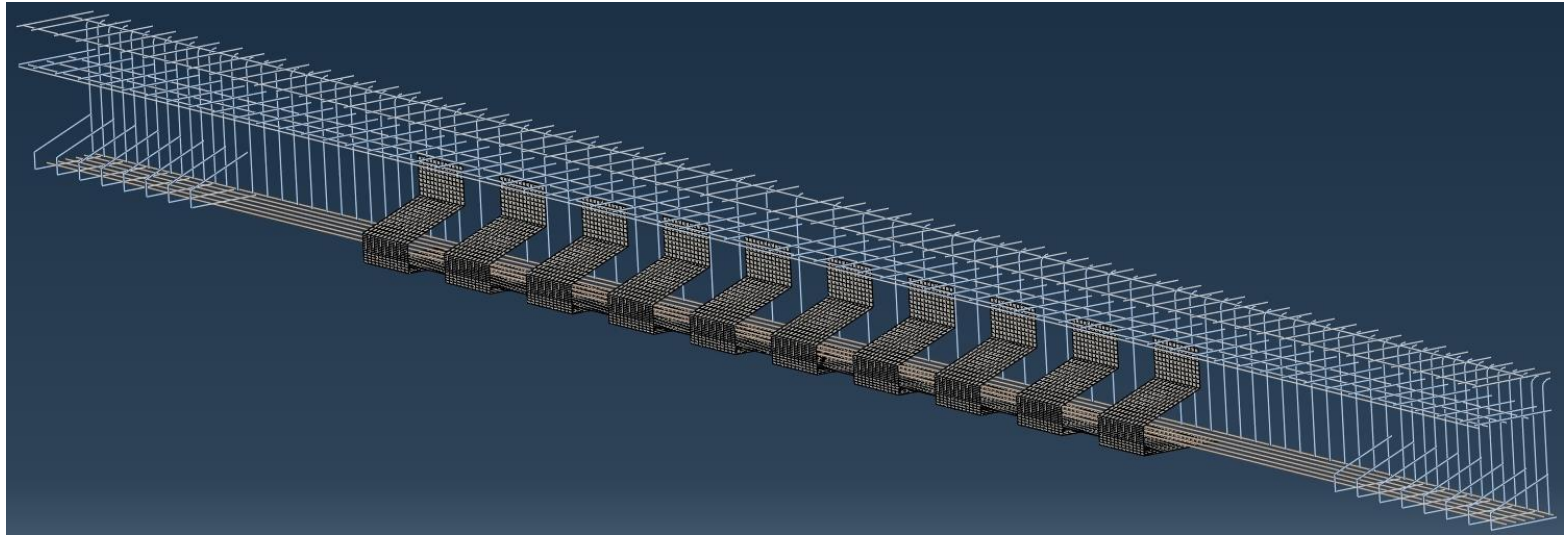
(a) Reinforcements cage and CFRP
