AN INVESTIGATION OF WATER PIPELINE RENEWAL PRACTICES

MASTER OF SCIENCE IN CIVIL ENGINEERING

THE UNIVERSITY OF TEXAS AT ARLINGTON

April 2018

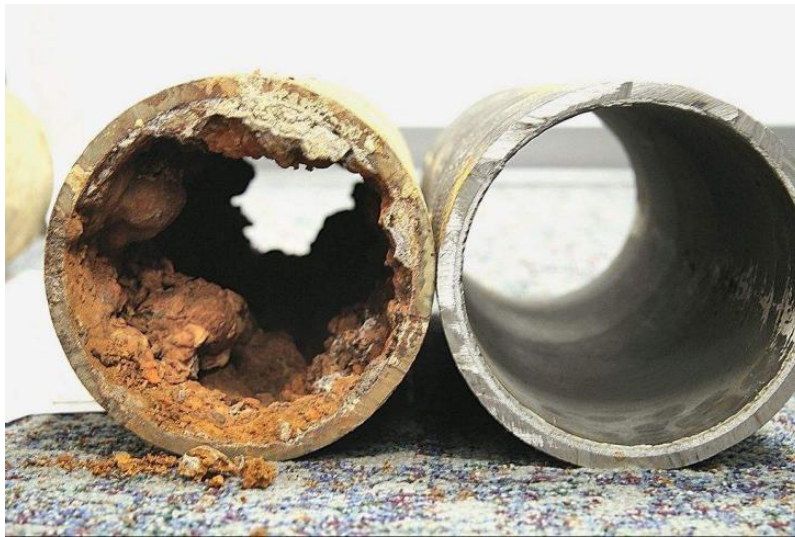
Figure 2.1 Deteriorated Pipe vs New Pipe (Bryant, 2011)

Physical and chemical processes such as corrosion, cracking and manufacturing defects lead to gradual deterioration of pipes within a water distribution system. This issue is inevitable and is recognized by all civil engineers. Unfortunately, the estimation of the physical condition of pipes requires monitoring up close and on site. This fact alone limits the effort of keeping proper flow conditions and preventing failures of pipe that might cause costly losses for a city and affect its general population. Figure 2.1 is an example of a severely deteriorated pipe segment compared to a new sample.

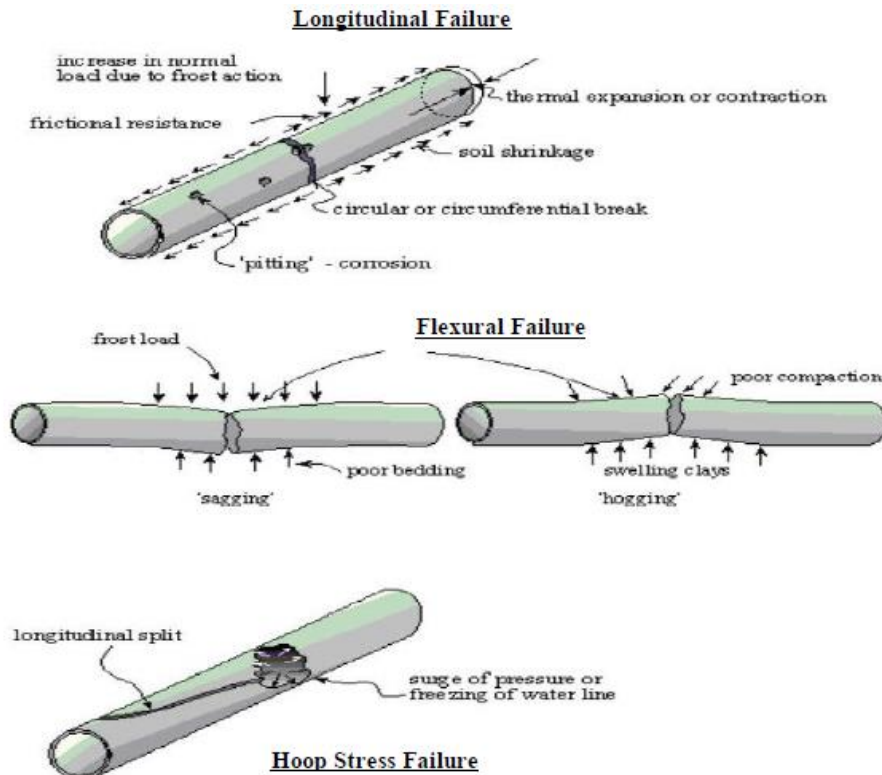
Figure 2.2 Various Water Main Failure Conditions (Kleiner and Rajani, 2001)

Furthermore, Figure 2.2 below shows some of the failure conditions that may result in a pipe break or leak. Since there are several combinations of physical externalities that can cause a pipe to experience any of these failure modes, the following figure is intended to illustrate the most typical causes and types of failure, which a water main may experience.

As shown in the figure above, breaks and leaks can happen in pipes under varying stress condition such as tension force and compression force. A pipe will break or crack accordingly depending on the strength and direction of these forces. Although determining a breaking pipe is easier than determining a leaking pipe, maintaining both is important to maintain the durability of the water pipe. However, it is necessary to develop and implement an assessment model that can predict the occurrence of such failures before they occur in order to avoid interruption of main utilities.

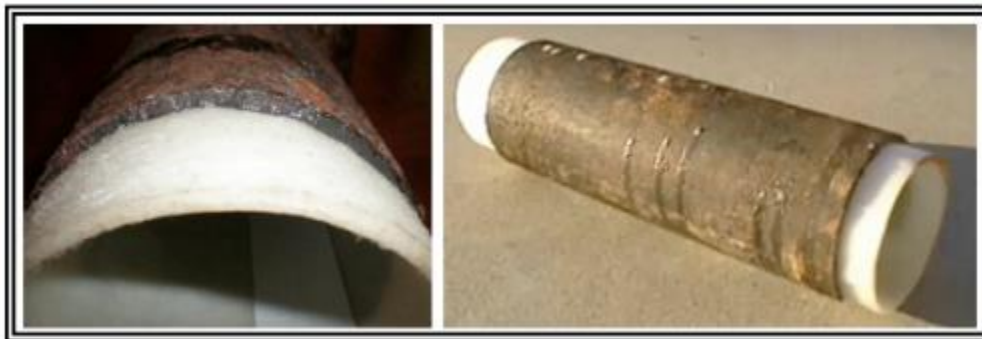
Figure 2.3 CIPP (El-Baroudy, 2013)

A cured in place pipe is an important method of trenchless rehabilitation, which is extensively being used to repair existing pipelines. In simple words, the convenient features of this method includes a pipe within a pipe, seamless and jointless with the capability to rehabilitate pipes ranging from five to 114 inches in diameter. Figure 2.3 shows the simplest version of CIPP.

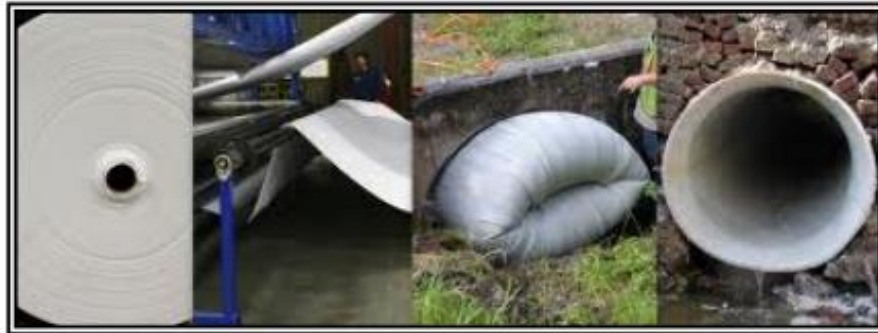
Figure 2.4 Polyester Felt Tube (El-Baroudy, 2013)

A polyester felt tube is fabricated to fit the host pipe. It is then inverted (turned inside out) and pulled inside the host (old) pipe. The liner may be designed with sufficient thickness when cured to sustain the loads imposed by exterior groundwater and interior service pressure, and by soil and traffic acting on the pipe, which is shown in the following figure:

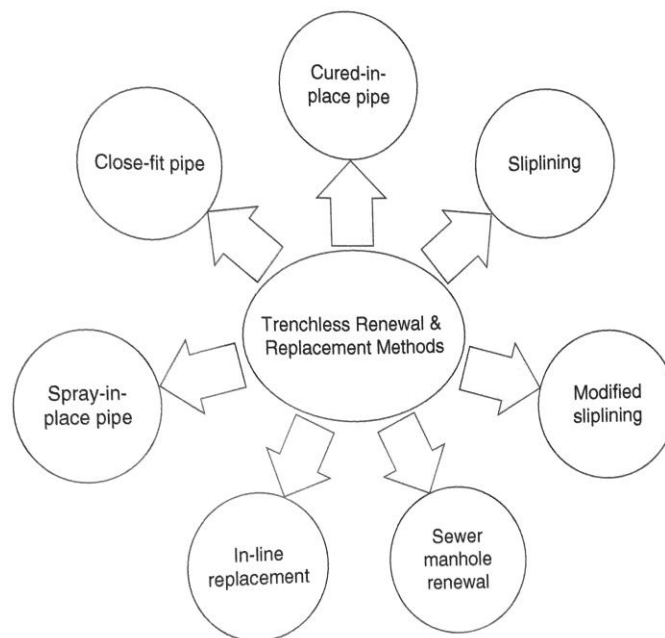
Figure 3.1 Basic Trenchless Renewal Methods (Najafi, 2016)

There are different types of trenchless methods for pipe replacement rehabilitation and repair; each method has advantages and disadvantages. Selecting the appropriate method depends on a project condition. Najafi (2016) has categorized these methods into seven as shown in the Figure 3.1.

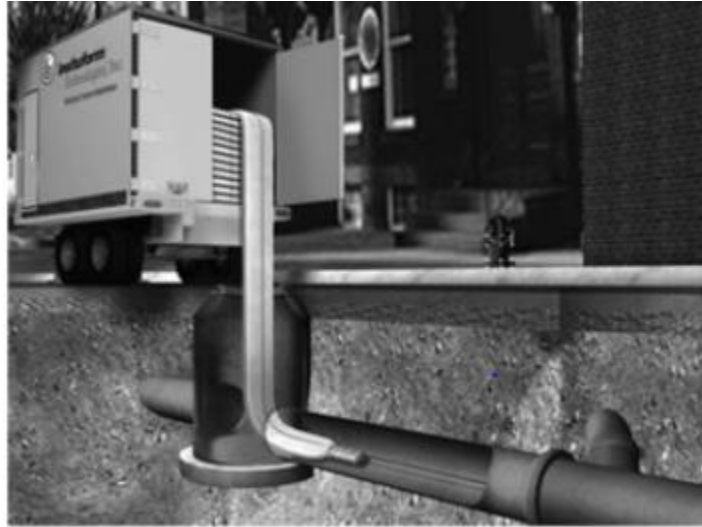
Figure 3.2 Installation Process of CIPP (Insituform Technologies, 2018)

from where the utility hole and the excavation are carried out. In addition, it might be possible for the inversion of the liner upstream to be carried out from the downstream access point. Despite the fact that it works out well, the potential for risk is on the higher side in such cases. Figure 3.2 shows the installation process of CIPP.

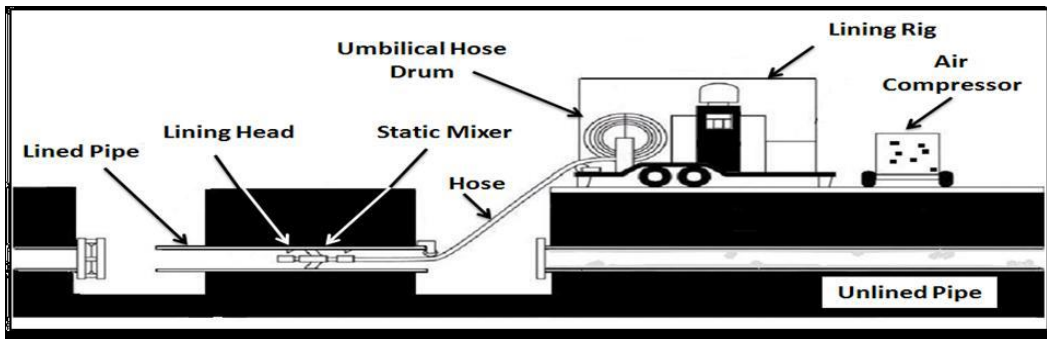
Figure 3.4 Layout for SIPP (3M Water Infrastructure, 2018)

This method is used these days extensively. It is an efficient and long-lasting solution for the restoration of aging underground piping systems. One of the key elements of this system is how the rehabilitation method is going to be used to make sure that the existing pipelines can be prepared. It involves the placement of the robotic lining system that is developing the manufacturing lining polymeric in an appropriate manner. Most of the time, it is a joint that is seamless and lay out symmetrically. SIPP has four types of lining systems. Figure 3.4 shows the general site layout for SIPP.

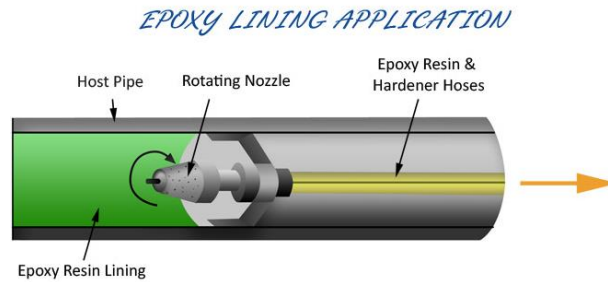
Figure 3.5 Epoxy Lining (ISTT, 2017)

Epoxy lining is a long-term solution to breaks and leaks, blockages, prevents erosion, water damage, maintains water flow and prevents mold growth. This method acts as a barrier to heavy metals leaching into drinking water lines from metal piping systems. According to some studies, the Epoxy lining is eco-friendly; for instance, zero waste, no carbon emissions, prevents chemical leaching, and conserves water supplies (Wiley, 2017). Figure 3.5 shows the process of epoxy lining.

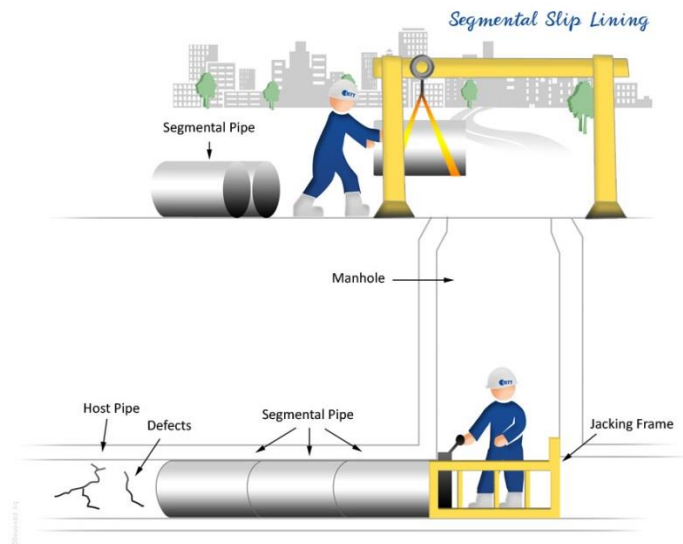
Figure 3.7 Layout of Sliplining Method (ISTT, 2017)

rehabilitation process can be carried out appropriately. At the same time, the anchoring of the installed pipe using the grouting can also be done correspondingly. Figure 3.7 shows the process of SL method.

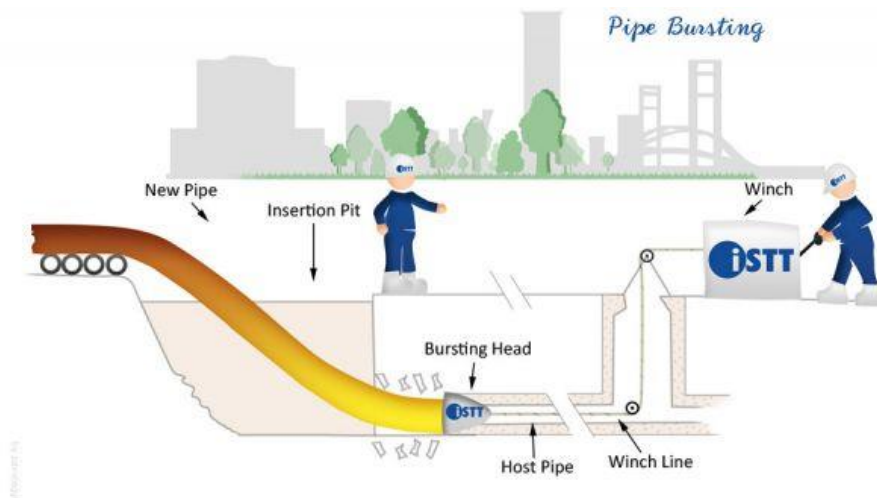
Figure 3.8 Layout for pipe bursting method (ISTT, 2017)

The pipe removal method can be used to replace pipes up to 36 in. at a maximum of 300 ft. (Najafi, 2016). Pipe bursting also can be used to upsize a pipeline; this feature can be considered a unique advantage among the other trenchless technologies (Hashemi and Najafi, 2017).

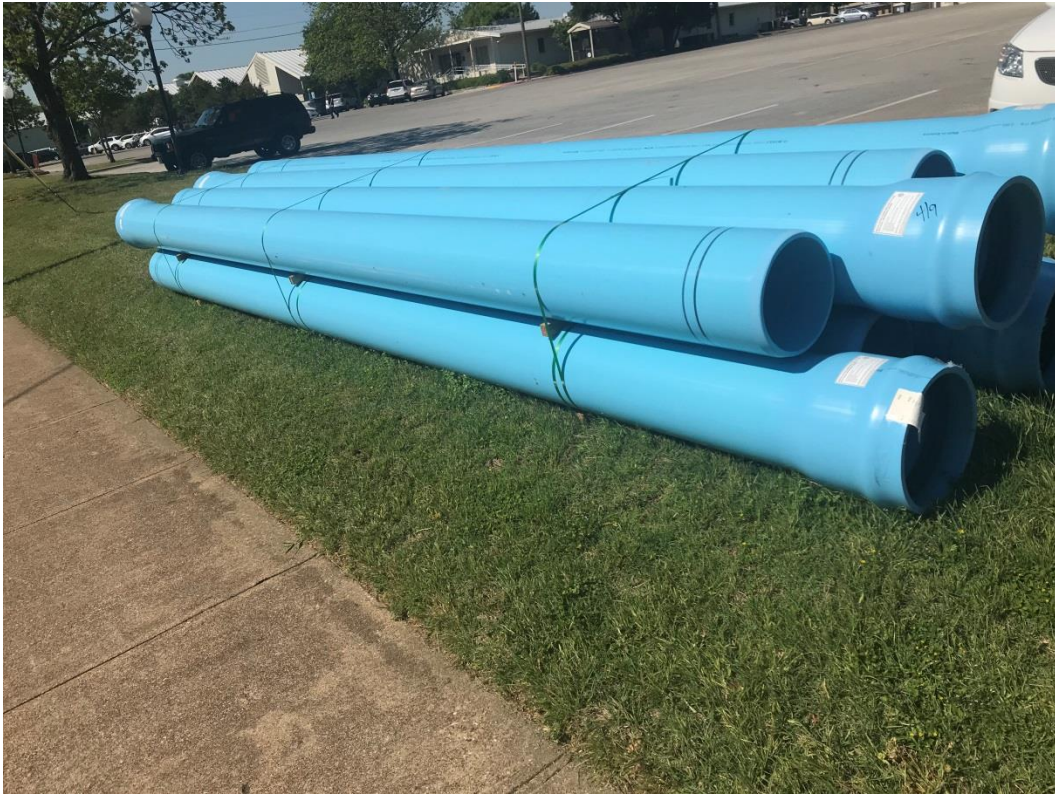
Fig. E1. Pipes delivered and stored in the right of way

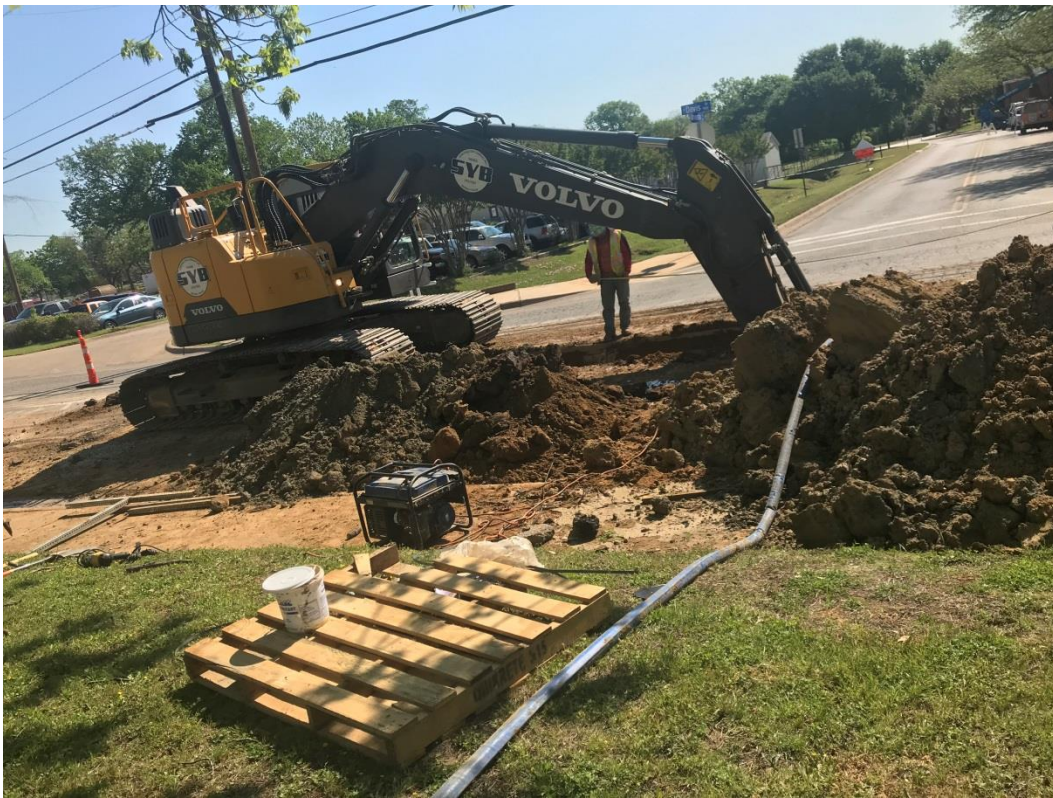
Fig. E3. Trenches dug to the curb after pavement is cut to trench width using a pavement saw

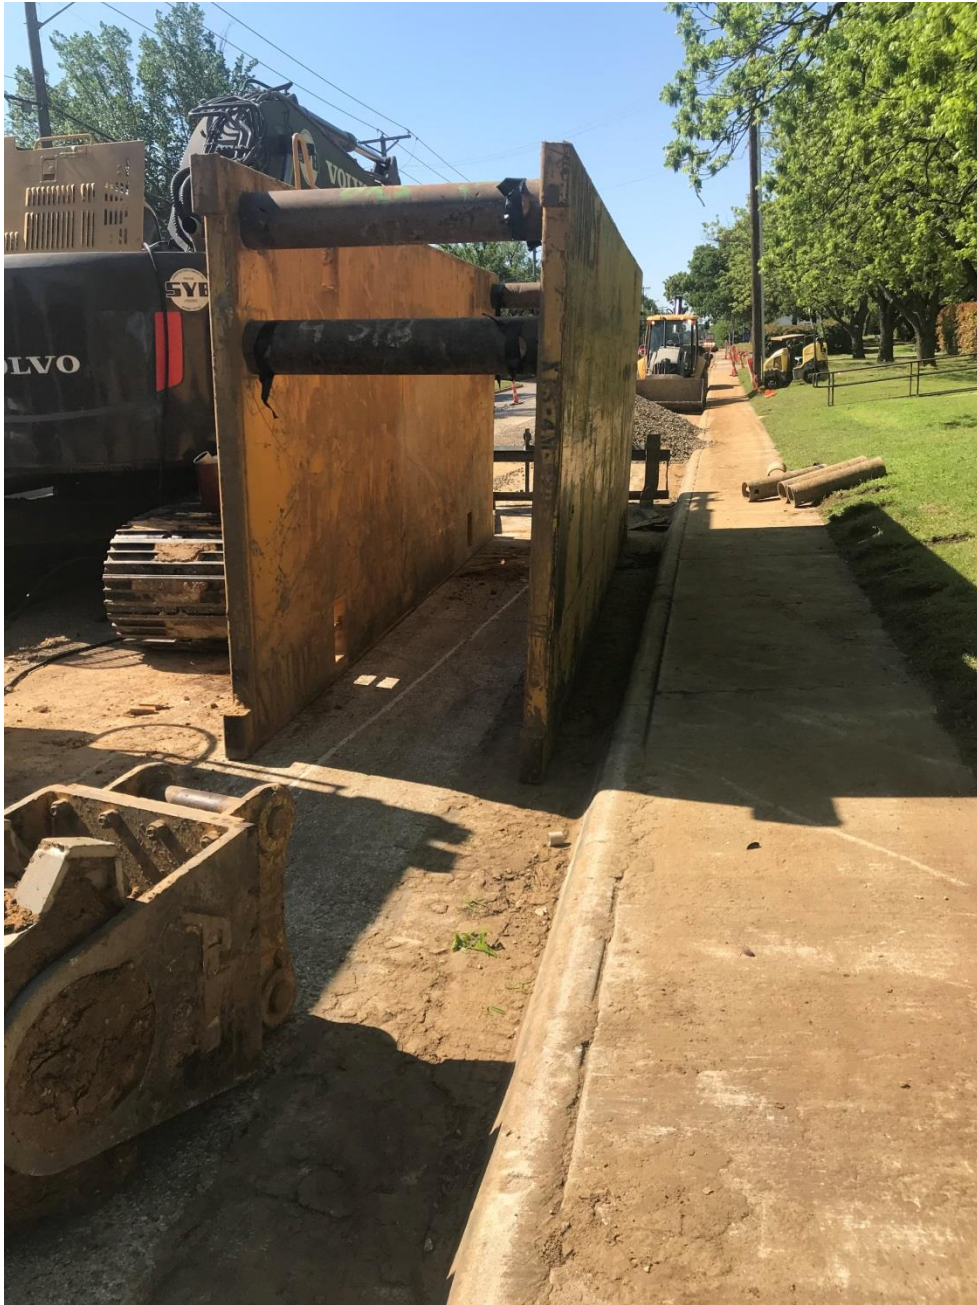
Fig. E4. Shoring system that used to support the laterals A

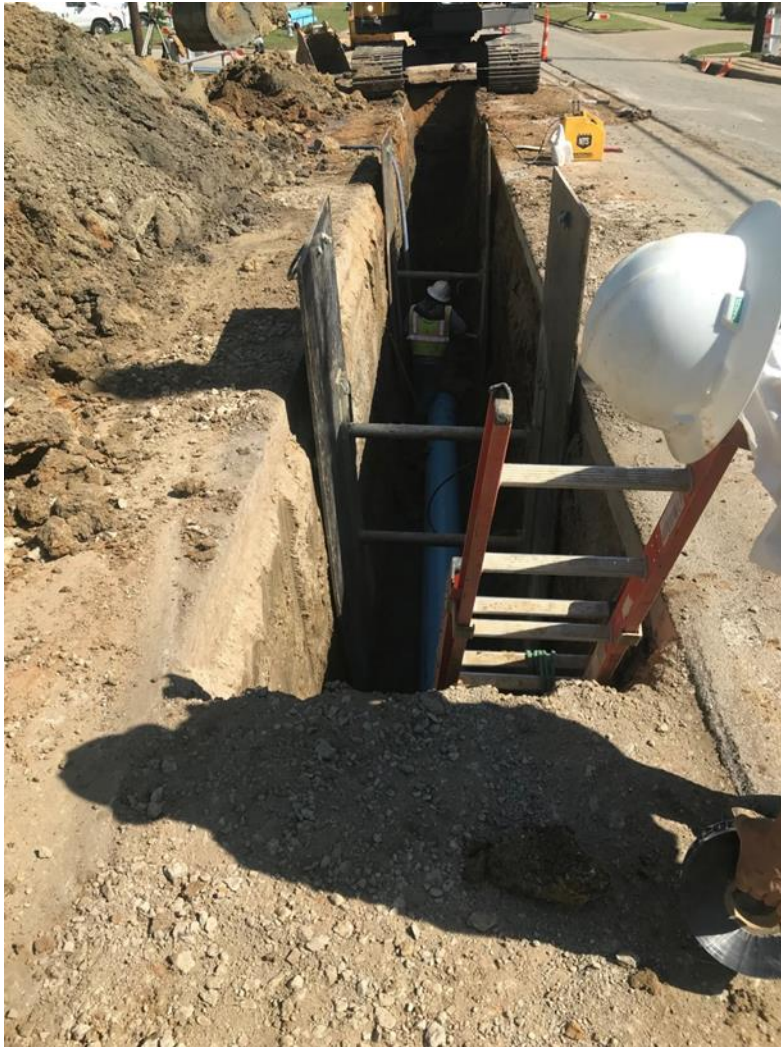
Fig. E5. Installation of pipe after trenching and supporting the lateral soil

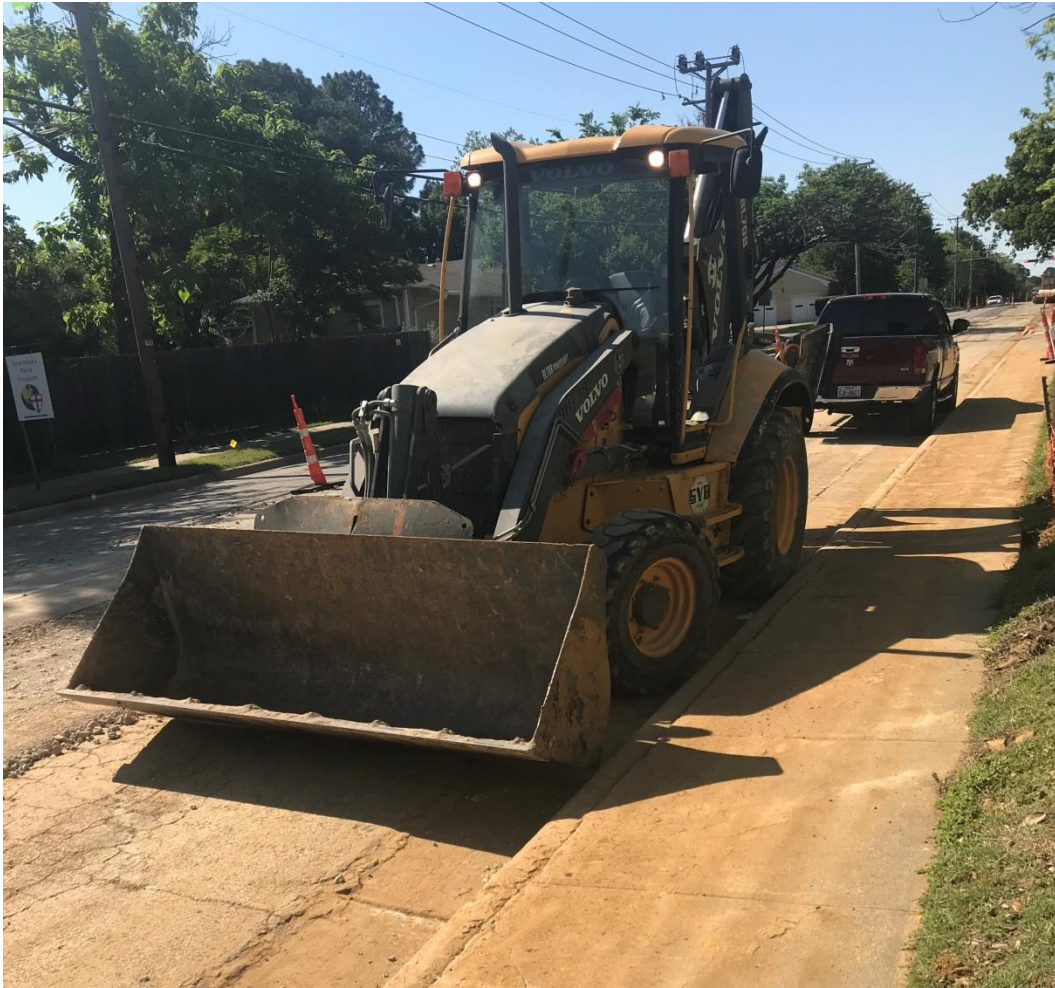
Fig. E7. Loader used for backfilling

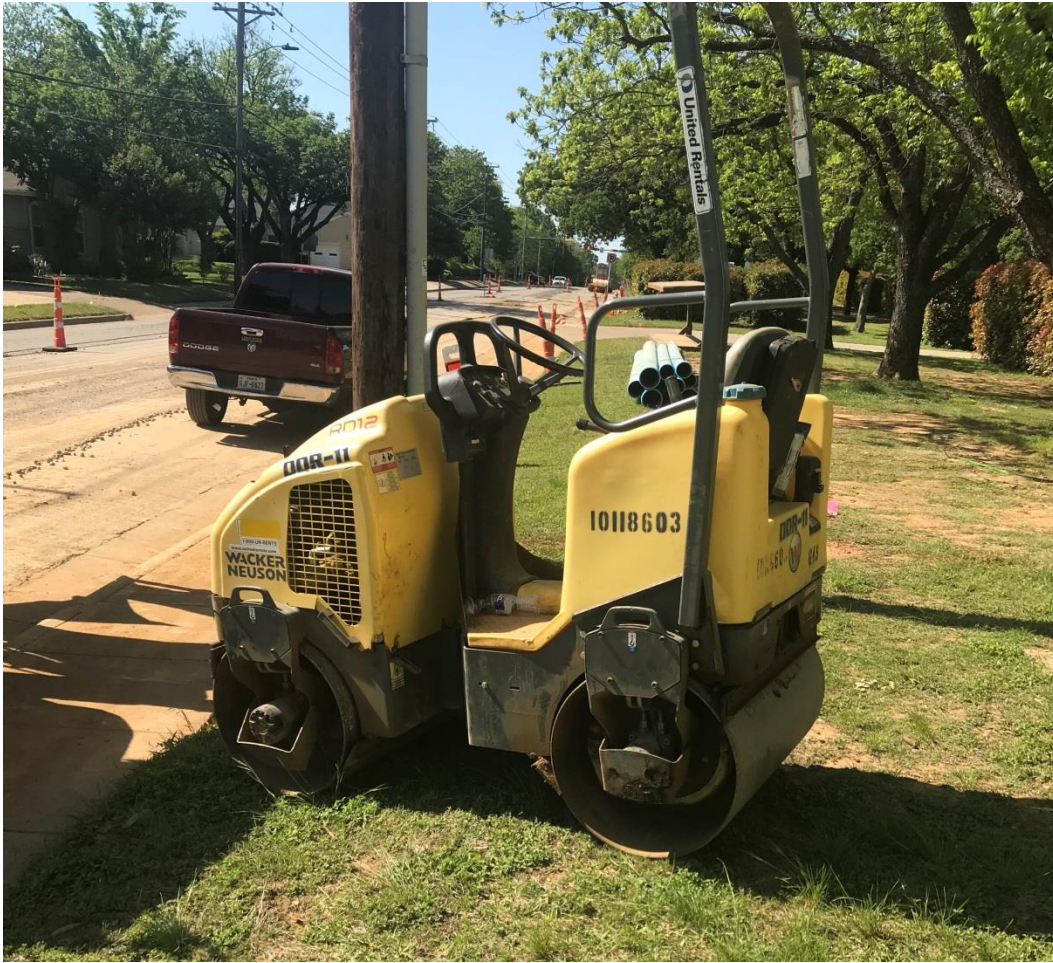
Fig. E8. Compaction machine used after backfilling

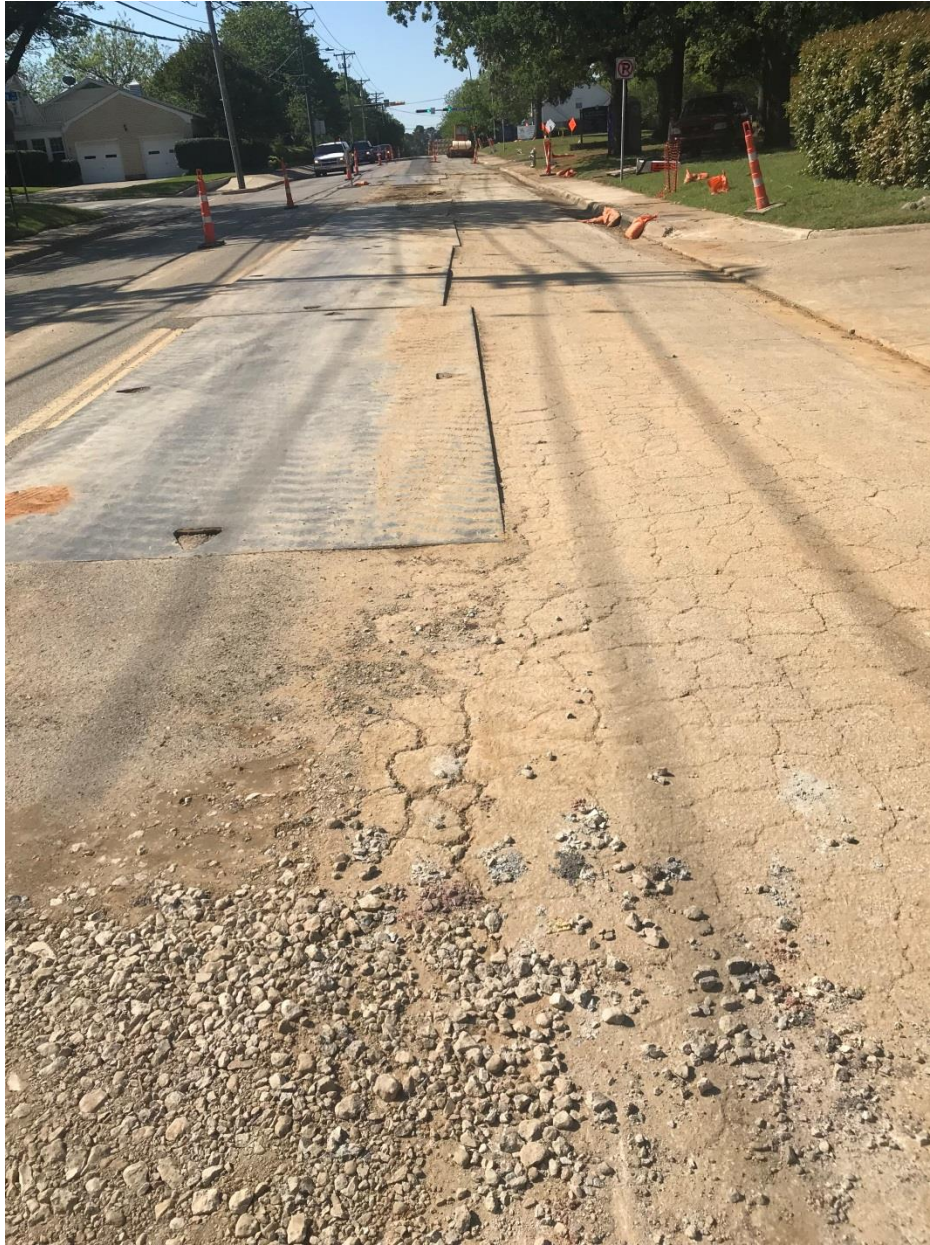
Fig. E9. Temporary pavement installed as work progresses forward
