# **Evaluation and Retrofitting of Prestressed Concrete Girder Bridge with Excessive Vibration**

### Evaluation and Retrofitting of Prestressed Concrete Girder Bridge with Excessive Vibration

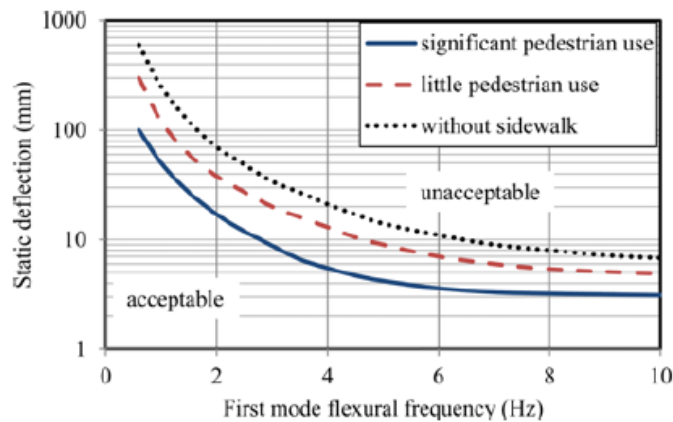
Figure 2- 2: First flexural frequency vs static deflection curve (Canadian standards, 1990)

While AASHTO (2017) criteria only focuses on deflection, researchers have been studying other vibration criteria such as acceleration and frequency and their effects on human susceptibility. In fact, acceleration parameter can capture human susceptibility more accurately than the displacement parameter for vibration (Gaunt, 1981). Oehler (1970) concluded that the deflection limit cannot mitigate vibration consistently. Fountain and Thunman (1987) had a similar conclusion stating that the deflection limit does not prevent human reactions inducing vibration and acceleration. Canadian standards, CSA (1990) provided a relationship between natural frequency and maximum static deflection of the superstructure of pedestrian bridges. Wright and Green (1964) also proposed a relationship after extensive analytical and field study. Figure 2-2 shows a plot of first flexural frequency vs static deflection based on Canadian standards. Australian codes, Austroads (1996) proposed a similar relationship such as the Canadian standards which is shown in Figure 2-3.

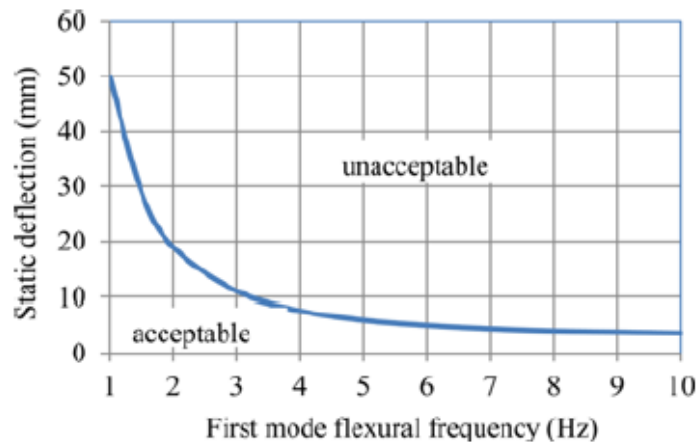
Figure 2- 3: First flexural frequency vs static deflection curve (Australian codes, 1996)

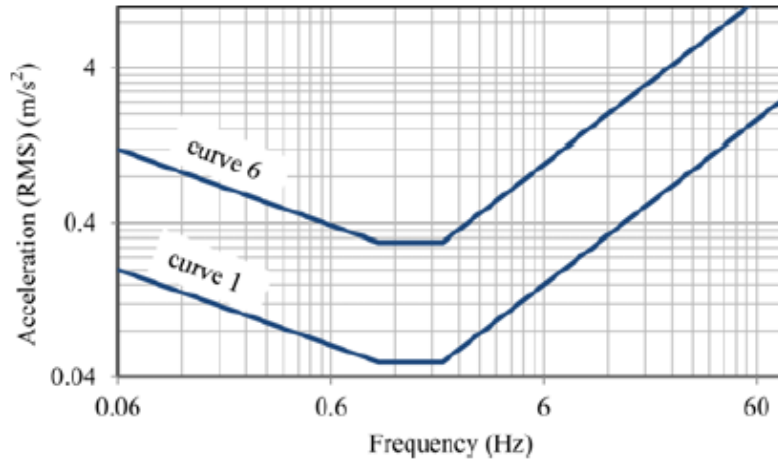
Figure 2- 4: Maximum vertical accelerations of Bridges for everyday events (curve 1) and storm condition (curve 2) by Irwin (1978)

Irwin (1978) suggested limits for root-mean-square accelerations for everyday usage and storm conditions which are shown in Figure 2-4.

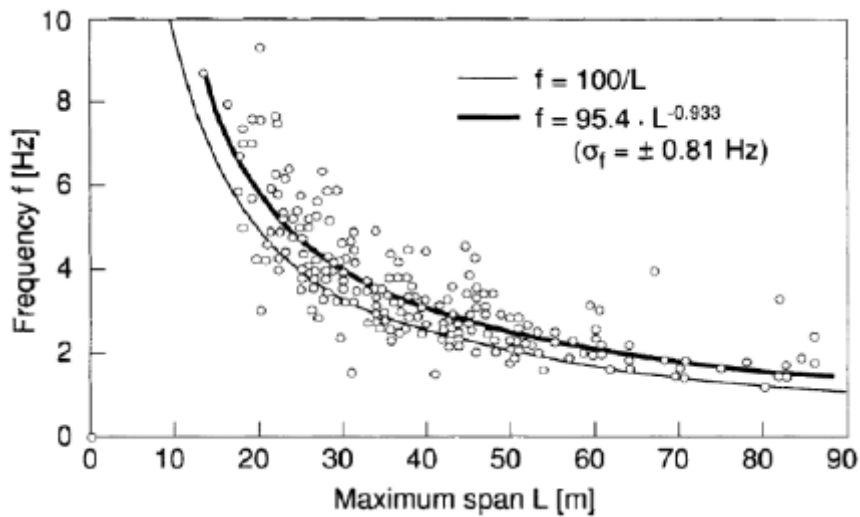
Figure 2- 5: Fundamental frequency vs maximum span length of bridges (Amman, 1995)

researchers applied ambient vibration technique on different types of bridges such as a double-deck bridge (Harik et al., 1997), prestressed concrete box girder bridge (Citak et al., 2012, Farrar et al., 1984), continuous girder bridge, cable-stayed bridge (Ren et al., 2005) and stone masonry bridge (Krstevska et al., 2008). Furthermore, Idris et al. (2016) conducted an ambient vibration test on a prestressed concrete bridge and identified the different modal frequencies of the bridge and the fundamental mode of vibration. Fundamental mode is the mode with the lowest natural frequency (Damodarasamy & Kavitha, 2009). Due to its direct relationship with stiffness, the natural frequency of the bridge is a very important parameter (Lin & Yang, 2005). The natural frequency of a bridge is a function of its mass and stiffness distribution, boundary condition, and continuity conditions between various components of the structure (Grimmerlsman, 2006). Amman's (1995) study indicated that there is a correlation between fundamental frequency and maximum span length of the bridge from the experimental data analysis of 224 bridges (Figure 2-5).

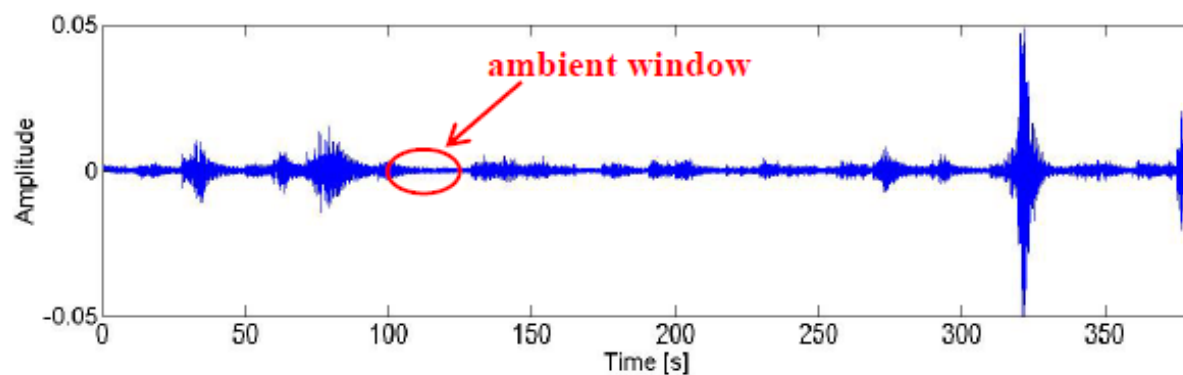
Figure 2- 6: Ambient window of a signal (Neitzel et al., 2011)

To calculate the fundamental frequency from ambient vibration data, Fast Fourier Transform (FFT) or Power Spectral Density (PSD) analyses are used on vibration signals to extract the frequencies and modes. An ambient window was found just after excitation and analyzed using FFT or PSD. Figure 2-6 shows a typical ambient window of a signal while Figure 2-7 shows FFT analyzed data.

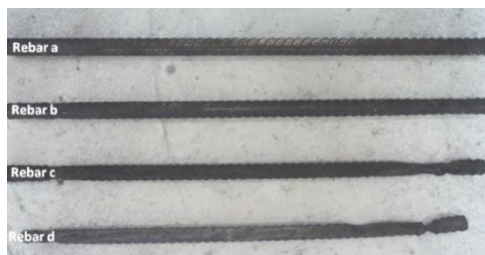
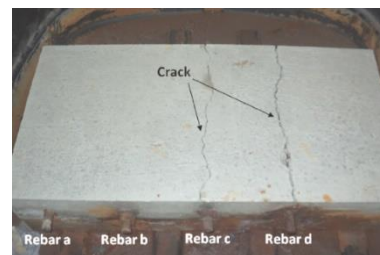
Figure 2- 9: (a) Corroded rebars of post corroded slab; and (b) Concrete slab after accelerated corrosion (right) (Zaki et al., 2018)

Zaki et al. (2018) used GPR to scan a concrete slab and successfully detected rebar corrosion in the sample. The process involved casting the concrete slab and then scanning the slab using GPR with a 2 GHz antenna. After the scanning, imposed current technique was used to collect data from the GPR. Four different levels of corroded rebars were used to embed inside the slab (Figure 2-9) to identify and compare the corrosion.

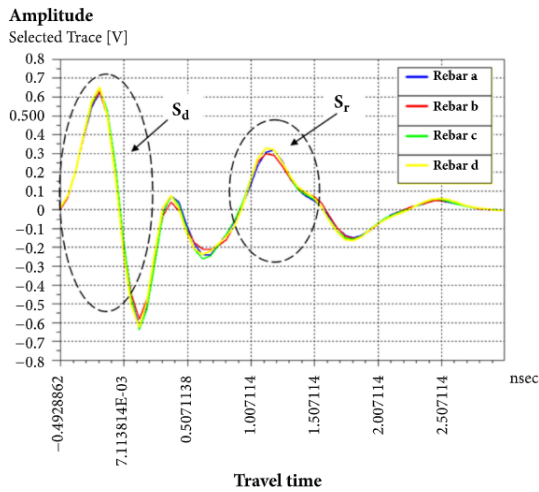
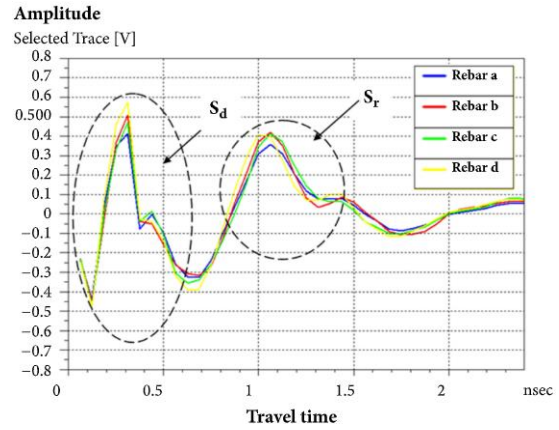
Figure 2- 10: a-scan of the concrete slab: (a) Before; and (b) After accelerated corrosion (Zaki et al., 2018)

The a-scan and b-scan results of GPR were analyzed to identify the rebar corrosion in the concrete slab. The corrosion of the rebar can be detected successfully using the scans at an early age even before any visual corrosion damage. A-scan results showed lower amplitude and larger wave travel

times which can be explained by the corrosion products and chloride contents presented in the corroded rebars (Figure 2-10). The b-scan image was blurred and distorted indicating rebar corrosion due to the presence of chloride and other corrosive contents. Figure 2-11 shows the distorted threshold level of the image for the GPR b-scan. To sum up, the scans obtained from the GPR can successfully detect localized damage of the rebars of the concrete slab due to corrosion.

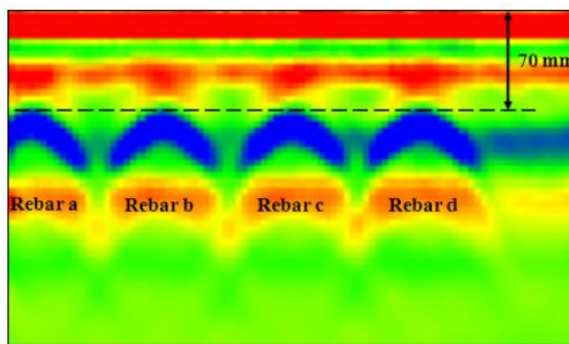
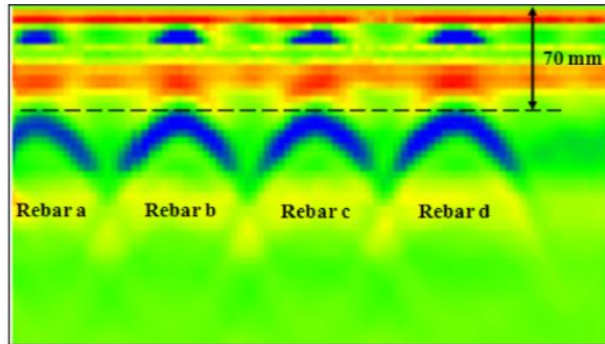
Figure 2- 11: b-scan of the concrete slab: (a) Before; and (b) After accelerated corrosion (Zaki et al., 2018)

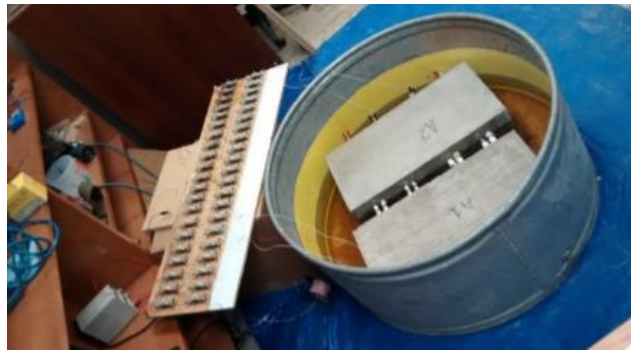
Figure 2- 12: Accelerated corrosion setup (Raju et al., 2018)

Raju et al. (2018) related the rebar corrosion quantity with the maximum reflected waveform amplitude from GPR scanning. Accelerated corrosion was used to induce rebar corrosion (Figure

2-12), and GPR scanning monitored corrosion at three stages: before and after submersion into the salt-water solution and at the end of a pre-set corrosion period. As expected, the rebar corrosion mass loss was greater for longer duration corrosion periods, larger rebar sizes, and lower cover. The data analysis showed that the GPR amplitude increased with increased corrosion activity. Again, a polynomial curve with high reliability, normalized for rebar size and cover, was proposed for rebar corrosion loss for a given concrete dielectric constant (Figure 2-13). Correspondingly, the model was calibrated with the GPR scan data from a portion of a demolished old concrete bridge deck.

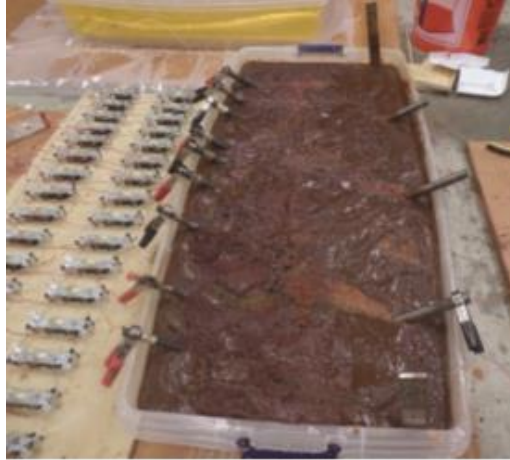
Figure 2- 14: Tank for accelerated corrosion (Hasan & Yazdani, 2015)

Hasan and Yazdani (2015) correlated the maximum positive amplitude of GPR with the reinforced concrete corrosion quantity. At first, steel rebars were immersed in a 5% brine solution and then direct current was applied to the rebar ends simulating an accelerated corrosion situation (Figure 2-14). Different levels of corrosion (0% to 45%) were simulated and the extent of corrosion was altered from 0% to 45% (Figure 2-15). Then the rebars were put inside three oil emulsion tanks with various dielectric constants similar to concrete and the maximum amplitudes from GPR were documented for the corroded bars. The maximum positive amplitude of GPR and the area loss due to corrosion of rebars demonstrated a linear relationship (Figure 2-16). It was concluded that the linear relationship between the GPR maximum amplitude and the rebar corrosion can be used as a quantitative NDE technique to assess corrosion.

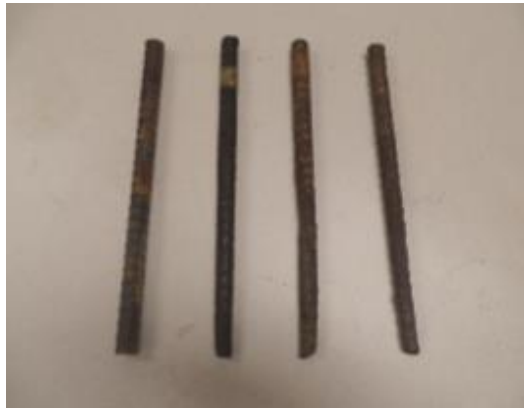
Figure 2- 15: Rebars with different degrees of corrosion (Hasan & Yazdani, 2015)

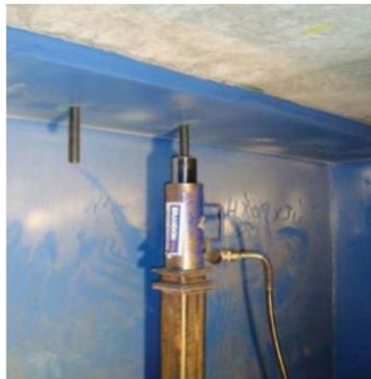
Figure 2- 27: Hydraulic jack used for inserting spiral pins into the bridge (Collin, et al., 2015)

Coiled spring pins have also been successfully used in creating composite action on a non-composite bridge (Pitsund Bridge). The installation involves drilling through the steel flange and into the concrete deck from underneath, applying lubricant and corrosion protection into the hole and pressing the spring pins into place by using a hydraulic jack. Figure 2-27 shows the installation of a spiral pin into a bridge.

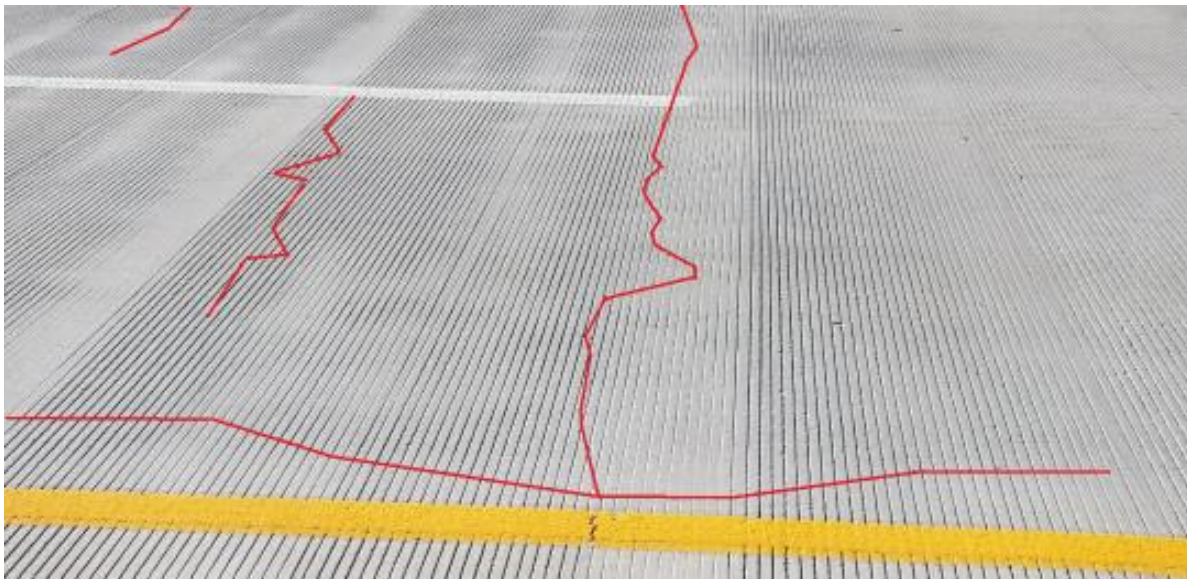
Figure 3- 3: Visible cracks on the deck

The Bridge was observed to have excessive vibration, cracking, and potholes on the concrete deck. The University of Texas at Arlington (UTA) team was, therefore, requested by the Dallas District Bridge Section to evaluate the subject bridge. The bridge is fairly new and was constructed in 2011. Therefore, it is unusual for it to experience excessive vibration, cracking, and potholes. The UTA team initially visited the bridge site on January 29, 2018, with personnel from the Bridge Section and Area Office. Extensive transverse and longitudinal cracks, marked by the red lines in Figure 3- 3, were observed on top of the deck surface. TxDOT officials informed the team that a pothole appeared on top of the deck and was subsequently repaired (Figure 3-4). Unusually high vibration was also felt on the deck as heavy traffic flowed over the bridge.

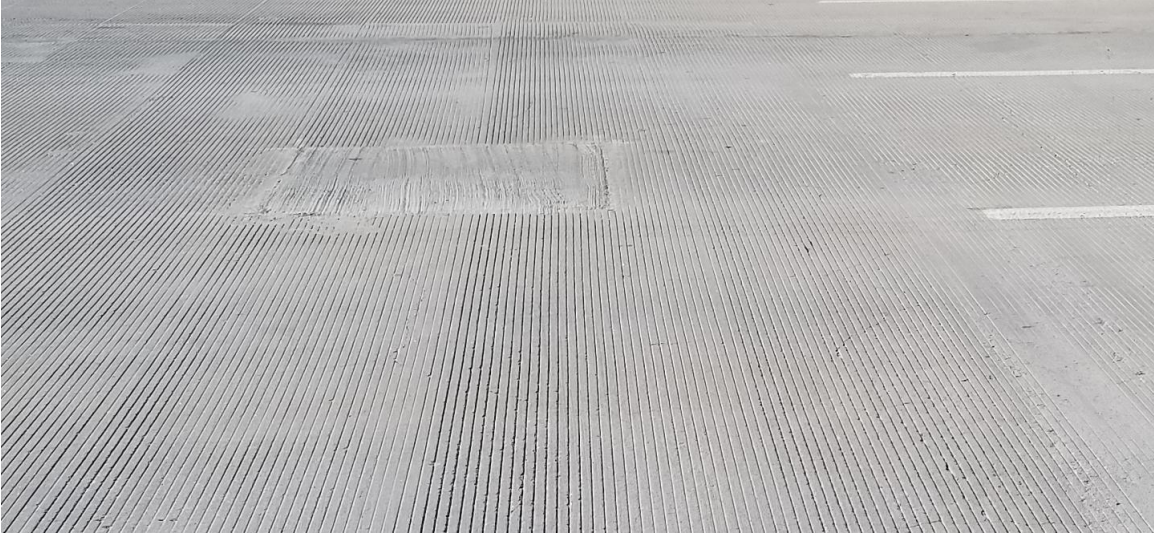
Figure 3- 4: Repaired pothole on the deck.

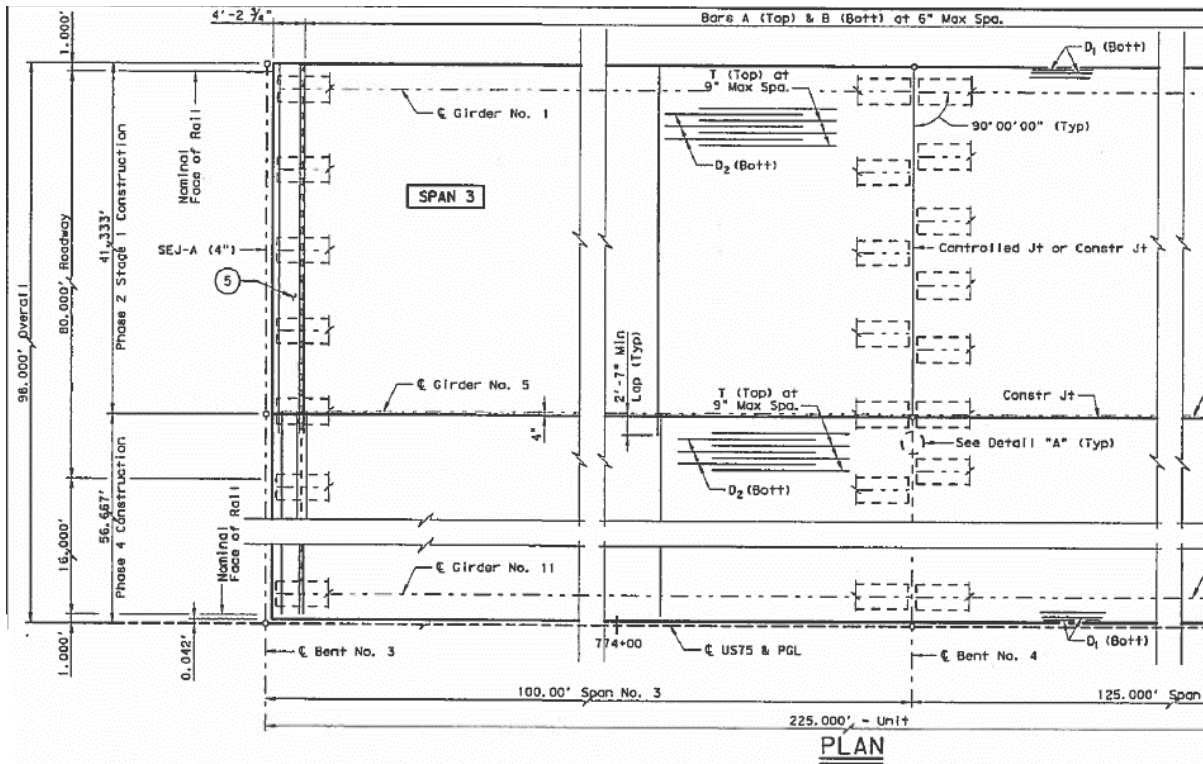
Figure 3- 5: Slab plan for span 3

The slab plan and transverse typical sections of span 3 are shown in Figures 3-5 and 3-6, respectively. Tx54 prestressed girders were used, and the typical section is shown in Figure 3-7.

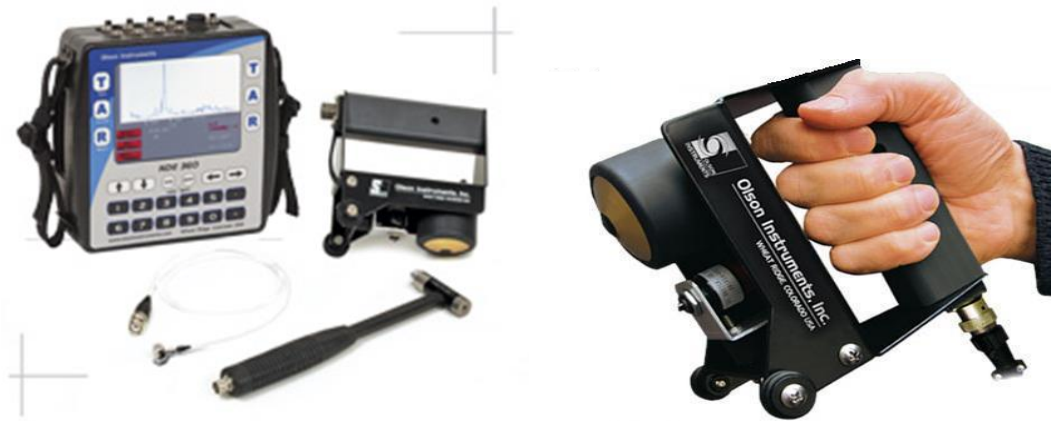
Figure 4- 10: IE Device

a spot on the surface and then records and analyzes the echo. Unlike the GPR, the IE system is a spot scanning device, which is used to scan discrete data points in a pre-determined grid on the concrete deck surface. Figure 4-10 shows the IE device that was used herein.

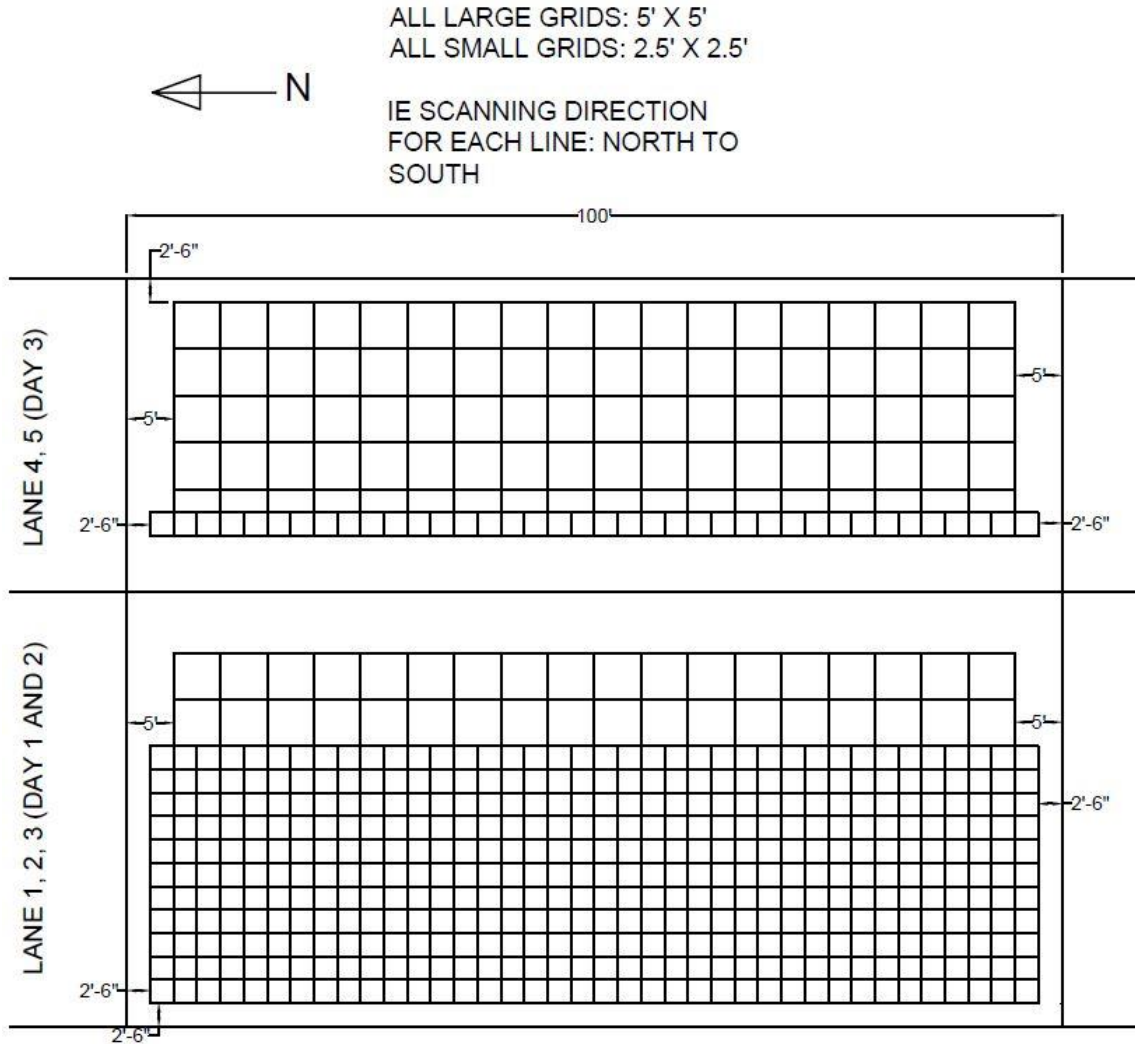
Figure 4- 11: Working grid for IE scanning

The IE data were gathered at discrete points with variable spacings (2.5 ft. to 5 ft. spacing) on a pre-selected grid pattern, post-processed and then analyzed. Results of IE data analysis at each point provided the state of any delamination at that point. The IE scanning grid showing the data points is shown in Figure 4-11.

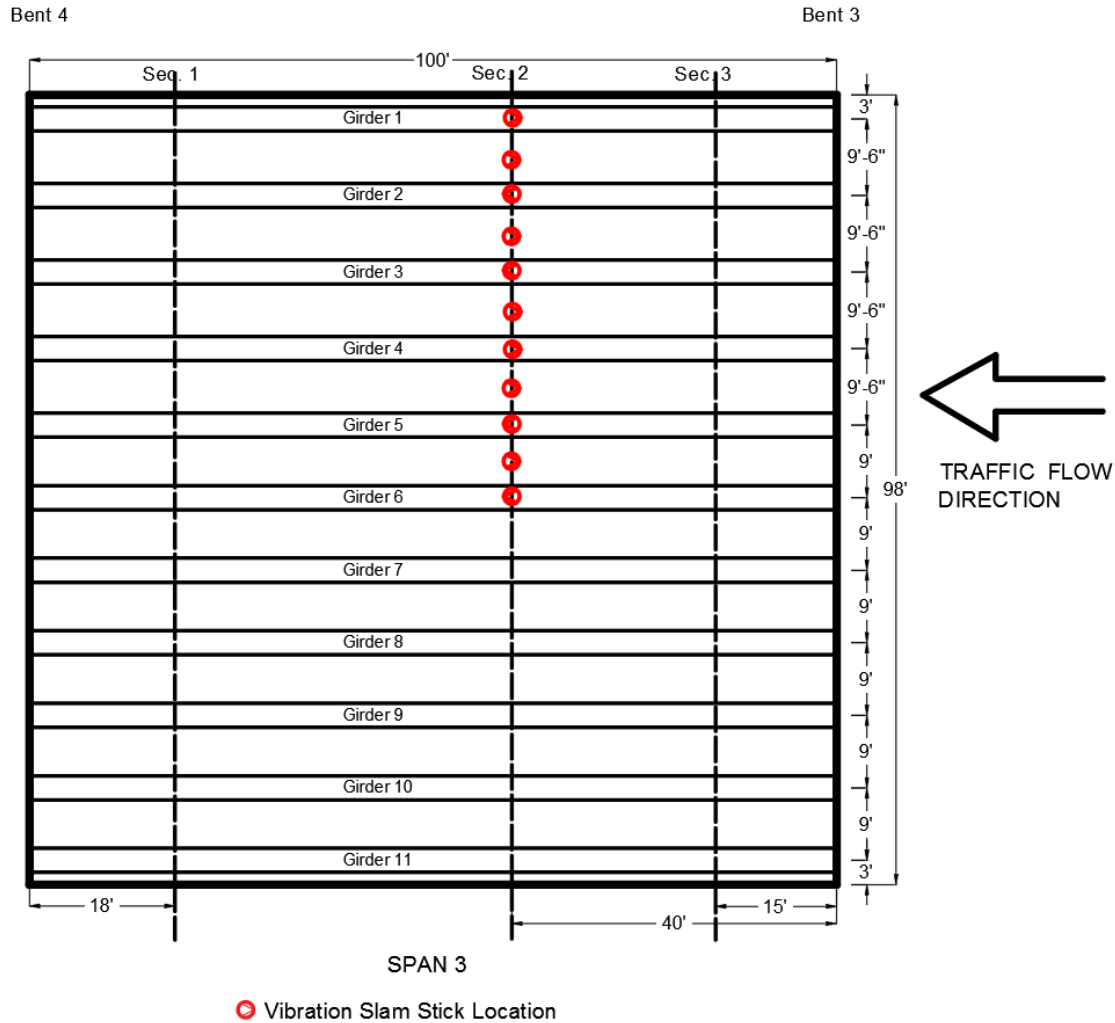
Figure 4- 13: Locations of vibration meter under the deck and the girders for SB Bridge

Ambient vibration test was conducted on span 3 of the SB Wilson Creek Bridge and data was collected from six girders, five locations on the deck, two bearing pads, and three locations on the bent caps. Figure 4-13 shows the locations of the vibration meter under the deck and the girders.

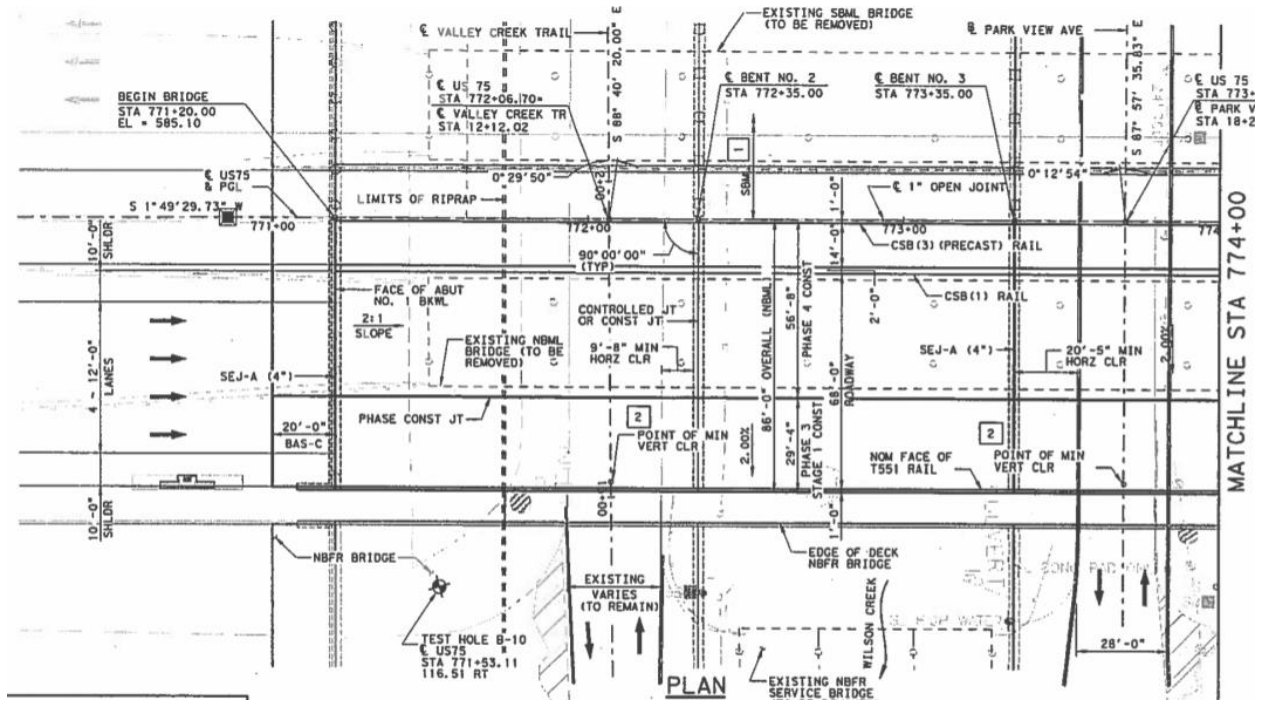
Figure 4- 15: Plan view of the NB Bridge

The Wilson Creek NB Bridge was tested for ambient vibration to compare with the SB Bridge. Span 3 was selected for the ambient vibration to avoid traffic closure. Figures 4-15 and 4-16 show the plan and typical transverse section of span 3 of the bridge, respectively while Table 4-4 shows a comparison between the SB and NB bridge data.

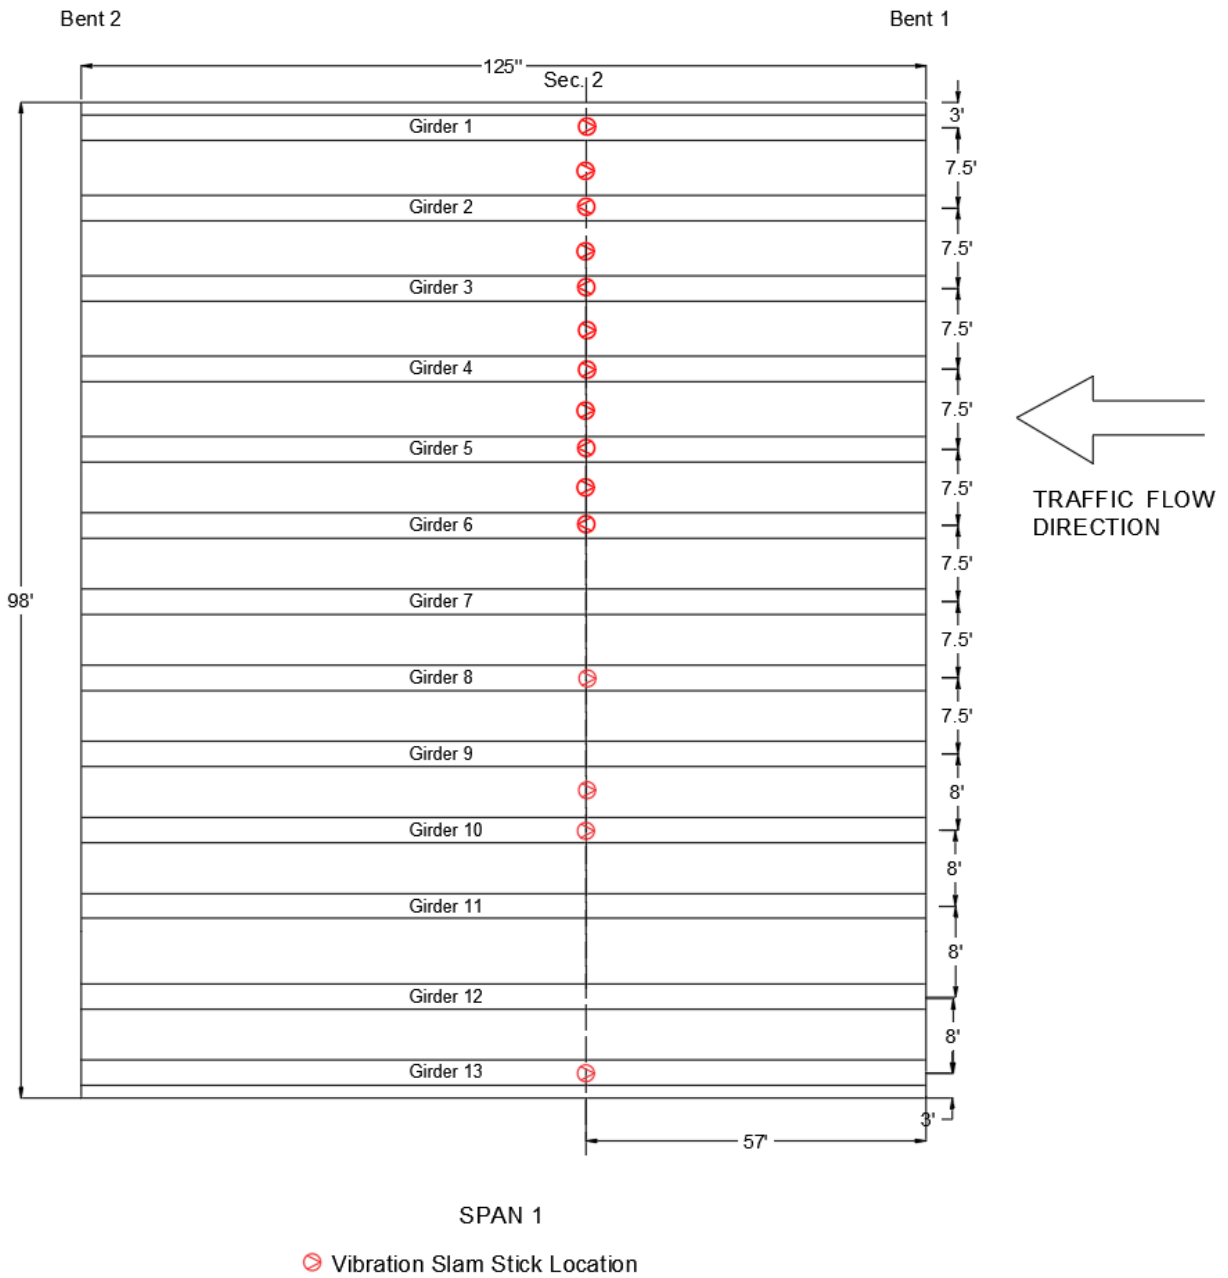
Figure 4- 22: Locations of the vibration data logger for the Virginia Parkway Bridge

Figure 4-22 shows the locations of the vibration slam stick under the girders and deck during the vibration testing.

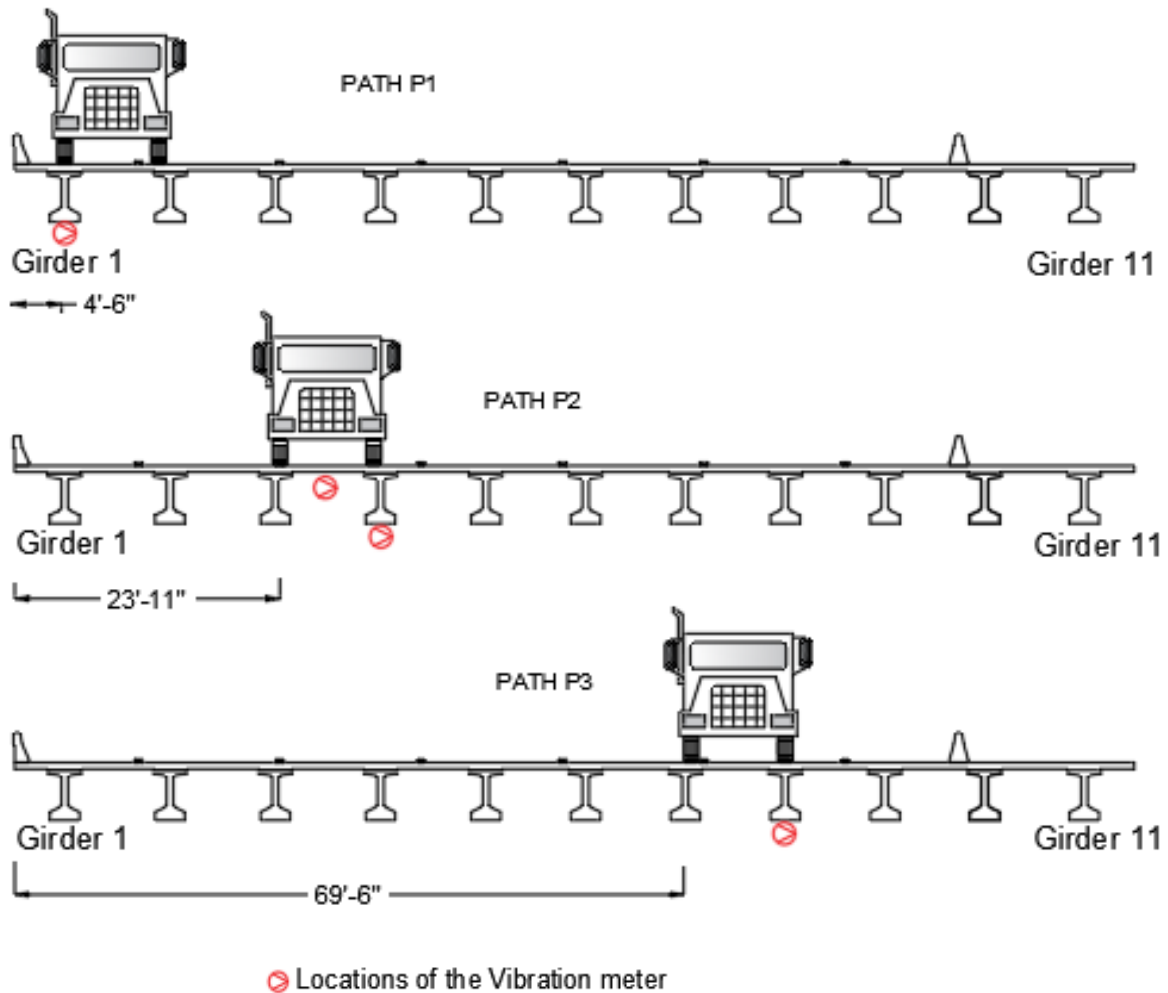
Figure 4- 23: Load test paths with the vibration data logger location

During a static load test, some of the girders (Girder 1 during Path P1, girder 4 during Path P2 and girder 8 during Path P3) and a portion of the deck (between girders 3 and 4 during Path P2) were instrumented with the vibration data logger. Then, the load test was repeated at velocities of 10, 20, 25, 30, 50, and 60 mph along paths P1, P2, and P3. The instrumentation plan for the vibration data logger is shown in Figure 4-23. Figure 4-24 shows a dump truck on the span for the load test while the vibration meter was placed under a girder.

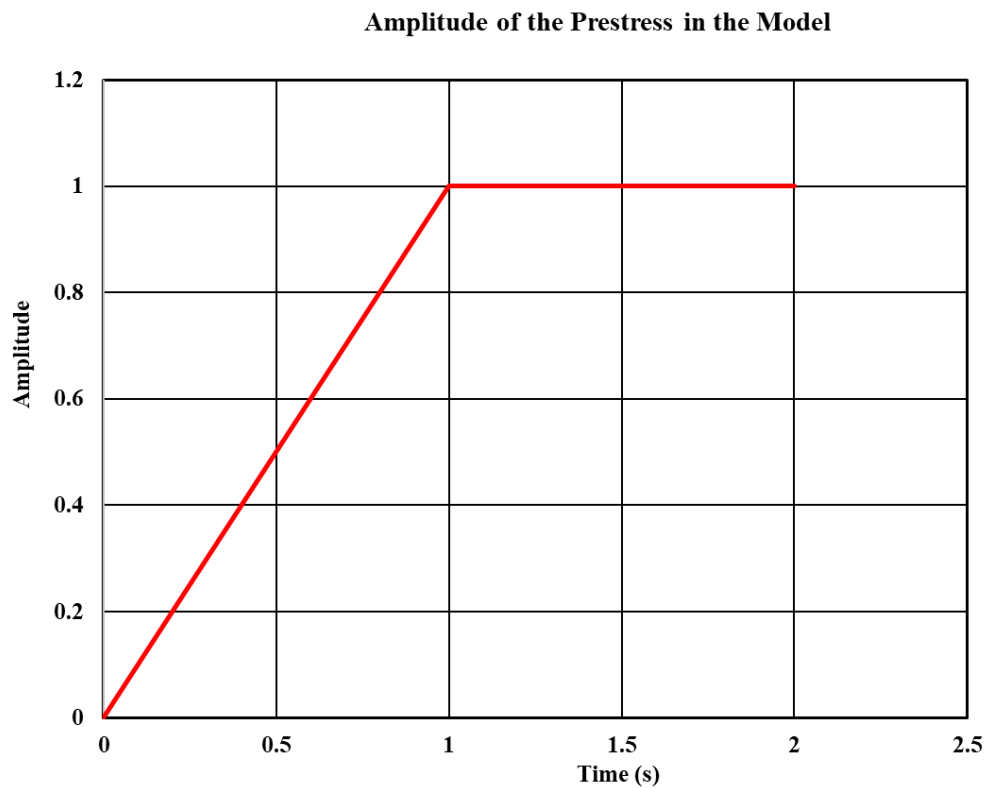
Figure 5- 11: Amplitude of the applied prestress in different steps of the model

Thermal loading was used according to section 2.3.3 to apply prestress on the prestressing strands of the girders and the deck. Initially, the temperature of the tendons of the girders was set as 0 °C. During step 1 (0-1 second), the temperature was set as -520 °C to achieve the required prestress. During step 2 (1-2 seconds), the temperature was kept constant at -520 °C to sustain the prestress obtained from step 1. Figure 5-11 shows the amplitude of the applied prestress due to thermal shrinkage in different steps of the model while Figure 5-12 shows the temperature profile of the model in step 1.

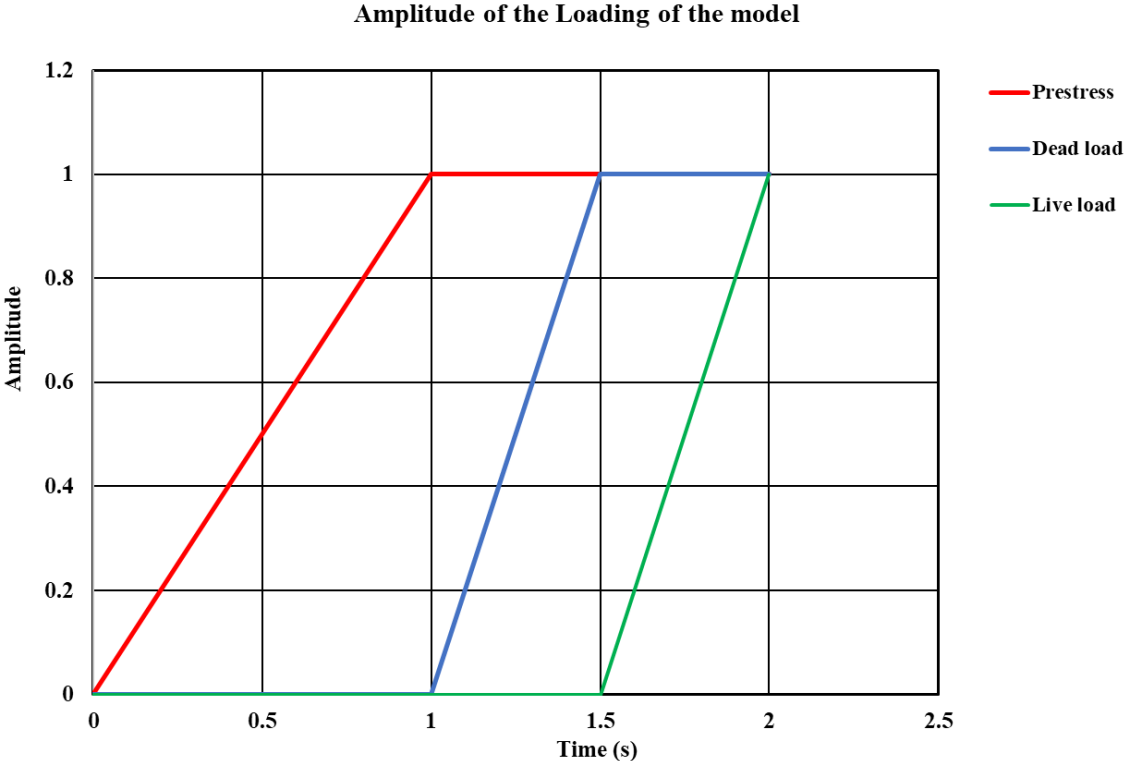
Figure 5- 15: Amplitudes of the multiple-step loading

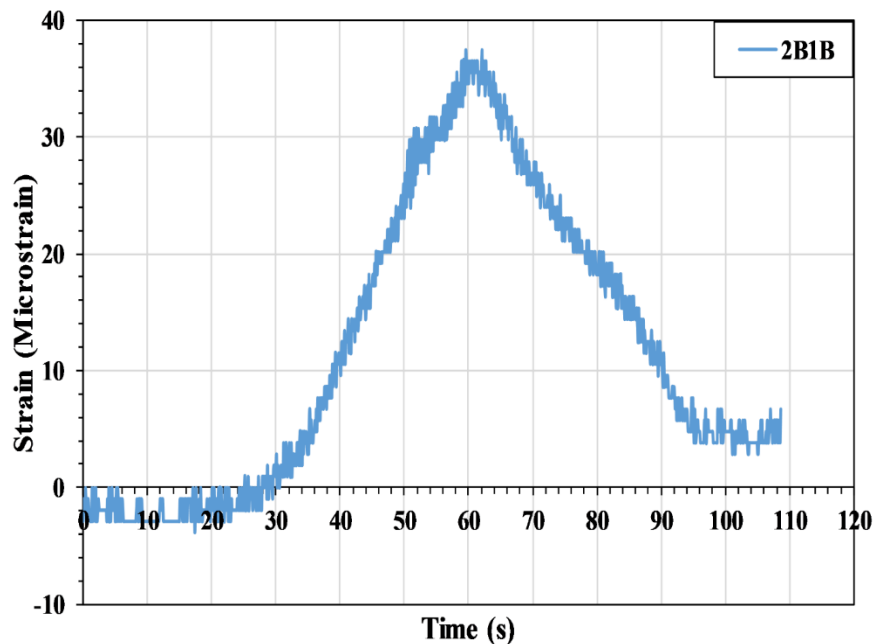
Figure 6- 1: Raw strain data for path P1 run 1

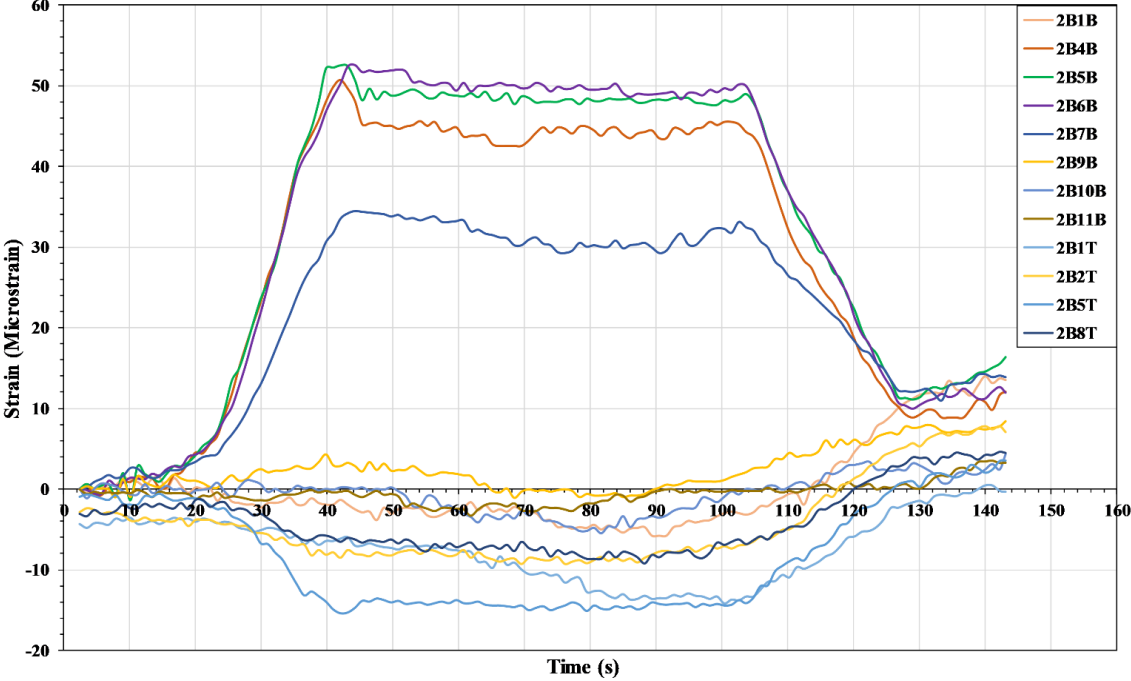
Figure 6- 8: Strain vs time diagram for the stop location test

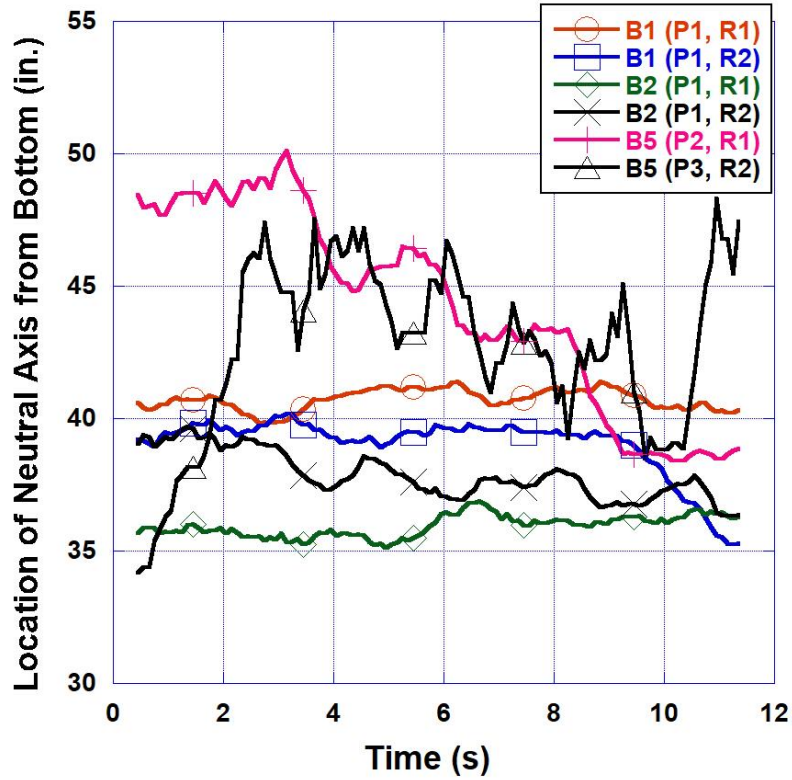
Figure 6- 10: Locations of the neutral axis obtained from the load test (Phase 1)

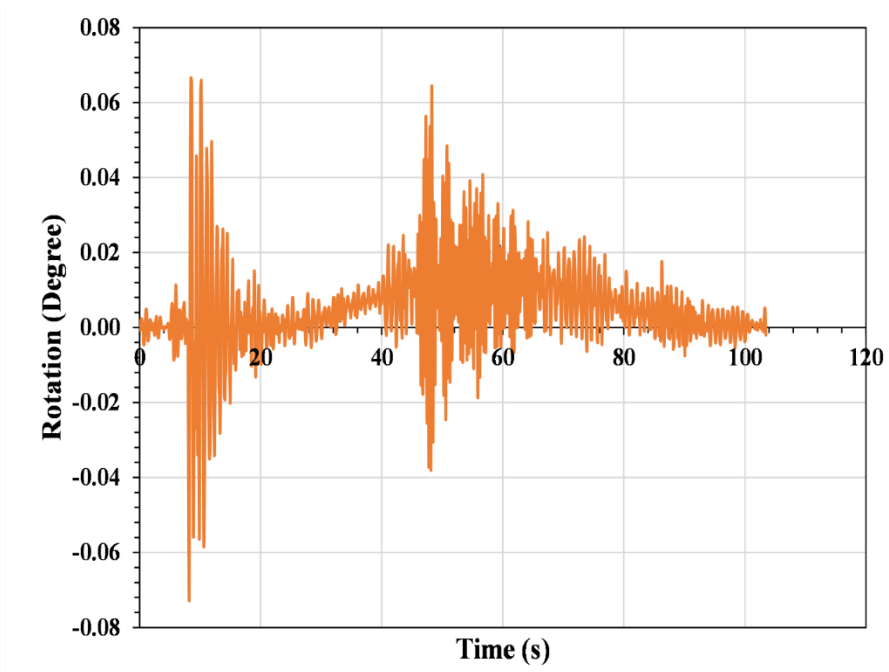
Figure 6- 11: Rotation vs. time for Path P2 Run 1

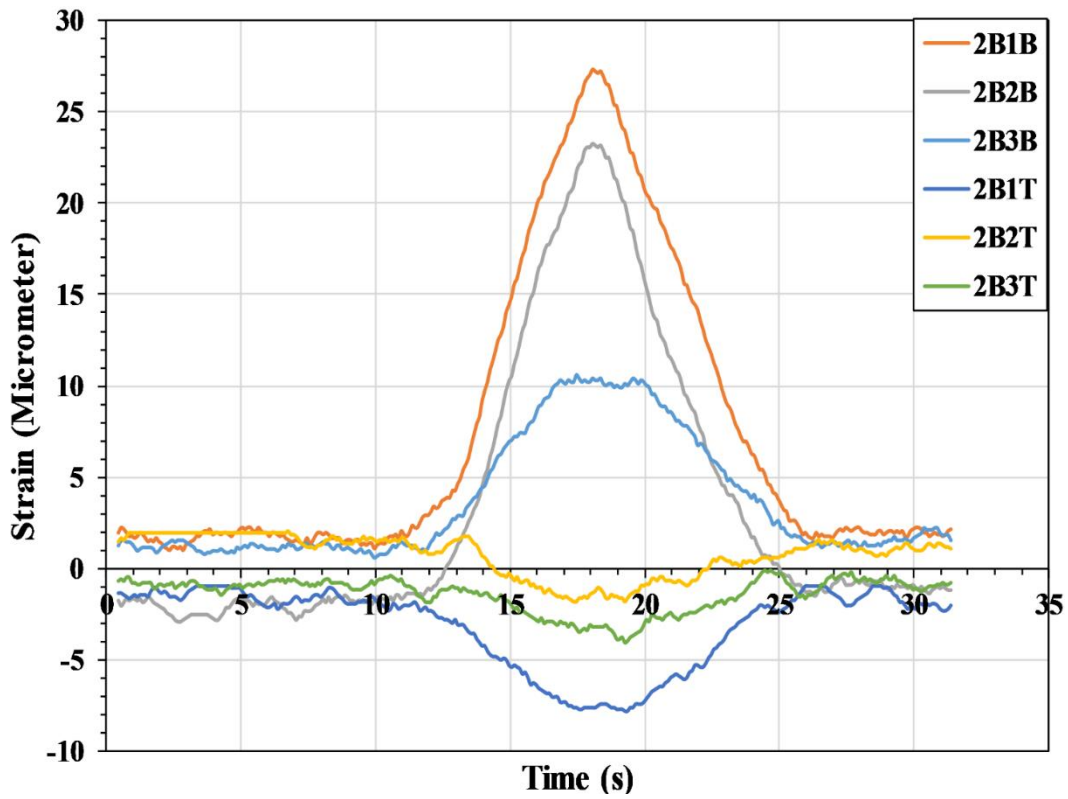
Figure 6- 15: Strain vs time diagram for Path P1 Run 2

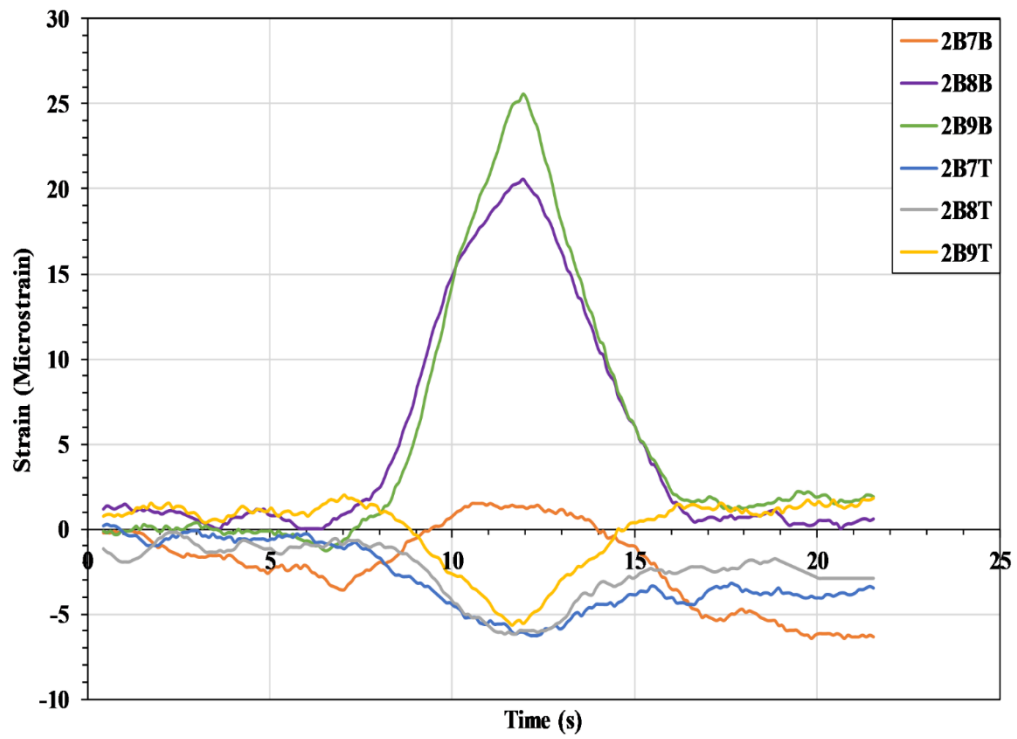
Figure 6- 19: Strain vs time diagram for Path P3 Run 2

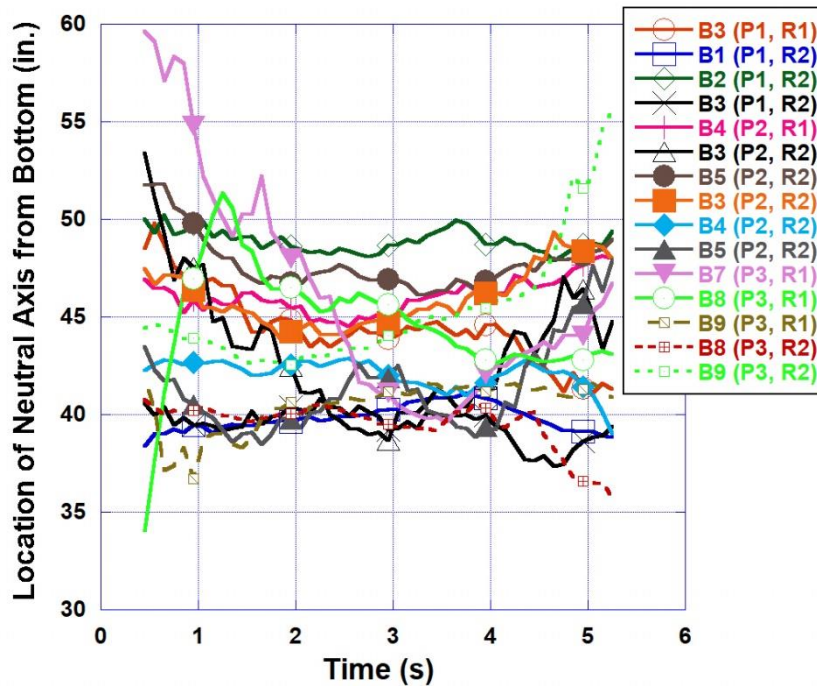
Figure 6- 21: Locations of the neutral axis obtained from the load test (Phase 2)
