# **Evaluation and Retrofitting of Prestressed Concrete Girder Bridge with Excessive Vibration**

### Evaluation and Retrofitting of Prestressed Concrete Girder Bridge with Excessive Vibration

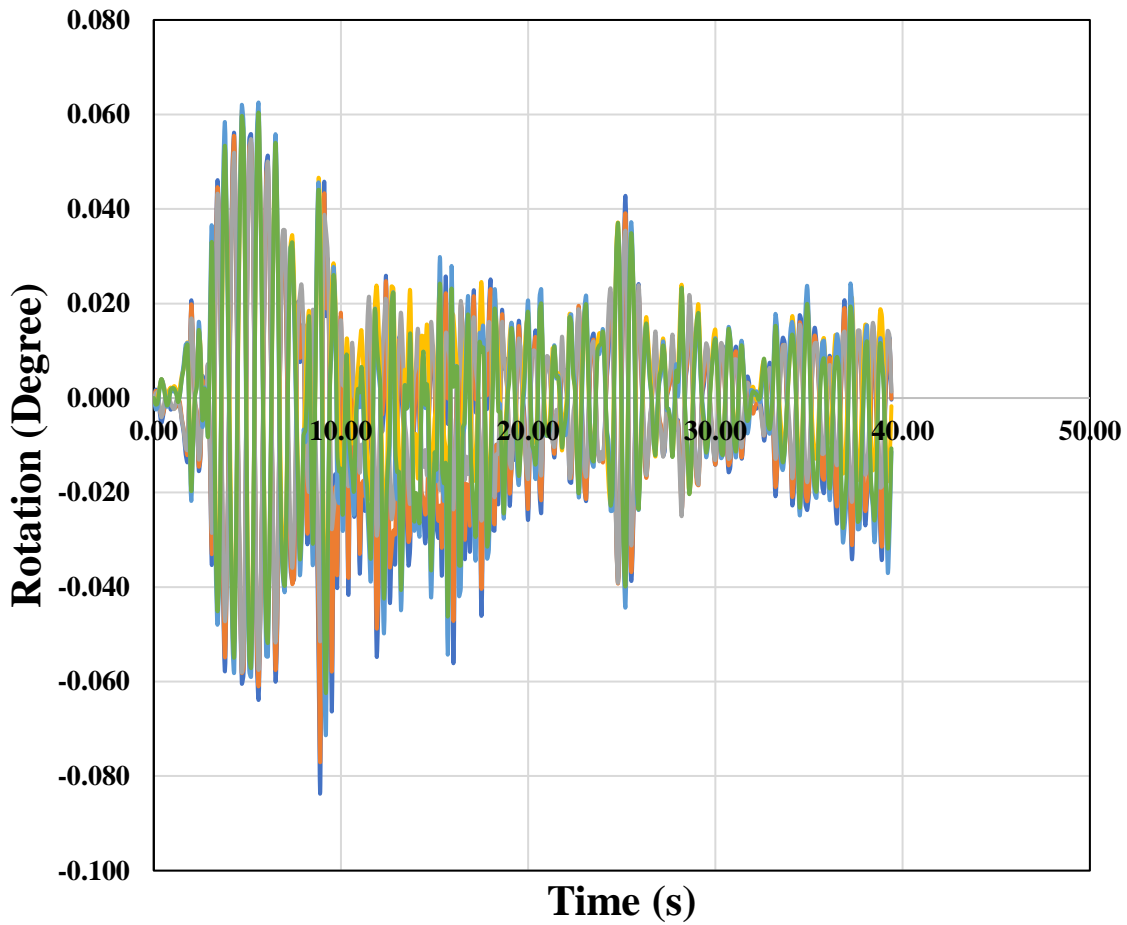
Figure 6- 24: Rotation vs time for Path P1 Run 1

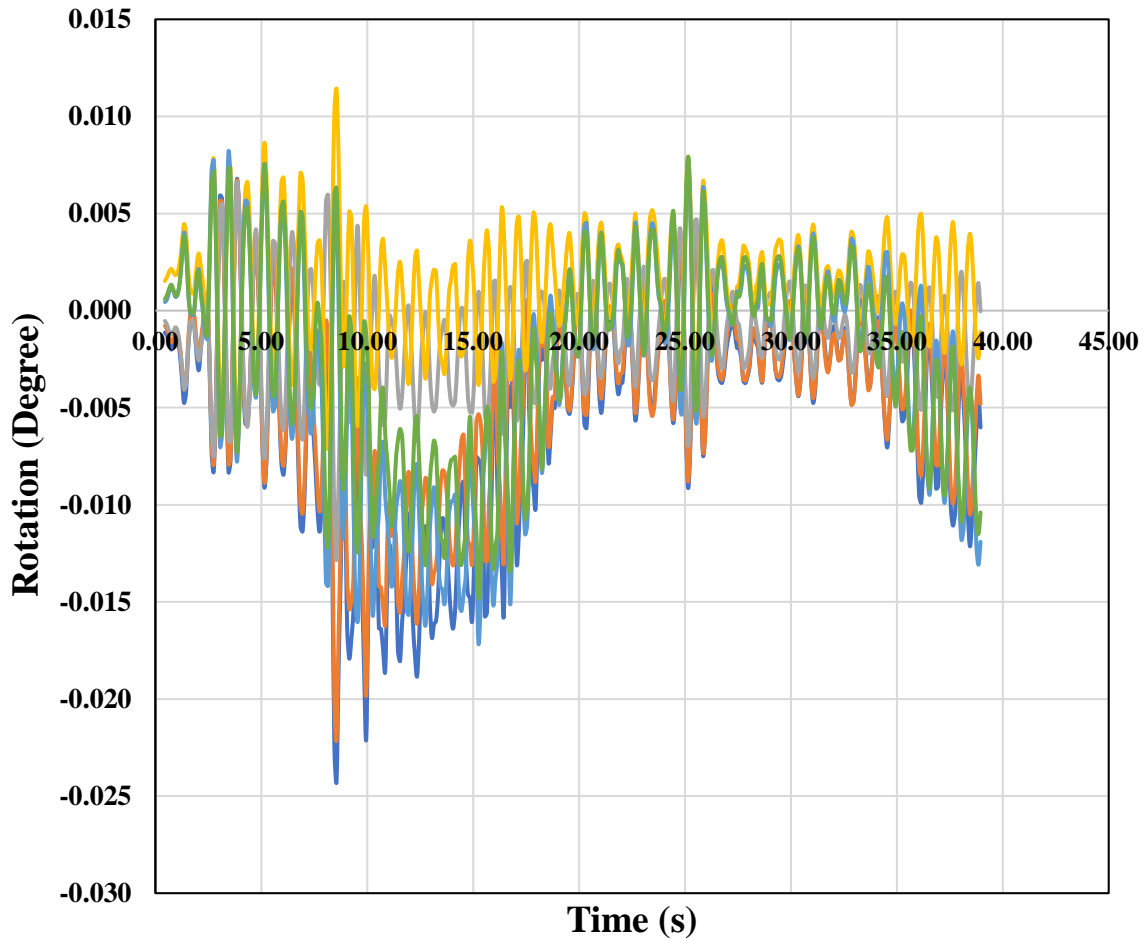
Figure 6- 25: Refined rotation data for Path P1 Run 1

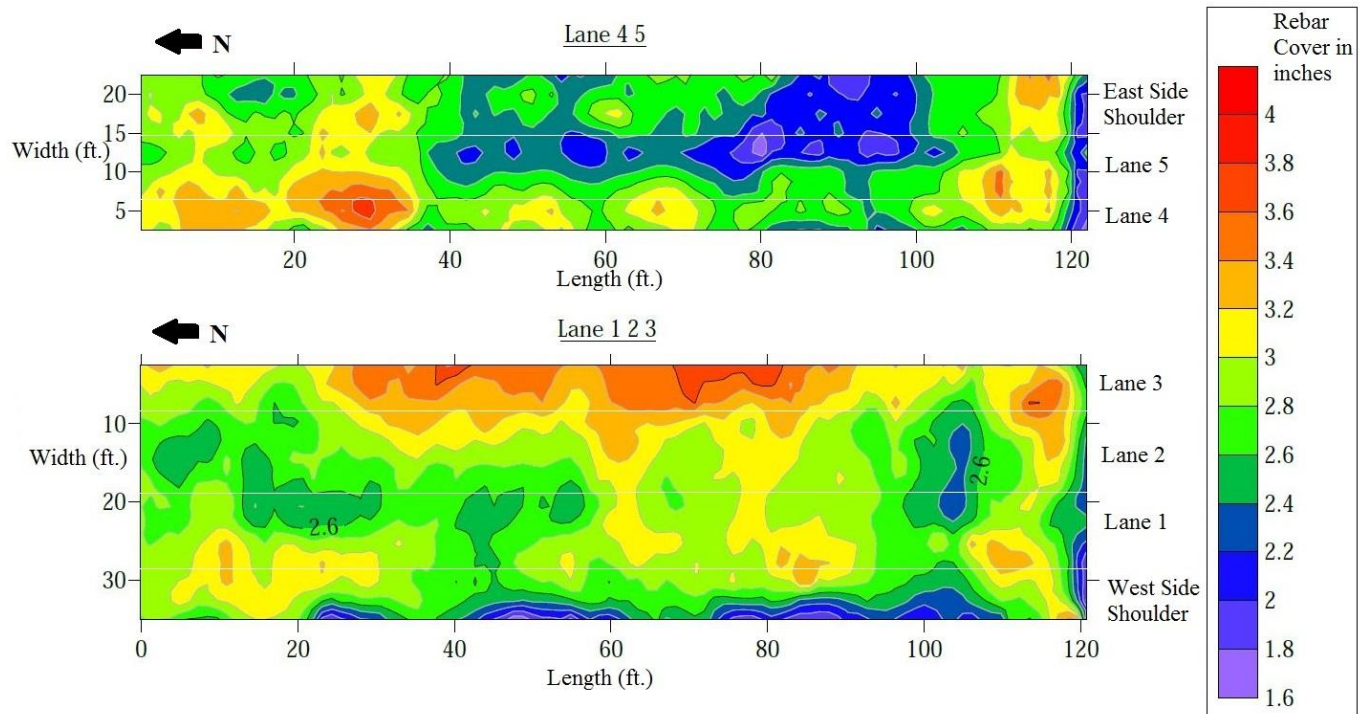
Figure 6- 26: 2-D contour plots showing rebar covers from GPR data

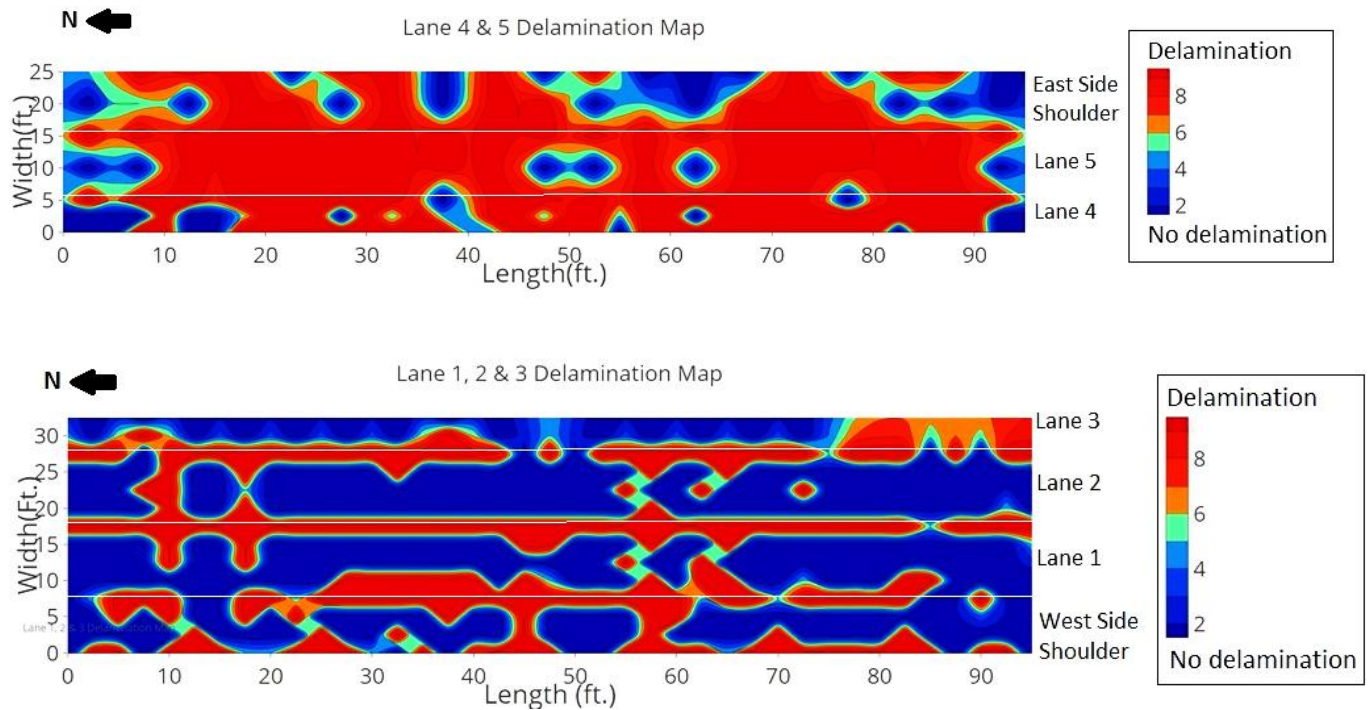
Figure 6- 27: Contour plots from IE data showing possible delamination

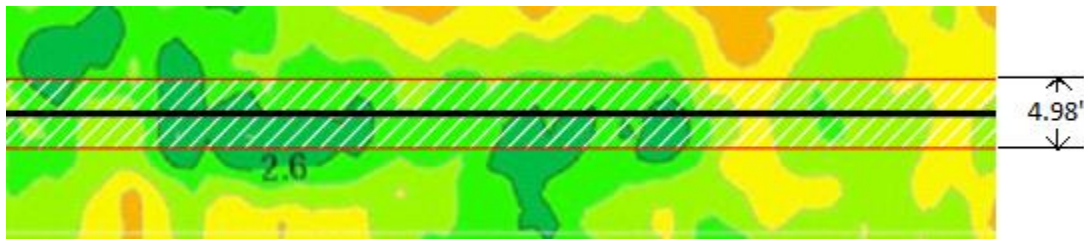
Figure 6- 28: Negative moment region (hatched area) and girder center line (black line) on a portion of GPR contour

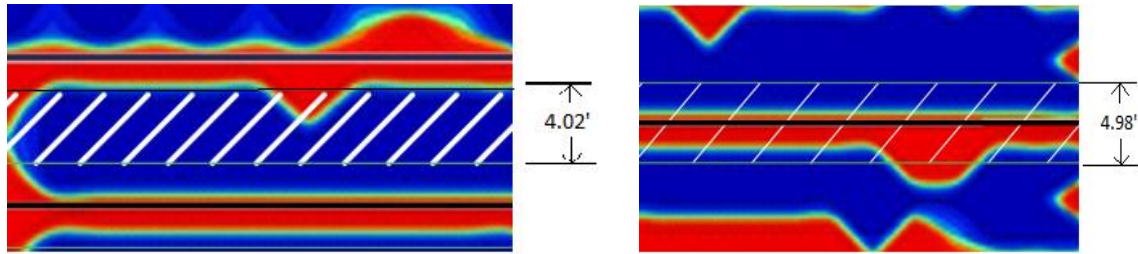
Figure 6- 29: Positive moment region (left) and negative moment region (right) from IE data

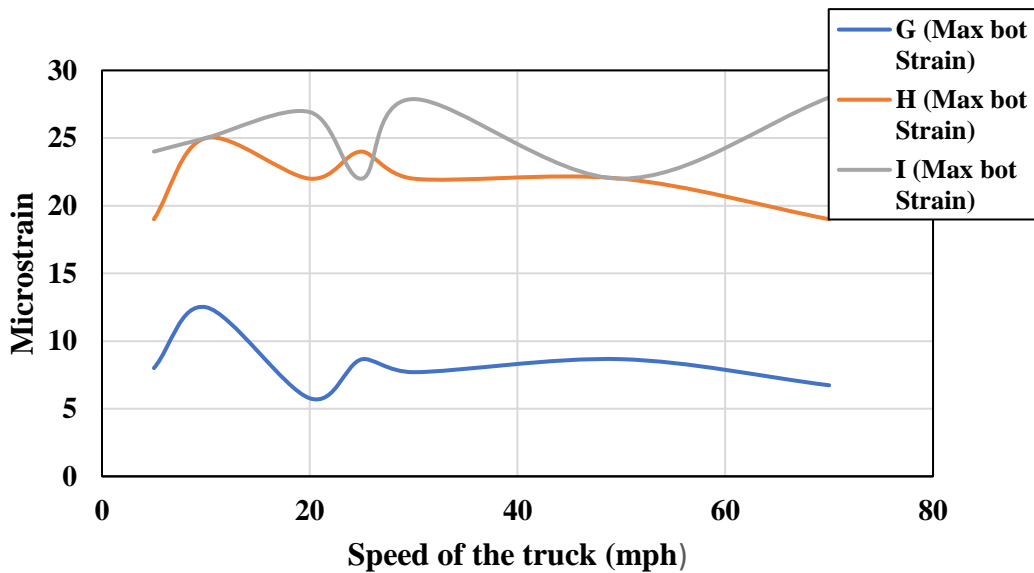
Figure 6- 34: Speed vs strain data for path P3

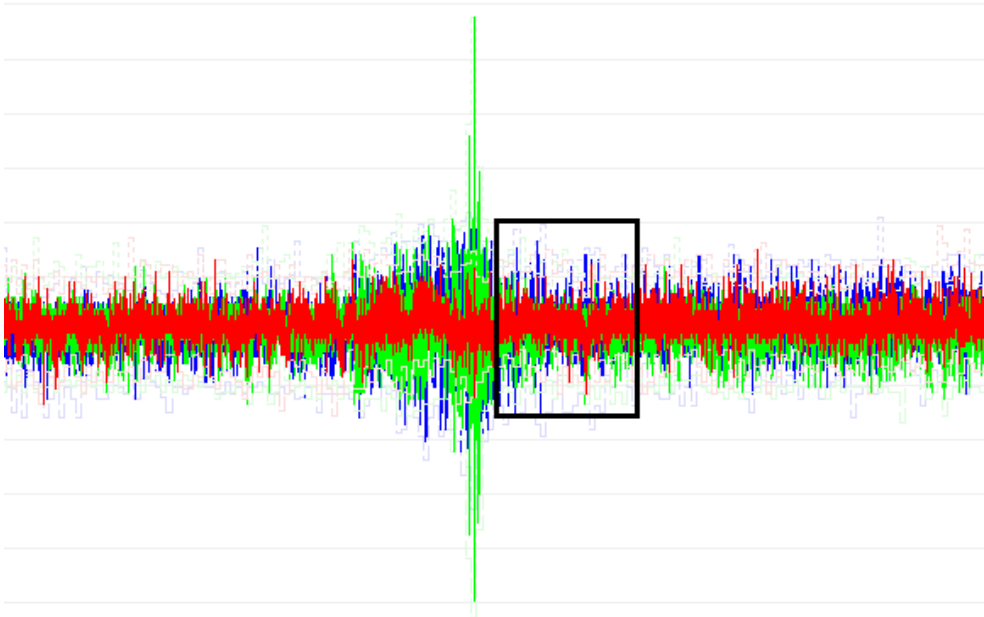
Figure 6- 35: Ambient window of the data shown in the box for path P2

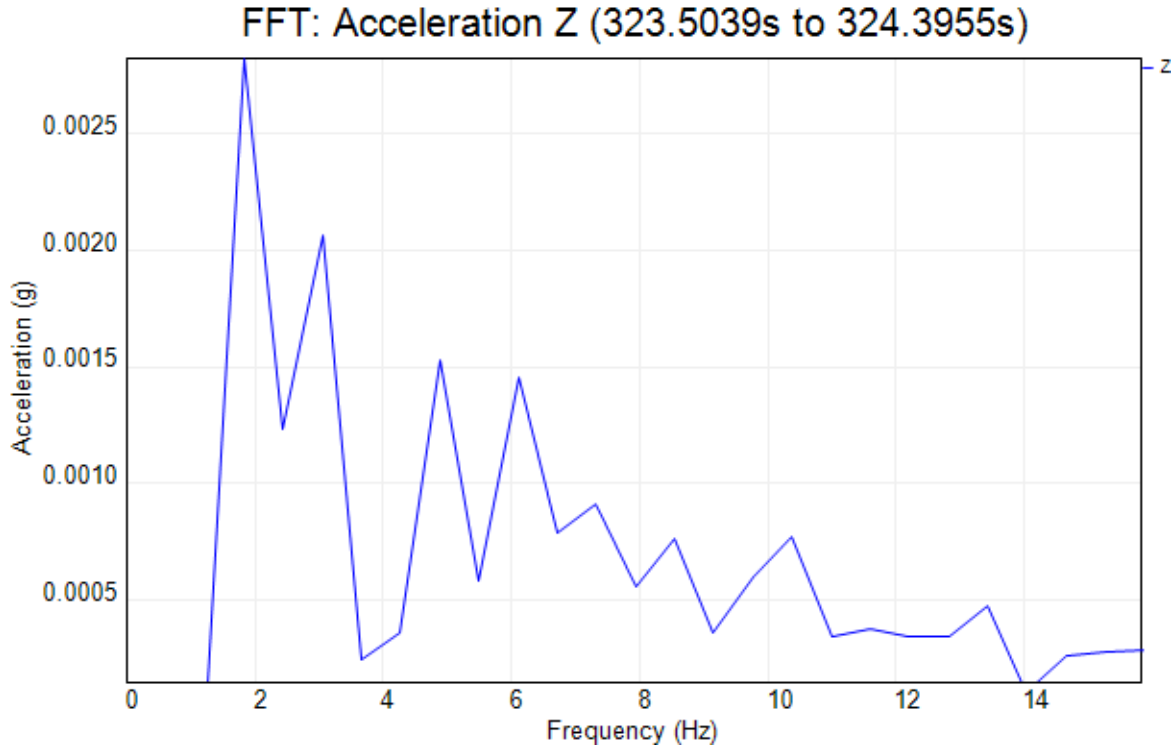
Figure 6- 36: FFT analysis on a 1-second ambient window for path P2

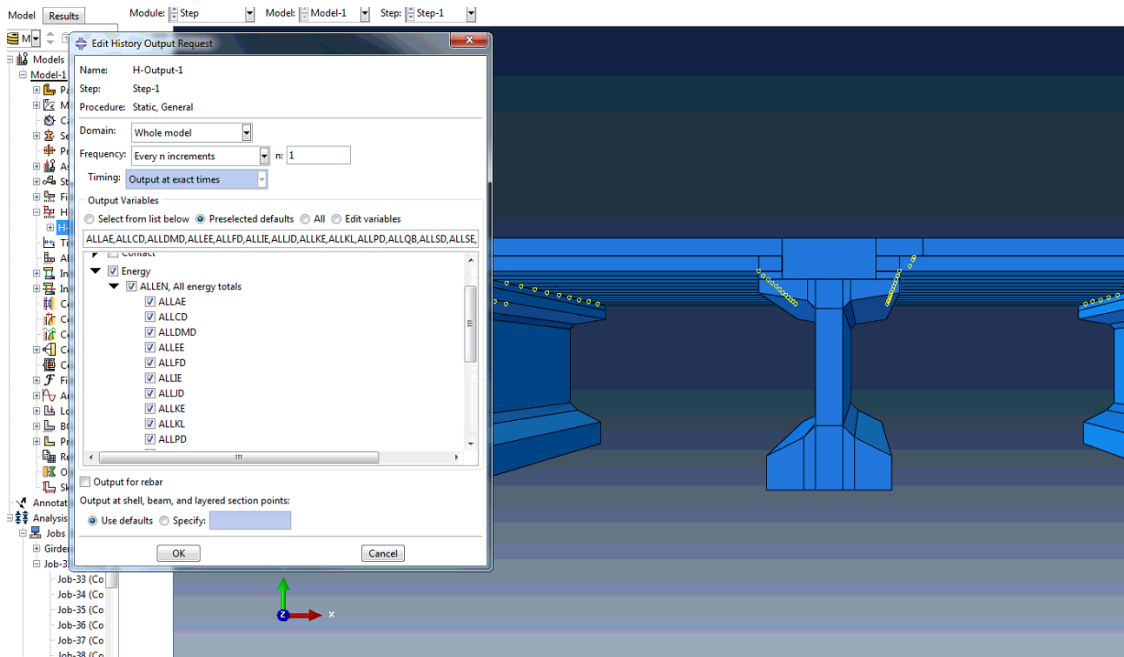
Figure 6- 37: History output request showing various components of energies of the model

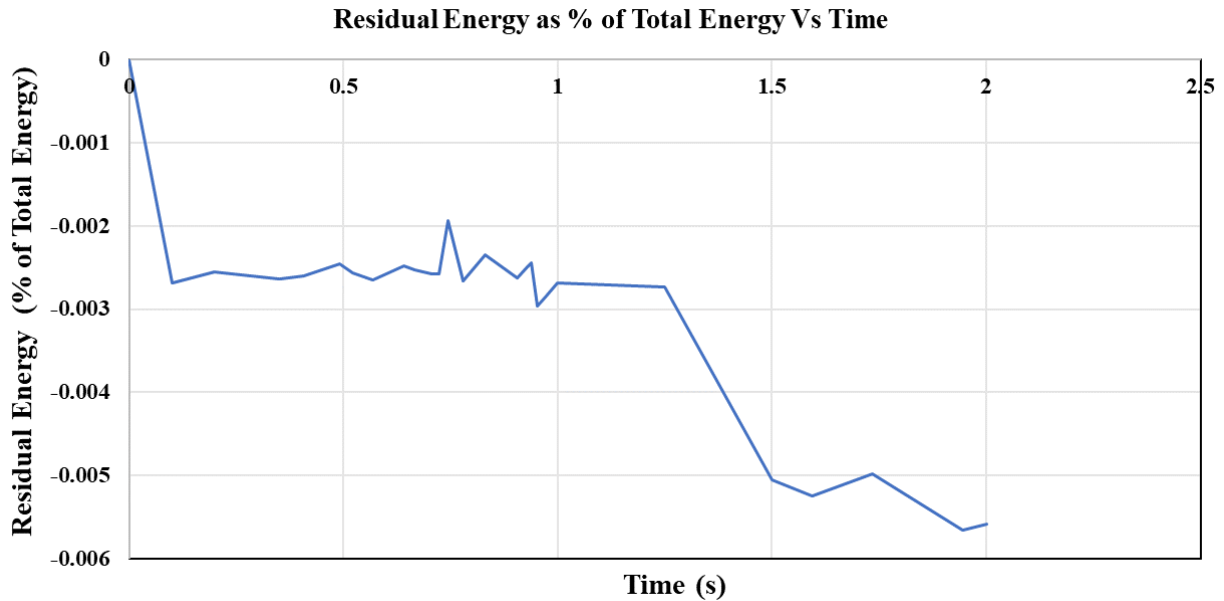
Figure 6- 41: Residual energy as a percentage of total energy vs time plot

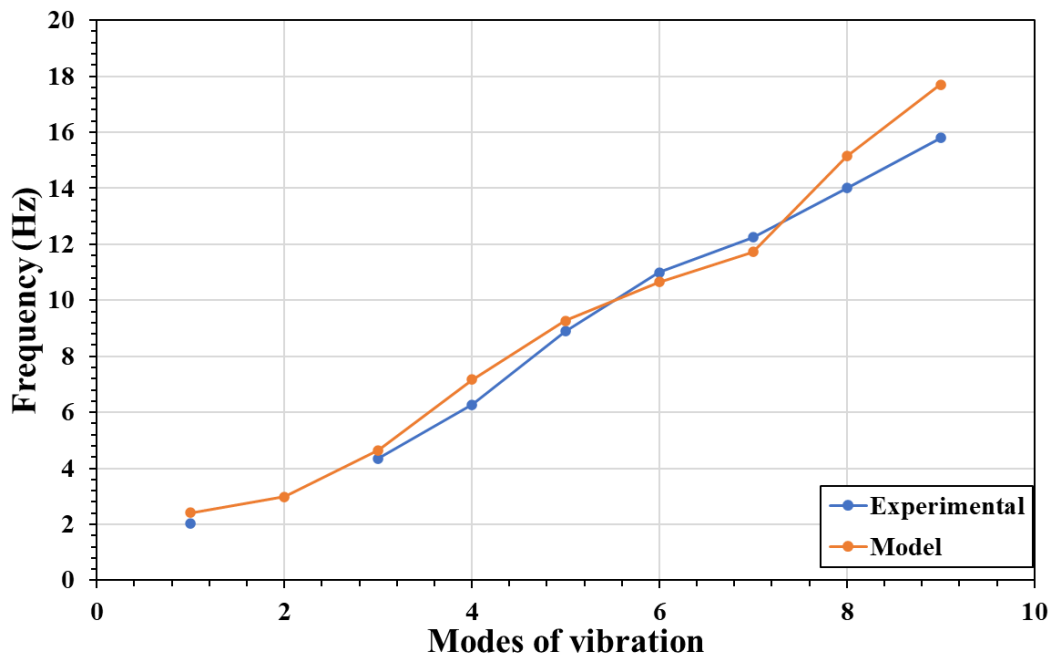
Figure 6- 47: Comparison between the experimental and modal frequencies

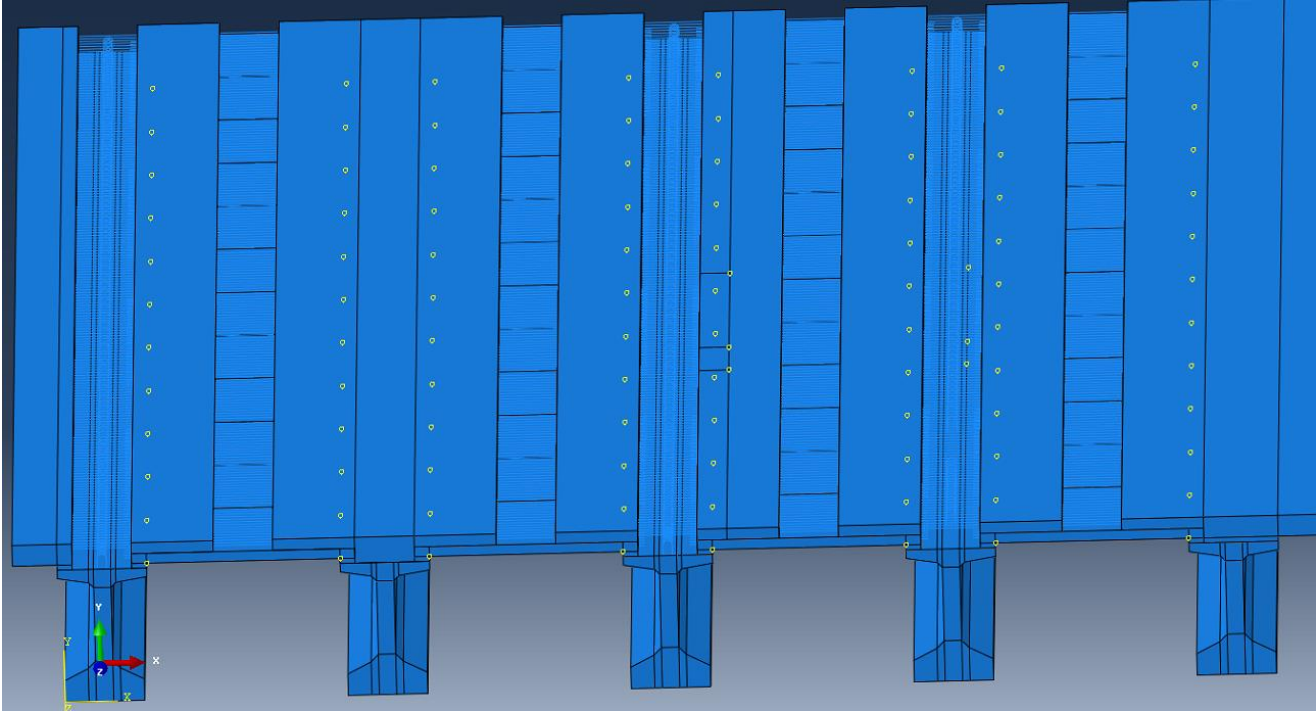
Figure 7- 7: Recasting on the girder lines and the panel lines (high strength concrete)

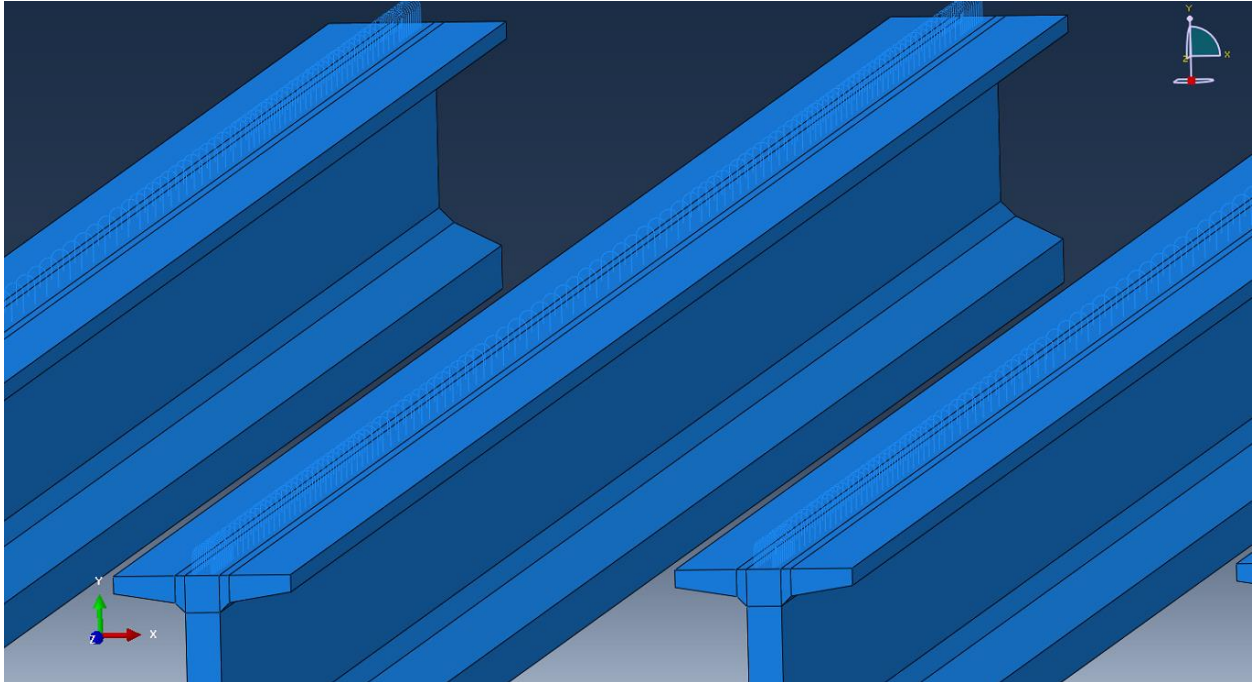
Figure 7- 10: Typical spacing of rebars of the calibrated ABAQUS model

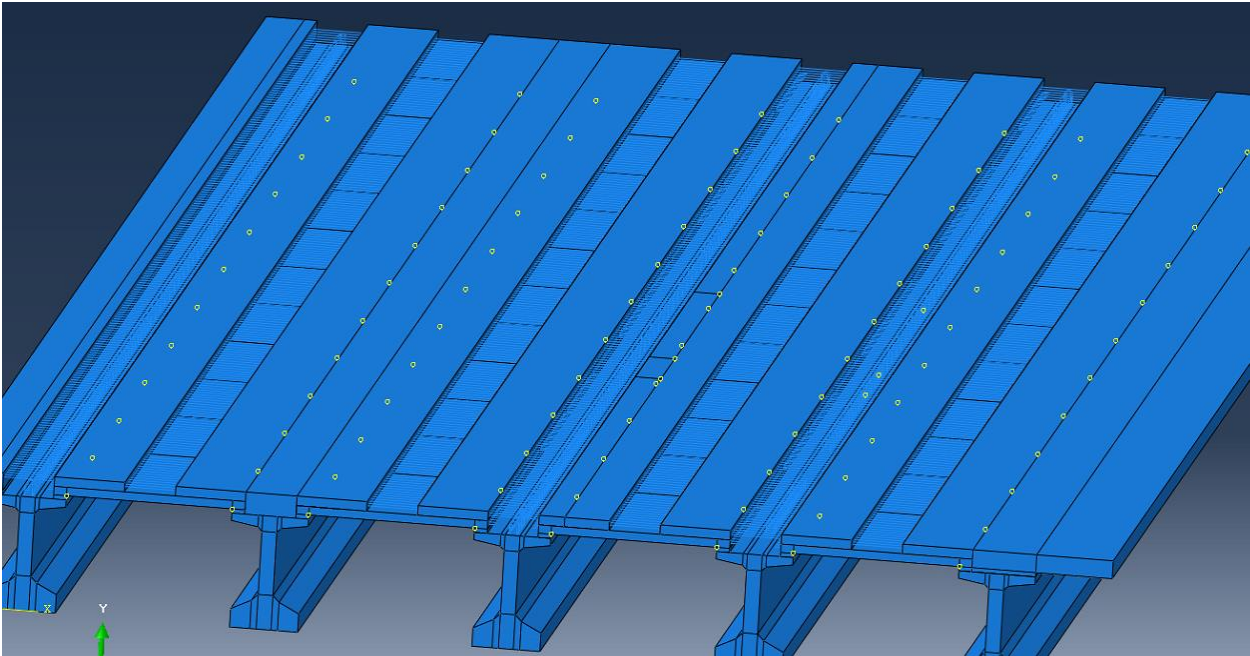
Figure 7- 11: Recasting on the girder lines and the pane line with additional R rebars (R2)

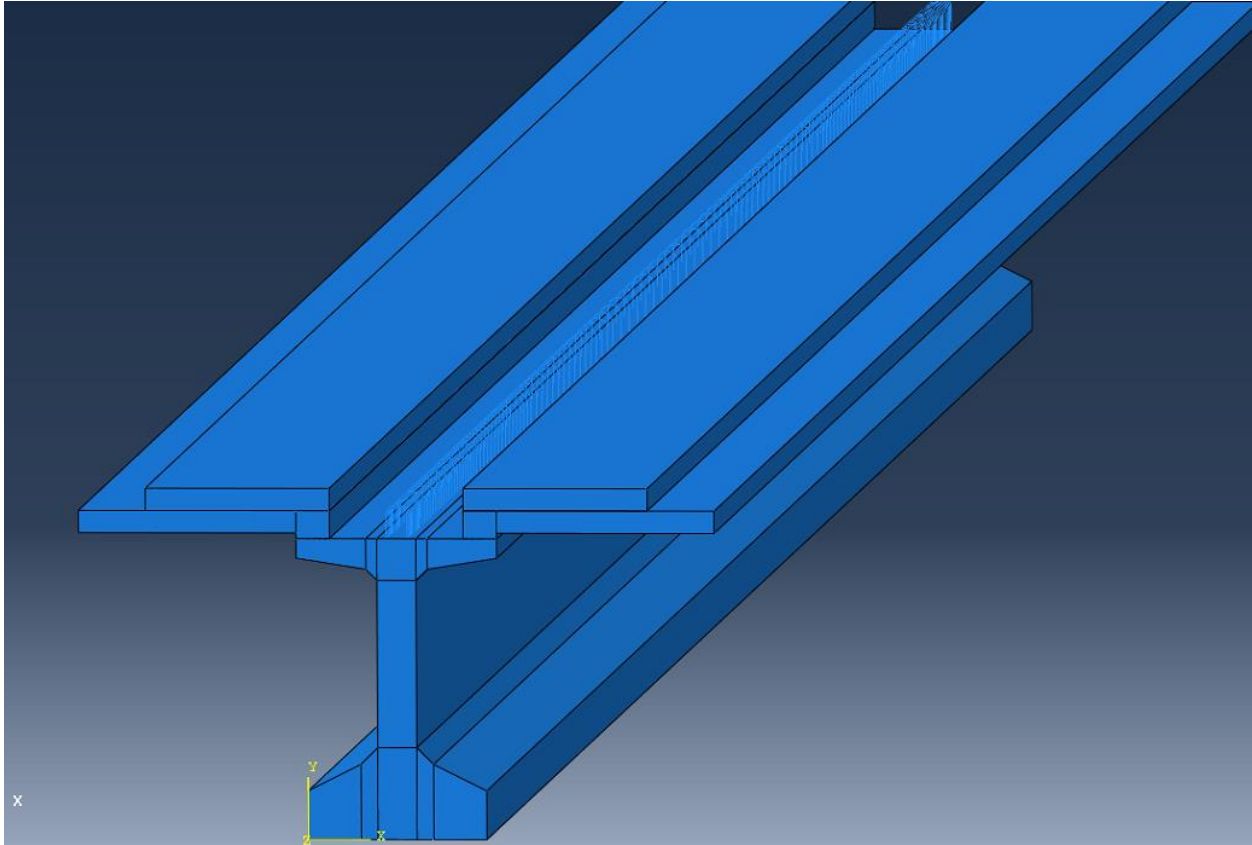
Figure 7- 13: Recasting on the Girder lines and Panel lines

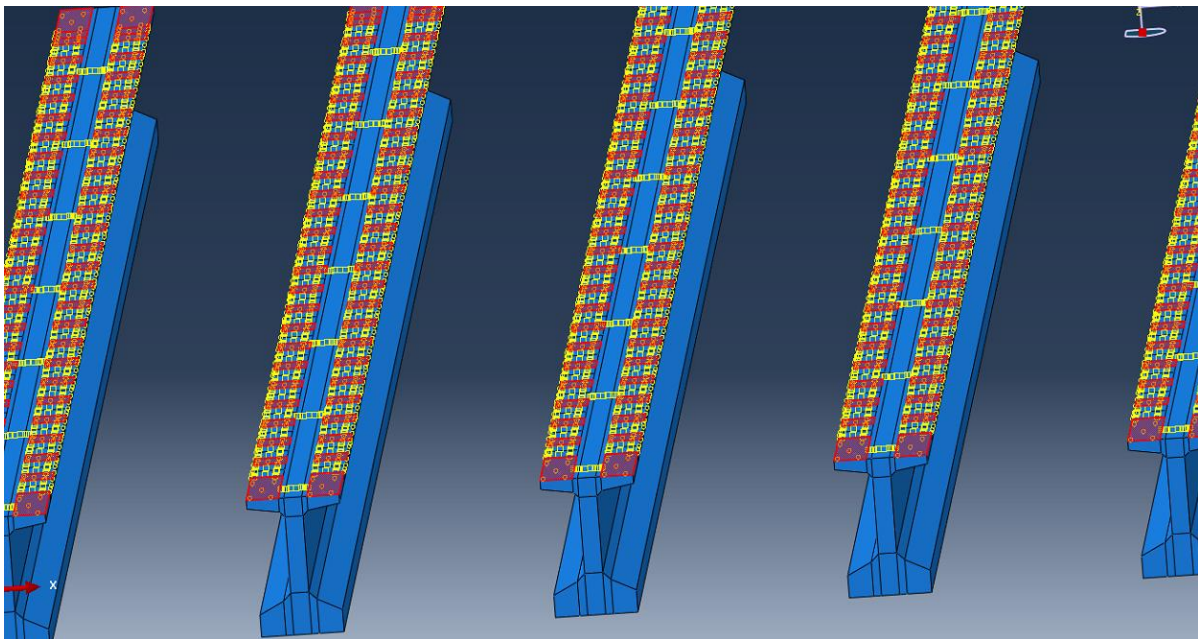
Figure 7- 19: 40 anchors on each side of the girders

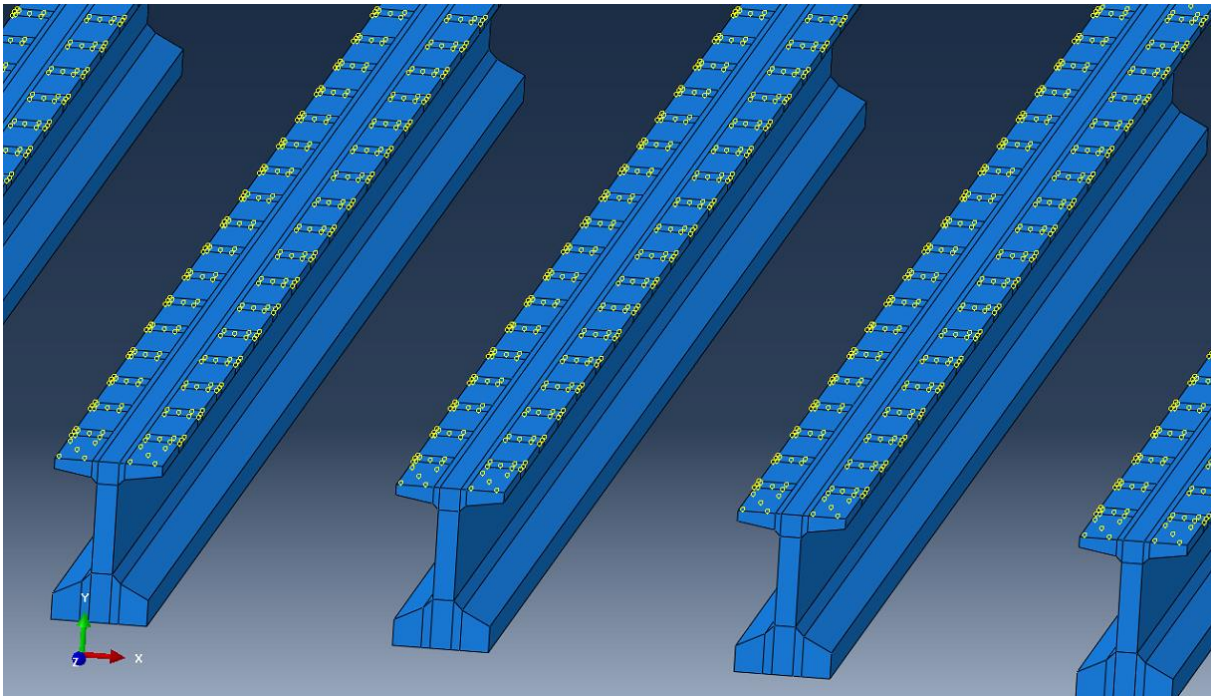
Figure 7- 20: 20 anchors on each side of the girders

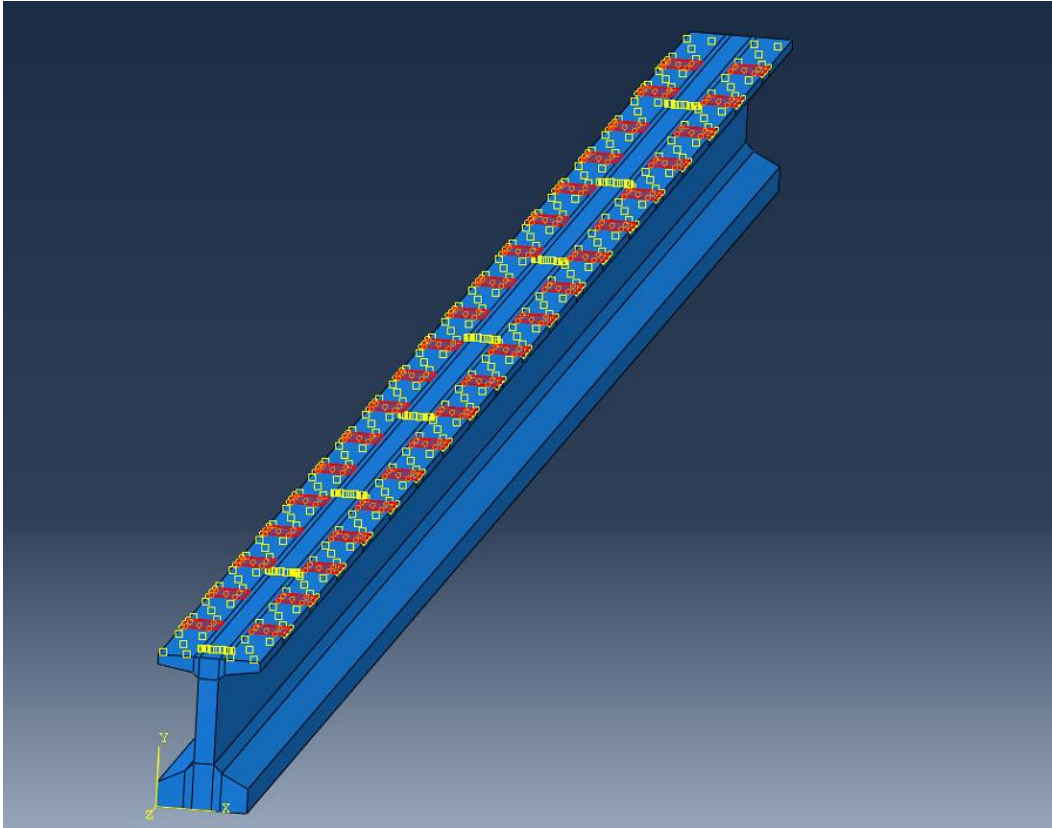
Figure 7- 21: Tension cones of the undercut anchors (red block)

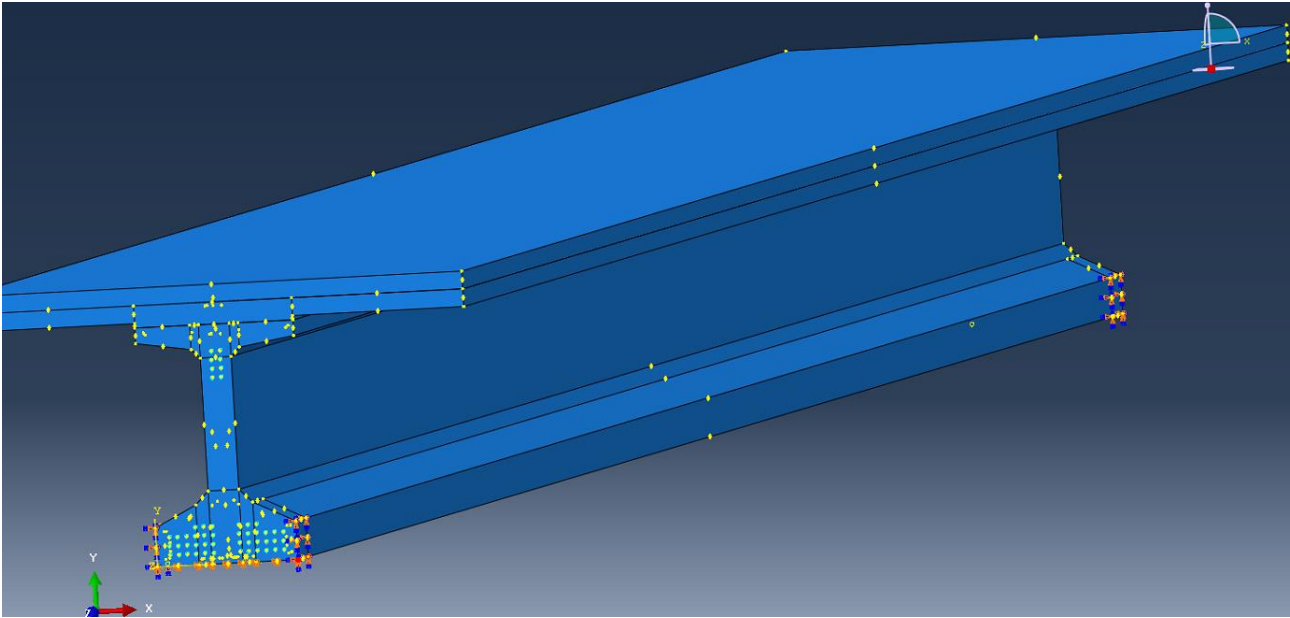
Figure 7- 27: Shear Keys near the support of a girder
