EXPERIMENTAL INVESTIGATION OF SHEAR
CAPACITY OF PRECAST REINFORCED
CONCRETE BOX CULVERTS

MASTER OF SCIENCE IN CIVIL ENGINEERING

THE UNIVERSITY OF TEXAS AT ARLINGTON

December 2006

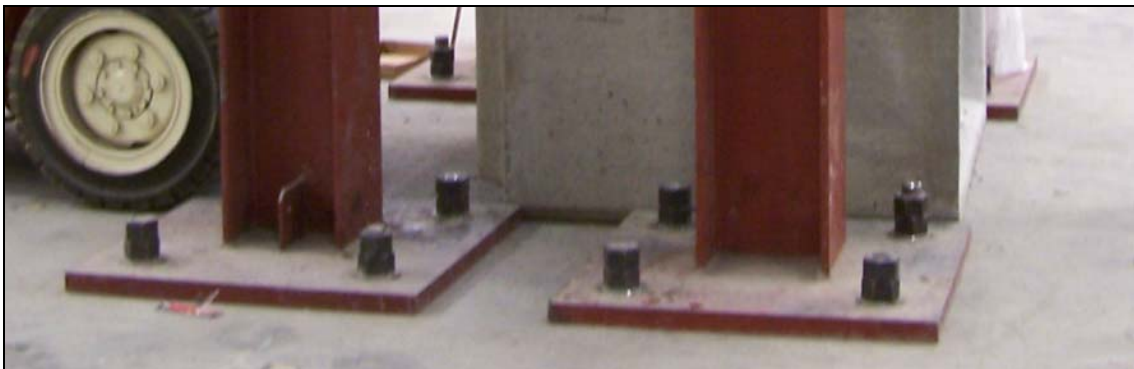
Figure 2.1: Load Frame Base

The aforementioned structural laboratory has a strong floor built into its northwest corner. This reaction floor, consists of a five foot thick reinforced concrete slab with two inch diameter anchor holes spaced on 0.61 m (2 ft) centers. A sub floor is located directly below the reaction floor for maintenance and for equipment anchoring. Every hole is designed to comfortably resist an 890 kN (200 kip) pull-out force. The culvert tests discussed herein utilized four load frame columns each having an anchorage pattern of four holes. High strength threaded rods and nuts were used to attach the columns to the reaction floor as shown in Figure 2.1.

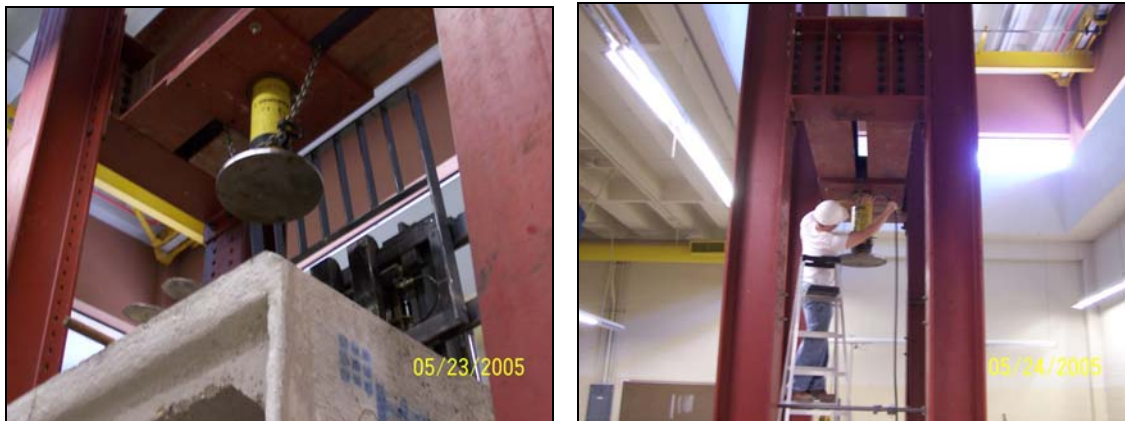
Figure 2.3: Transfer Girder with Hydraulic Jack

Once the load frame columns were in place, a load transfer girder was attached to the four columns. The elevation of the girder relative to the floor was set at approximately thirteen feet to allow clearance for the aforementioned A-frame. Affixed to the bottom flanges of the load transfer girders was an inverted hydraulic jack (see Figure 2.3). The jack was placed in a location along the span that was expected to induce the highest shear stress in the box culvert. The location of the hydraulic jack

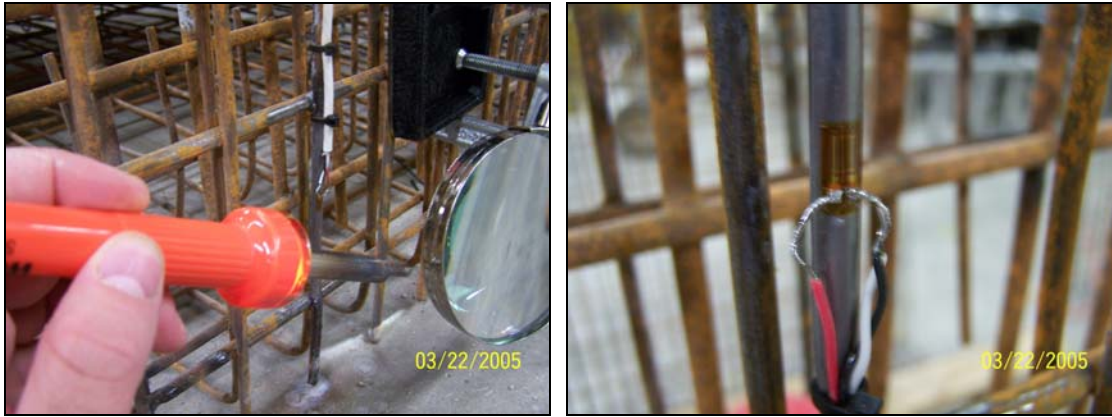
Figure 2.7: Soldering

Figure 2.7 shows a gage during and after the soldering process without the use of terminals. The wire utilized for this project was carefully selected based on inherent strength and resistance to electric interference. The three-conductor tinned-copper wires were bundled and encapsulated in a protective vinyl jacket to prevent puncture from aggregate impacts during casting. In addition, a braided wire shield was provided around the individually jacketed wires. The shielding served a dual purpose in that it provided additional toughness to the shell of the wire and provided protection from electrical interference. Once attached, the lead wires were routed through the reinforcement cage using small plastic zip-ties. Each wire was routed to the nearest lift hole, which were generally placed in the top slab of precast culverts for ease of lifting during construction. The lift holes are normally cut out of the box after casting; however, for our purposes that method would destroy the wires. Therefore, a four-inch diameter PVC pipe was length-wise cut to the thickness of the top slab and the wires were routed through a small hole on the side the PVC pipe (see Figure 2.8). Each lead wire was labeled using a Post-it® plastic flag to indicate which strain gage location it was connected to. The flags were wrapped several times with cellophane tape to ensure they would not be damaged, faded or accidentally removed during casting. Once labeled, the wires were tied together within the PVC pipe. The ends of the pipe were covered with utility tape prior to casting to prevent the concrete from making contact with and hardening around the free end of the lead wires.

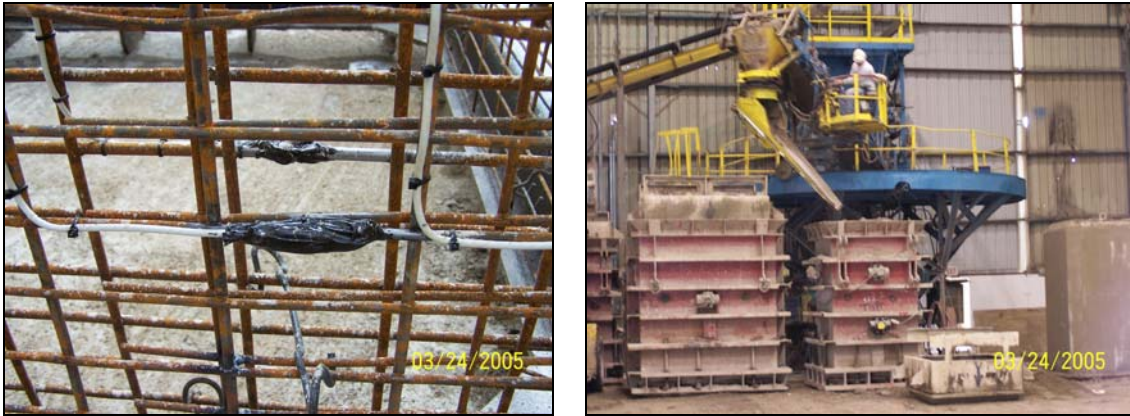
Figure 2.9: Protective Coating and Casting Process

The final step in the application process was to apply M-Coat J protective coating to the gage and stripped wire. During the planning stages of this project, protection of the strain gages during casting was a concern. The soldering process alone destroyed multiple gages due to the delicacy of the copper soldering tabs on the gage. Due to the aggressive vibration of the casting forms, the moisture in the concrete, and the flow of the concrete material through the reinforcement, the gages needed additional protection. M-Coat J was recommended by the gage manufacturer as an adequate solution. The material was mixed just before it was applied and then allowed

to dry for at least eight hours, depending on the surrounding temperature. Once dry, the coating had a rubberized texture that encapsulated the gage and the stripped wires, protecting them from the harsh casting process (see Figure 2.9).

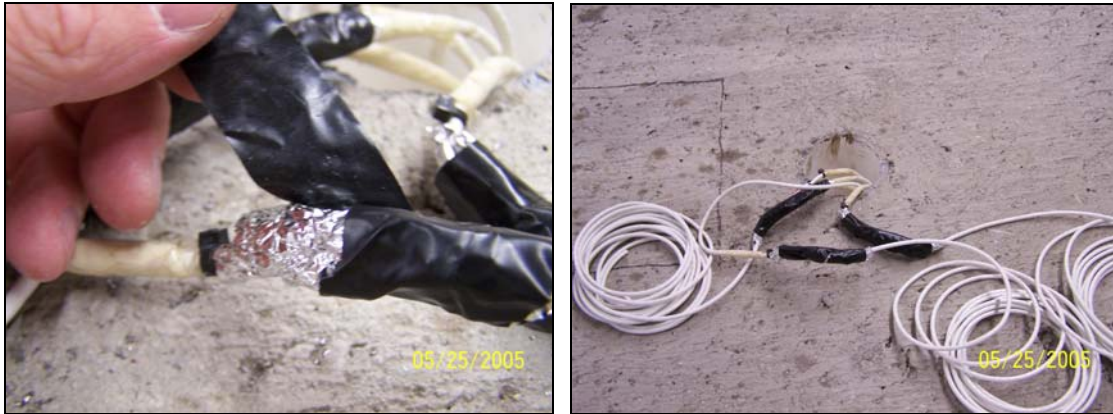
Figure 2.10: Lead Wire Splices

A few strain gages did survive the casting and transportation process. The lead wires associated with the surviving gages were carefully spliced with additional encapsulated lead wires as shown in Figure 2.10. The various layers of the encapsulated wire were stripped down to allow for a good connection. Everyday aluminum foil was used to bridge the braided wire shield, providing the same protection from electrical interference. The splice was then wrapped with electrical tape to hold the connection together in case the wires were accidentally tensioned.

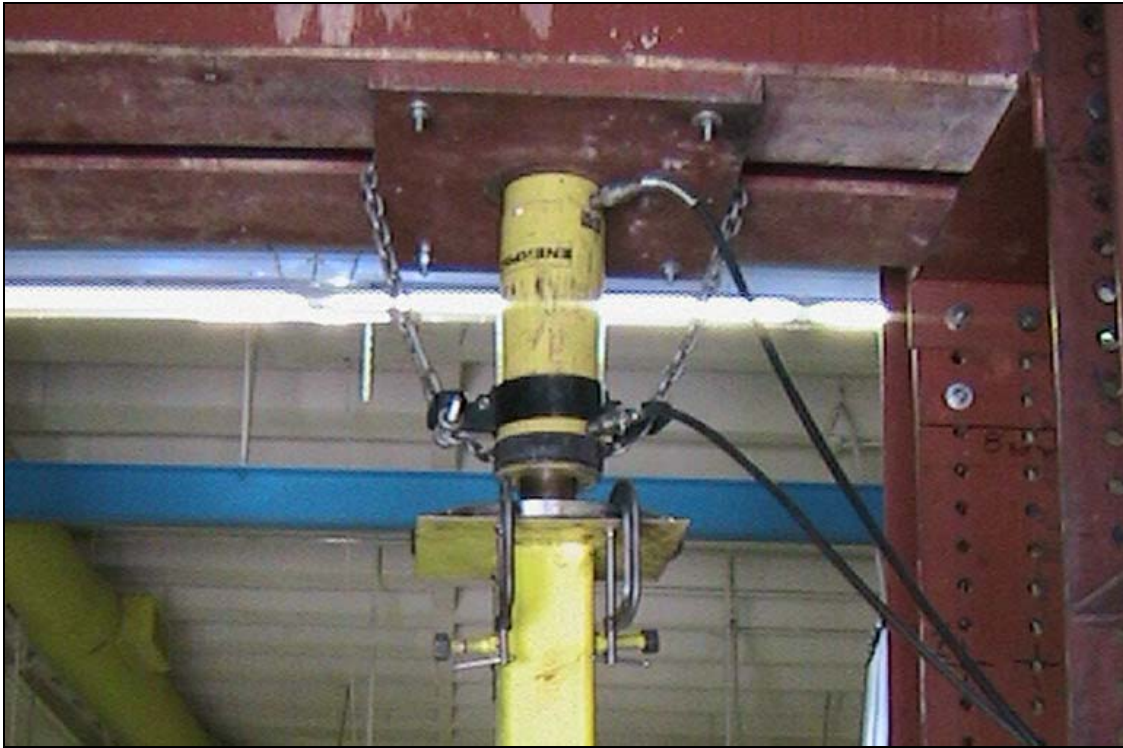
Figure 2.13: Inverted Hydraulic Jack and Transfer Column

The inverted hydraulic jack was joined to a 24x29.5x2-inch mild steel plate which was attached in soffit to the load transfer girders of the load frame. The jack was used to simulate a HS20 wheel load on top of each test culvert. It had a stroke range of approximately 6½ inches which was well above the anticipated deflection of the culvert. As stated before, the transfer girders were elevated 13-feet above the testing floor. The limited length of the hydraulic jack in the direction of loading made it necessary to utilize a load transfer column to extend to the culvert below. The column was made from a mild steel HSS 4x4x3/16-inch member. The column was welded to an end plate which was clamped to the face of the hydraulic jack using standard C-clamps (see Figure 2.13).

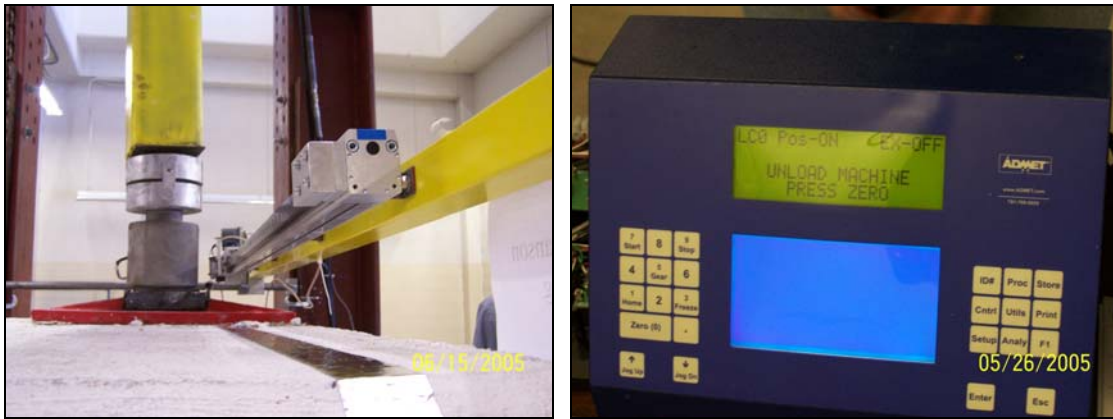
Figure 2.14: Load Cell, Self-Leveler and Admet® Controller

The load cell and Admet® controller were professionally calibrated and internally tested to ensure the accuracy of the load measurement. Taking all system errors into account, the load was measured within a range of one to two percent. Figure 2.14 displays the load cell, self-leveler and Admet® controller.

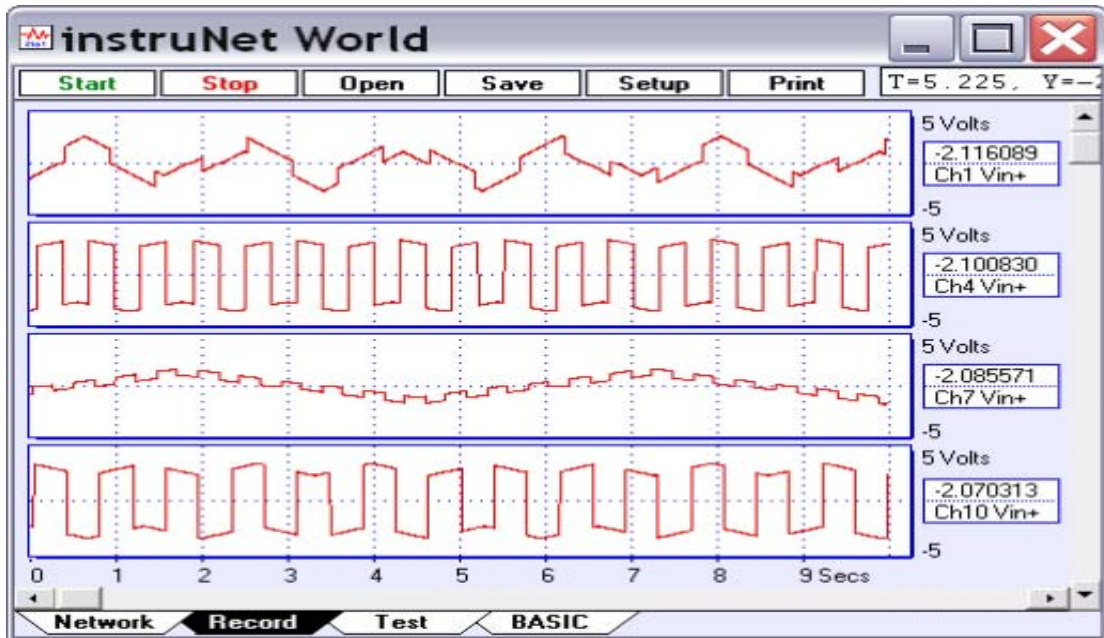
Figure 2.16: instruNet® World Software Interface

The laptop computer contained preinstalled instruNet® World software that was capable of recording input from all 32 channels of the converter board. The software interface (see Figure 2.16) provided a means to manage, monitor, and operate the data acquisition system. For the culvert tests, the program recorded data at a predetermined rate of 0.12 seconds per interval. The measured variables for the instruNet® World program were time (measured in seconds), applied load (load cell and Admet® controller), reinforcement strains (up to five strain gages), laser position along the span (potentiometer output), and culvert top slab deflection (high-resolution laser sensor). The software provided the option for binary or wave format text files as output. The wave files were used in this study and were transported to Microsoft® Excel for data analysis.

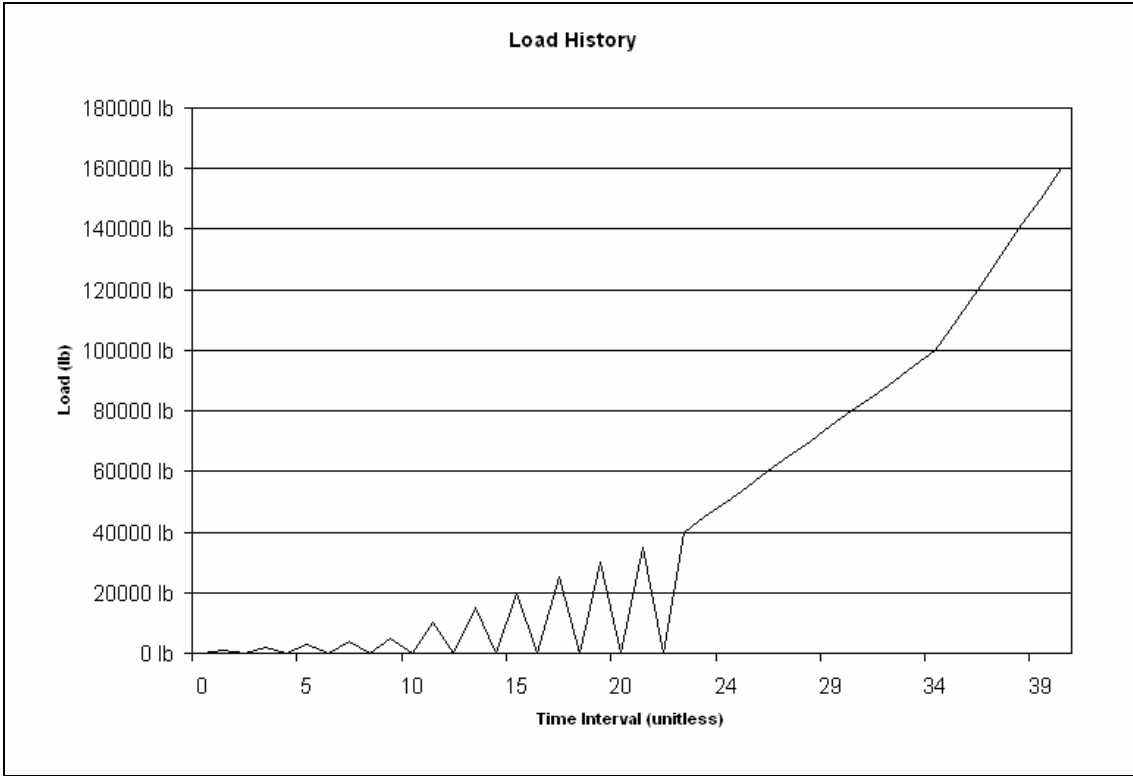
Figure 2.17: Typical Load History

system traversed across the span. Once the laser had traversed, the system was unloaded back to zero while the data acquisition system recorded a third string of data. This process was repeated at load increments of 5 kip until the first flexural cracks appeared. The loading and unloading measurements provided residual deflection data for the parallel analytical model. Once cracking occurred, the process above was repeated at varying load intervals; however, the system was no longer unloaded back to zero. Each culvert was tested to ultimate failure which was determined when the culvert could no longer carry additional load. Figure 2.17 shows a typical load history for each test.

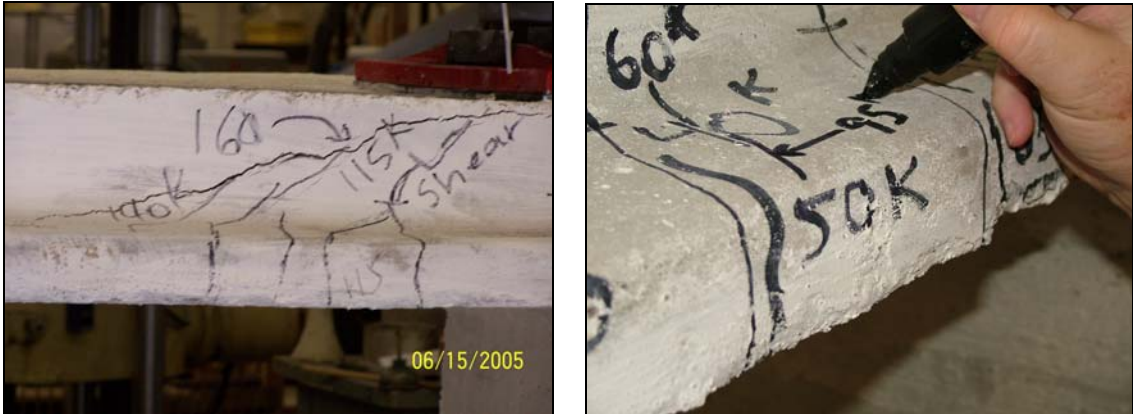
Figure 2.18: Crack Propagation

Throughout each test, cracks were recorded using three different methods. First, a permanent marker was used to sketch a line parallel to the actual crack for visibility in photographs. A perpendicular line was drawn at the end of the crack indicating the end of propagation. Additionally, the load increment at which the fracture occurred was written next to the perpendicular line to provide a frame of reference for propagation at higher loads (see Figure 2.18). Secondly, photographs were taken throughout the test to provide visual records. The last method of recording crack propagation involved a written log. Each entry included a description of crack width, location, load increment at which the fracture occurred, and the type of crack (flexure or shear). Details of the crack propagation for each test are presented in chapter three.

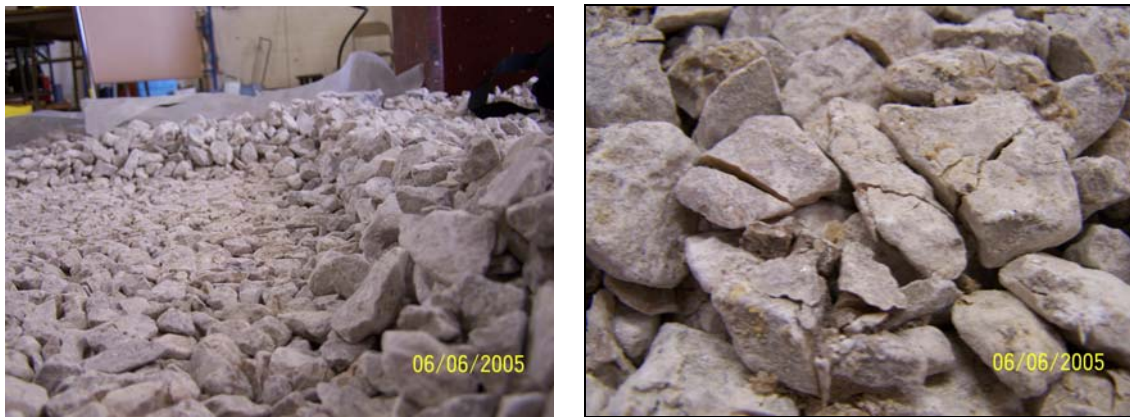
Figure 3.2: Bedding Settlement and Crushed Aggregate

The bedding material that was used in test 1 was unrestrained against spreading; therefore, the box was allowed to settle into the material. Under in-service conditions the bedding material would be held into place by surrounding pressures, reducing the amount of global settlement. The load was placed near a corner on the top slab, which caused differential settlement between the four corners. The corner opposite of the load experienced the least amount of settlement, while the corner under the load experienced the most. In addition, the high stress concentrations below the loaded corner caused some of the aggregate to be crushed (see Figure 3.2).

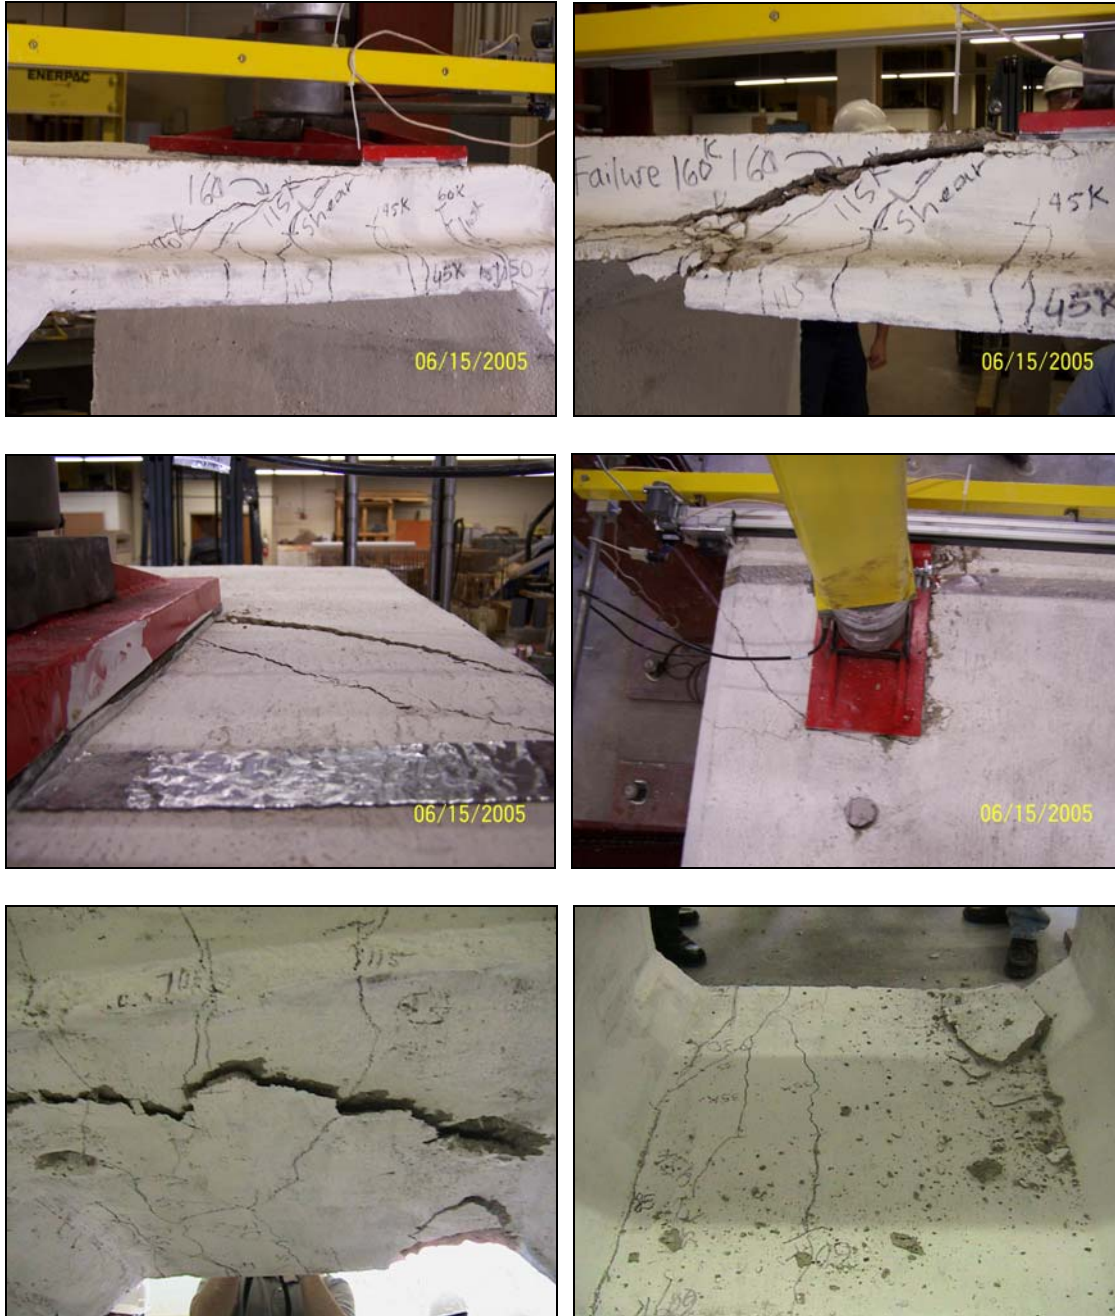
Figure 3.9: Test Two Failure

The first visible cracks were flexure cracks located on the bottom of the top slab and top of the bottom slab at 133 kN (30 kip). These cracks continued to widen and propagate until a 267 kN (60 kip). At that load, hairline flexure cracks, smaller than the 0.33 mm (0.013 in) limit, developed along the outside of the culvert walls. The first shear crack occurred at the spigot end near the adjacent wall at a load of 267 kN (60 kip). The shear crack spread to the bell end between 267 kN and 334 kN (60 kip and 75 kip). The flexure cracks along the sidewalls extended the full joint length from 334 kN to 512 kN (75 kip to 115 kip). Another shear crack developed on the mid-span side of the load plate at 512 kN (115 kip). Prior cracks continued to propagate and others continued to form until the ultimate failure load of 712 kN (160 kip) was reached. The

culvert failed in shear along around the load plate. Figure 3.9 provides pictures of each face of the culvert after failure.

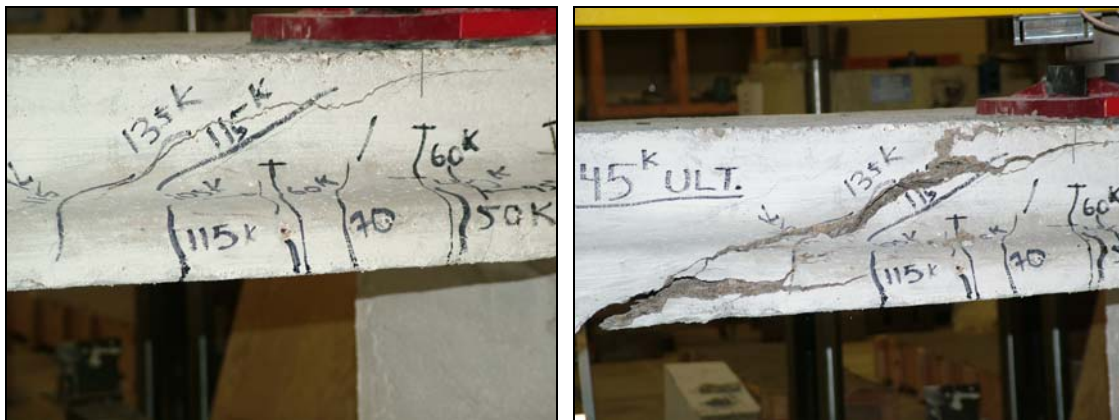
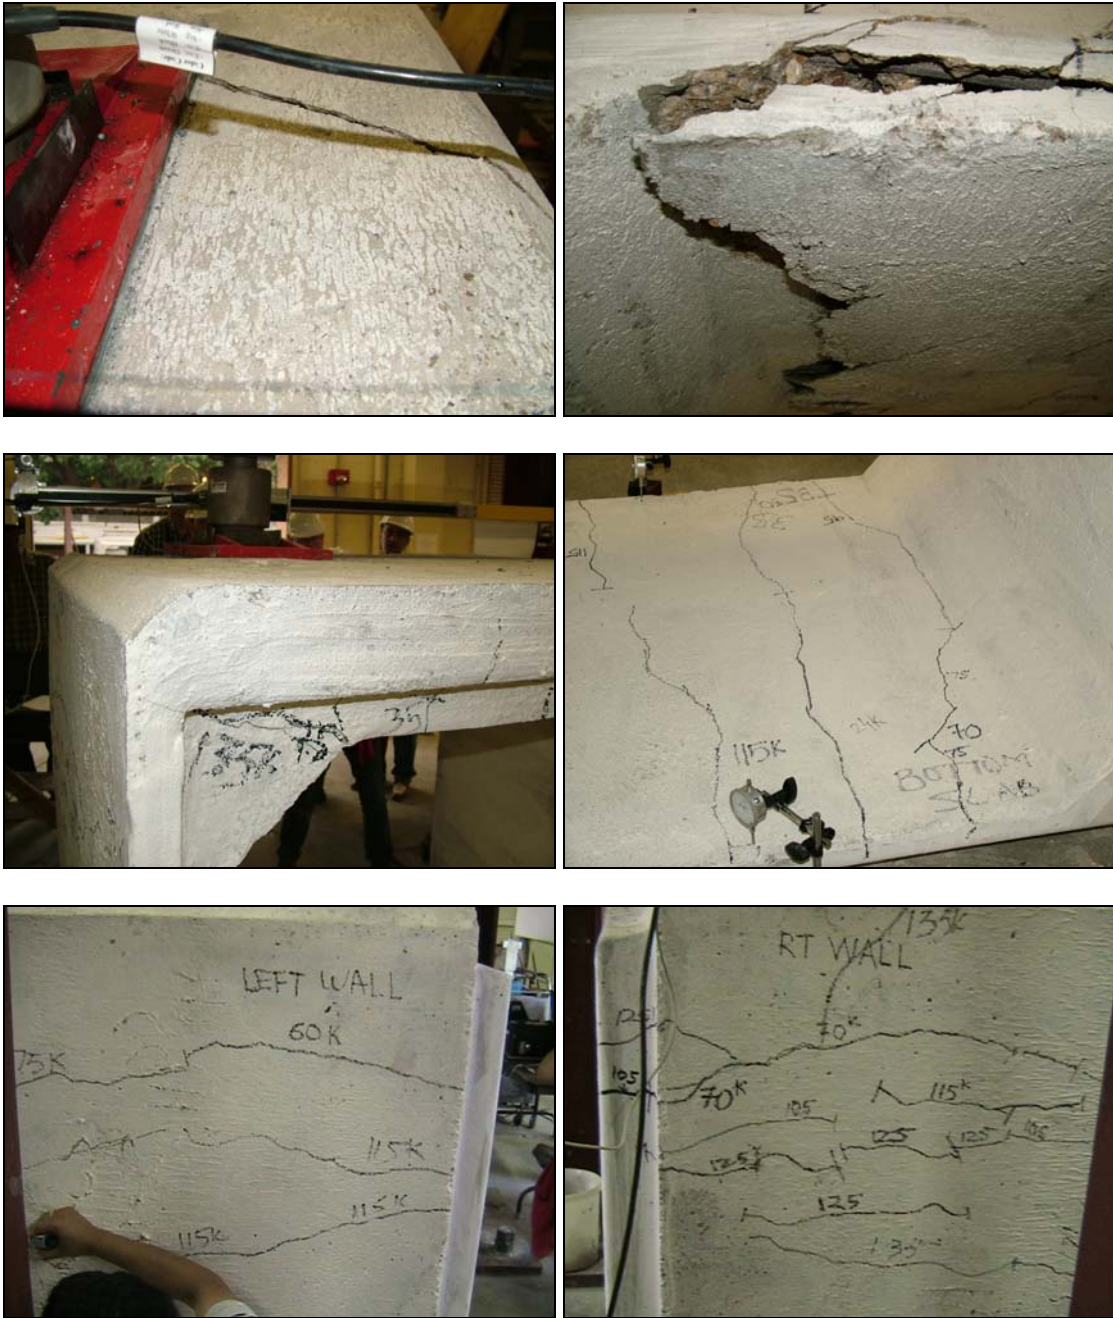
Figure 3.14: Test Three Failure

The first hairline crack occurred at 107 kN (24 kip) near the spigot end on the top of the bottom slab, and propagated further until a 156 kN (35 kip) load was reached.

At that load increment, a hairline flexure crack occurred on the bottom of the top slab. Hairline fractures continued to appear and propagate until 289 kN (65 kip). Flexure cracks on the outside of the sidewall closest to the load developed at 311 kN (70 kip) and on the outside of the opposite sidewall at 334 kN (75 kip). Additionally, the first shear crack developed on both the spigot and bell ends at the tip of the haunch adjacent to the load plate around 334 kN (75 kip). A second shear crack on the mid-span side of the load plate appeared at 512 kN (115 kip). Both flexure and shear cracks continued to propagate until ultimate failure occurred at 645 kN (145 kip). The ultimate failure occurred in shear between the load plate and the haunch on the mid-span side. Figure 2.13 provides pictures of each face of the culvert after failure.

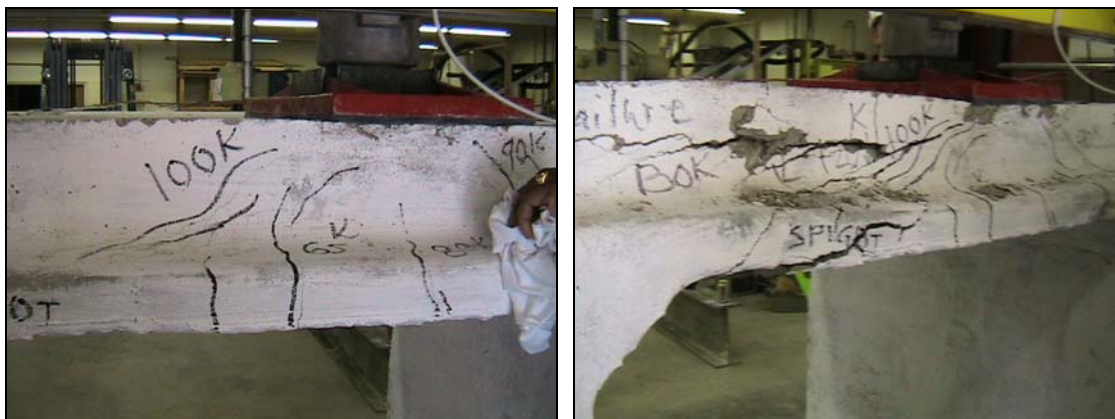
Figure 3.19: Test Four Failure

Hairline flexure cracks formed at 111 kN (25 kip) and were initiated simultaneously on the top of the bottom slab and the bottom of the top slab. Both cracks extended toward the bell end of the culvert at 133 kN (30 kip). Flexure cracks developed at the bell end (opposite end from the load) near mid-span at 200 kN (45 kip) and continued to propagate as the load increased. Hairline cracks spanning the entire joint length began to develop on the outside of the sidewall adjacent to the load at 245

kN (55 kip). The opposite sidewall experienced similar cracking at 289 kN (65 kip). Also at 289 kN (65 kip), the first serviceability failure crack developed on the bottom of the top slab in flexure. The first hairline shear crack developed between the load plate and adjacent haunch at 400 kN (90 kip). The first shear crack with a width of 0.33 mm (0.013 in) developed between the corner of the load plate and the tip of the haunch opposite of the load at 534 kN (120 kip). Formation and propagation of cracks continued until ultimate failure at 578 kN (130 kip). Failure occurred in shear/bond along the shear crack between the load plate and the opposite haunch. Figure 3.16 provides pictures of each face of the culvert at failure. Failure was believed to be caused by arching where a compressive strut that formed along the shear crack at mid-span buckled and detached from the reinforcement mesh.
