SLOPE STABILIZATION AND PERFORMANCE MONITORING
OF I-35 AND SH-183 SLOPES USING
RECYCLED PLASTIC PINS

MASTER OF SCIENCE IN CIVIL ENGINEERING

THE UNIVERSITY OF TEXAS AT ARLINGTON

December 2015

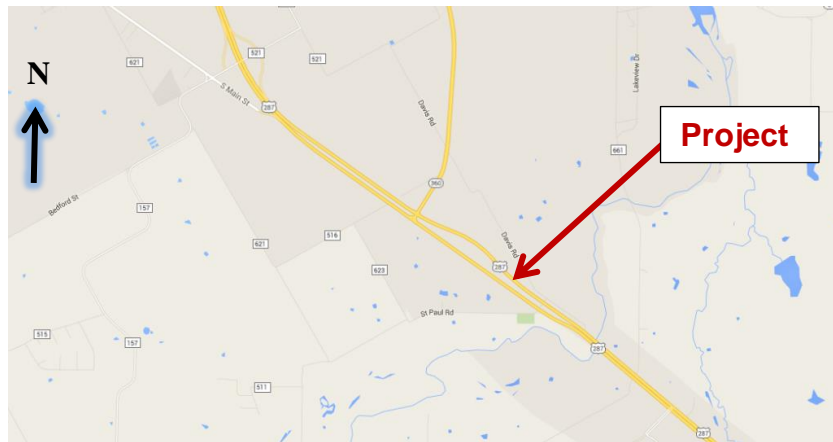
Figure 2-16 Location of US 287 slope.

Khan, 2013 performed a study using RPP to stabilize US 287 slope. The slope is located over Highway US 287, near St. Paul overpass in Midlothian, Texas as presented in Figure 2-16. The maximum height of the slope is approximately 30 feet with 3(H):1(V) slope. Cracks were observed in 2010 on the shoulder of the highway slope as shown in Figure 2-17. The slope was constructed in 2003 – 2004 from the fill soil in the vicinity of the project site.

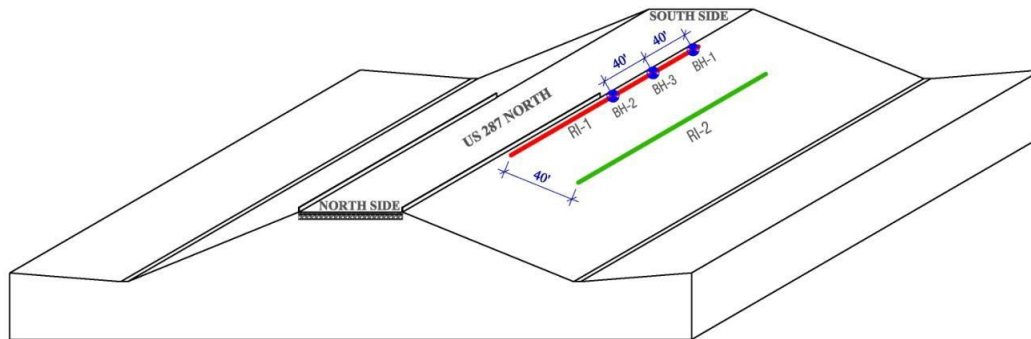
Figure 2-18 Borings and Resistivity Imaging location (Khan, 2013)

Geotechnical and geophysical investigation was conducted at US 287 on October 2010. Three geotechnical Borings and two 2D Resistivity Imaging (RI) were conducted in the site. The layout of the Borings and the location of RI profiles are presented in Figure 2-18.

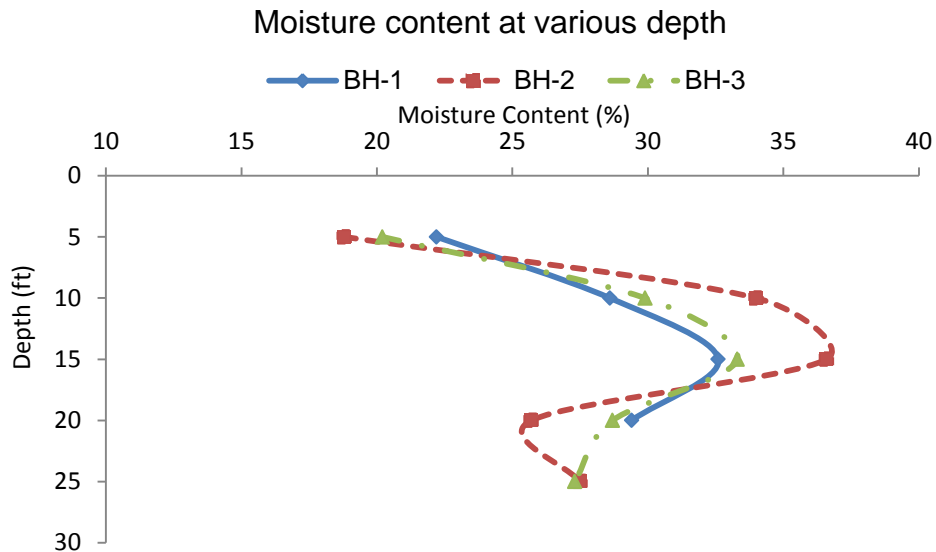
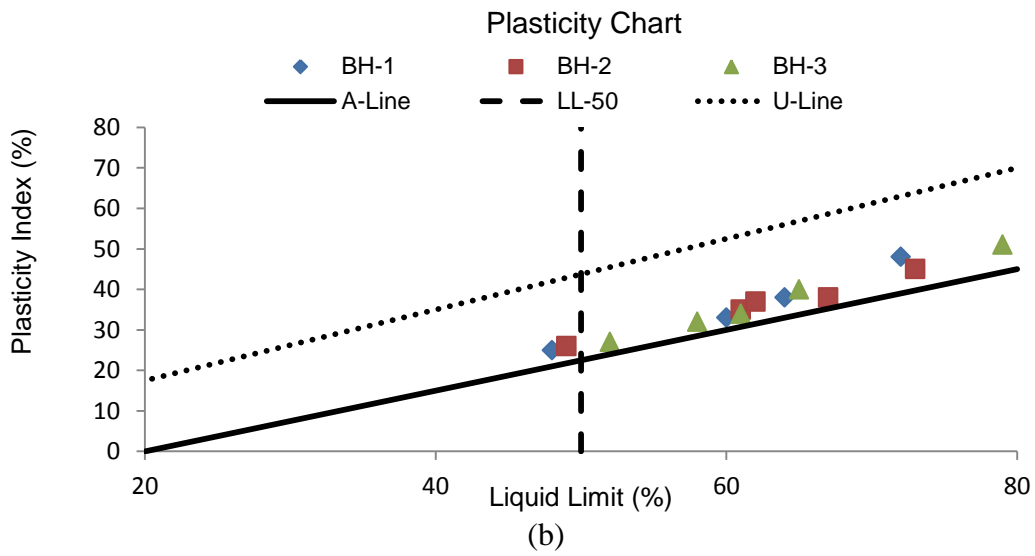
Figure 2-19 Laboratory test results of US 287, (a) Moisture variation along the depth, (b)

A total of 3 soil test borings were performed near the crest of the slope. The depths of soil test boring ranged from 20 ft. - 25 ft. Both the disturbed and undisturbed soil samples were collected from different depths and tested to determine geotechnical properties of the subsoil. Based on the laboratory investigation results, all the collected soil samples were classified as high plastic clay (CH) soil according to the Unified Soil Classification System (USCS). The liquid limits and the plasticity indices of the samples ranged between 48-79 and 25-51, respectively. The moisture profiles on the depth and plasticity chart along the 3 bore holes are presented in Figure 2-19. The moisture profile indicated an increase in moisture below 5 ft. that ranged up to 20 ft.

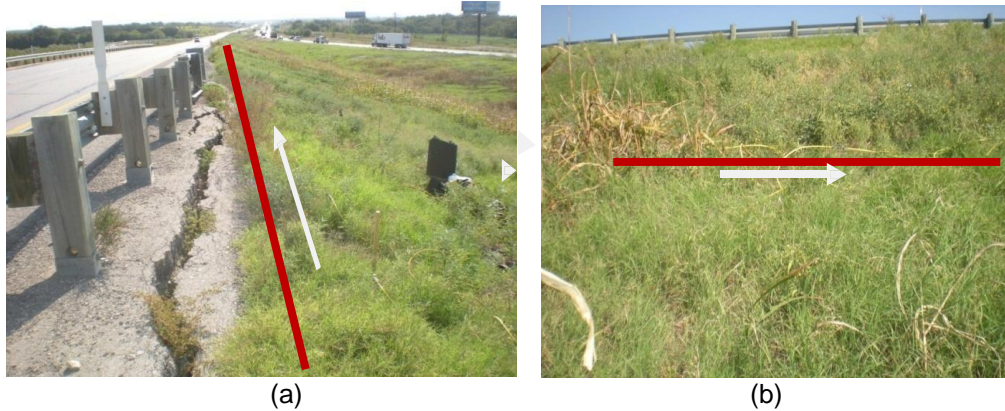
Figure 2-20 Resistivity Imaging (a) RI-1 and (b) RI-2 at US 287

investigations and geo-hazard studies (Hossain et al., 2010). During the current study, the RI test was used to investigate the subsurface condition of US 287 slope. A total of two 2D RI lines, designated as RI-1 and RI-2, were conducted at the slope. RI -1 was conducted at the top of the slope near the crest, as presented in Figure 2-20. RI-2 was conducted at the middle of the slope, 40 feet. apart from RI-1.

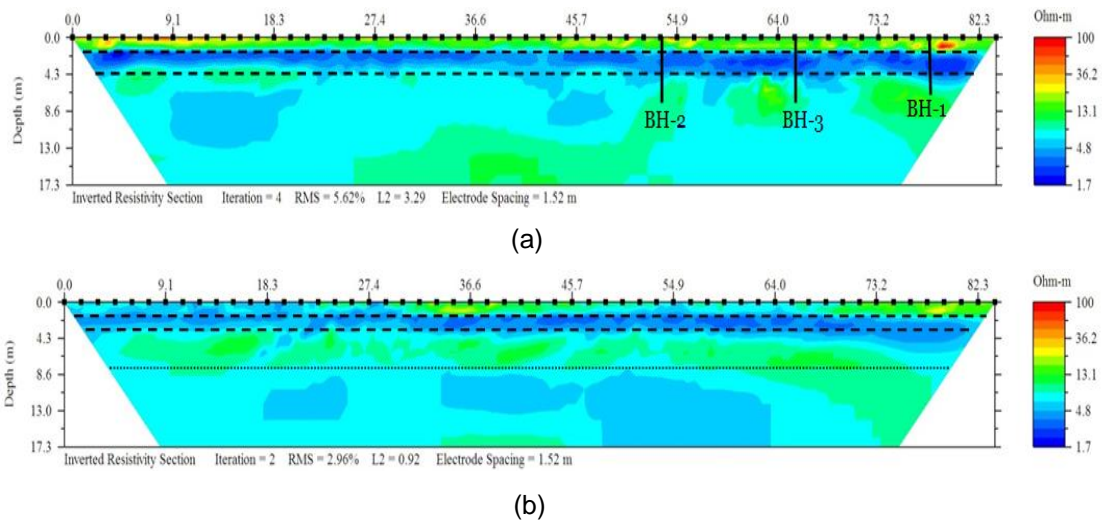
Figure 2-21 Resistivity Imaging Profile (a) Profile RI-1. (b) Profile RI-2

Based on the 2D RI profile, a low resistivity zone was observed near the top soil at both RI-1 (at crest) and RI-2 (middle of the slope). The resistivity of slope significantly decreased up to 16.4 ohm-ft. at depth from 5 ft. to 14 ft. It should be noted that the significant low resistivity might have occurred due to the presence of high moisture in the soil.

Based on the subsoil investigation and resistivity imaging, it was evident that a high moisture zone existed between 5 ft. and 14 ft. near the crest of the slope. The shoulder crack provided easy passage of rain water into the slope which eventually led to saturation of soil near the crest. As a result, the driving forces increased, which decreased the factor of safety. It should be noted that the US287 slope did not failed during the investigation. However, the slope might fail within the next few years, as the movement initiated at the crest which is an indication of initiation of failure. A back analysis was performed, using the finite element method, to evaluate the critical shear strength at factor of safety equal to 1.0.

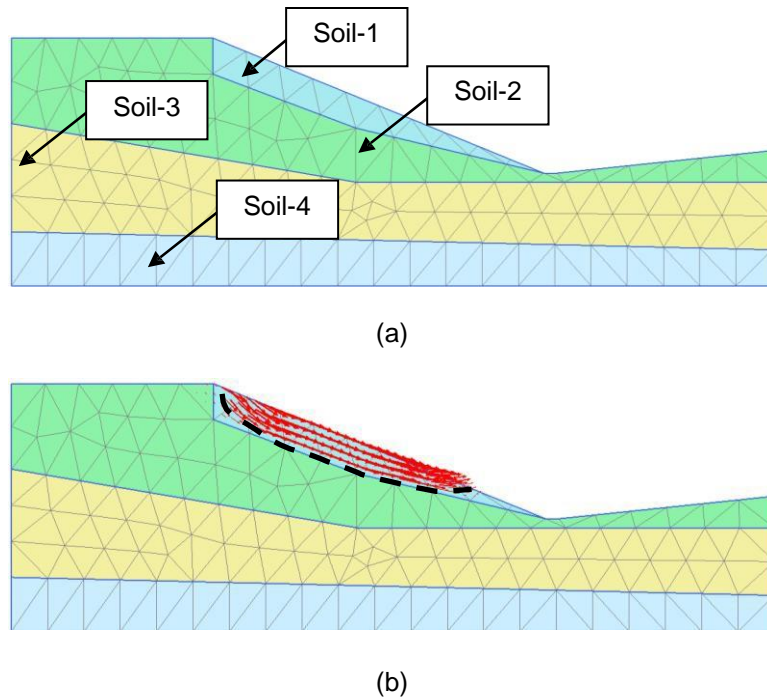
Figure 2-22 Slope stability analysis using Plaxis, (a) Soil Model , (b) Critical slip surface
(FOS 1.05) (Khan, 2013)

The soil profile for the model is presented in Figure 2-22 (a). The top 7 ft. of soil was considered as failure zone, with a fully softened strength. Other soil parameters for different soil layers were utilized from field investigation results. Several iterations were performed during numerical analyses to evaluate soil parameters at failure. The soil parameters observed at failure from numerical modeling are presented in Table 277. Based on the FE analysis, the factor of safety was found to be 1.05, as presented in Figure 2-22 (b).

The FEM analysis indicated the typical failure pattern of shallow slope failure, which resembled the observed displacement trend at the US 287 slope. To resist any further failure of the slope, it was essential to take remedial action.

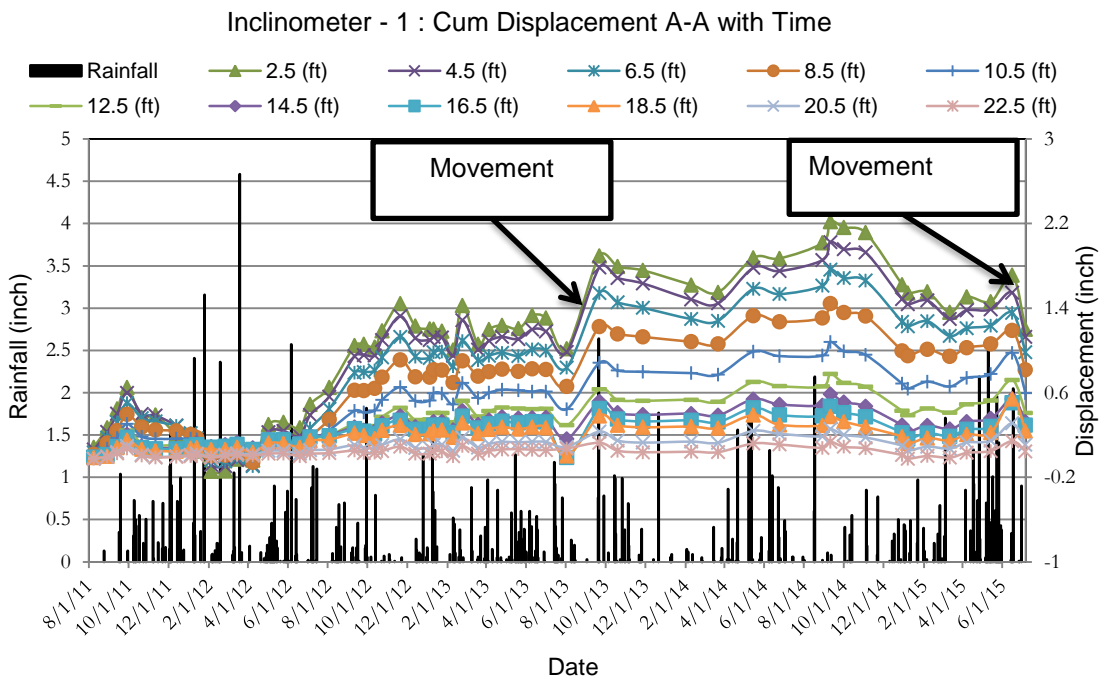
Figure 2-28 Displacement in Inclinometer I-1 at US 287

The US 287 slope had negligible movement during the wetting and drying period. The variations of horizontal displacement of the reinforced slope after October 2012 indicated that there was less than 0.1 inch movement in Inclinometer 1 (Reinforced Section 1) from October 2012 to June 2015. This is probably due to the fact that the load might have been mobilized in the Reinforced Section 1 and had less than 0.1 inch movement during the next wetting/drying period. There was an incremental horizontal displacement up to 0.5 inch during that period at Inclinometer 3 (Reinforced Section 2). The RPP was installed at the southbound slope.

On September 2013 there were slope failures at two locations over the south bound slope as shown in Figure 2-28. In addition, during the June 2015, two locations over the southbound slope had failed, due to a heavy rainfall event that month as shown in Figure 2-29. During the failure of the northbound slope, an increment in horizontal

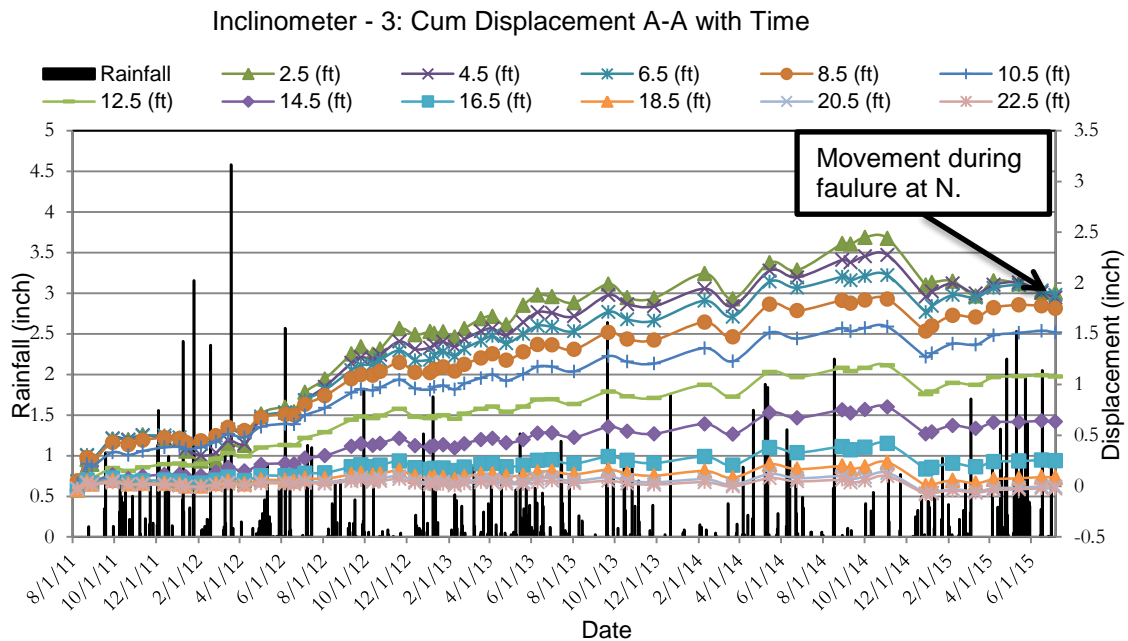
Figure 2-29 Displacement in Inclinometer I-3 at US 287

displacement was observed at the reinforced section 1. However, no sign of failure was observed at the reinforced section.

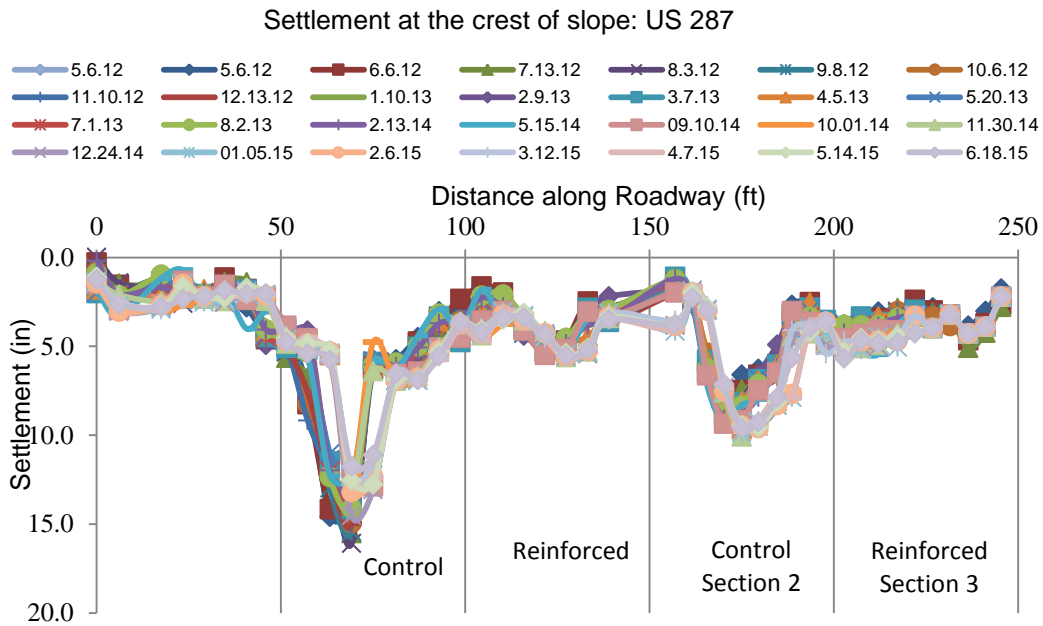
Figure 2-31 Settlement at the crest of the US 287 slope

The total settlement over the crest of the slope was measured during each survey and presented in Figure 2-31. The total settlement plot presented that the control sections of the slope had significant settlement at the crest when compared to the reinforced sections. The maximum settlements were 16 inches and 10 inches in the

Control Section 1 and Control Section 2, respectively. On the other hand, the Reinforced Section 1 had the lowest settlement (3 inches) followed by the Reinforced Section 3 (5 inches) and Reinforced Section 2 (6 inches). It should be noted that the Reinforced Section 1 had the lowest spacing of RPP (3 ft. c/c) at the crest of the slope. Reinforced Section 2 and Reinforced Section 3 had 4 ft. c/c spacing at the crest, which was higher than Reinforced Section 1.

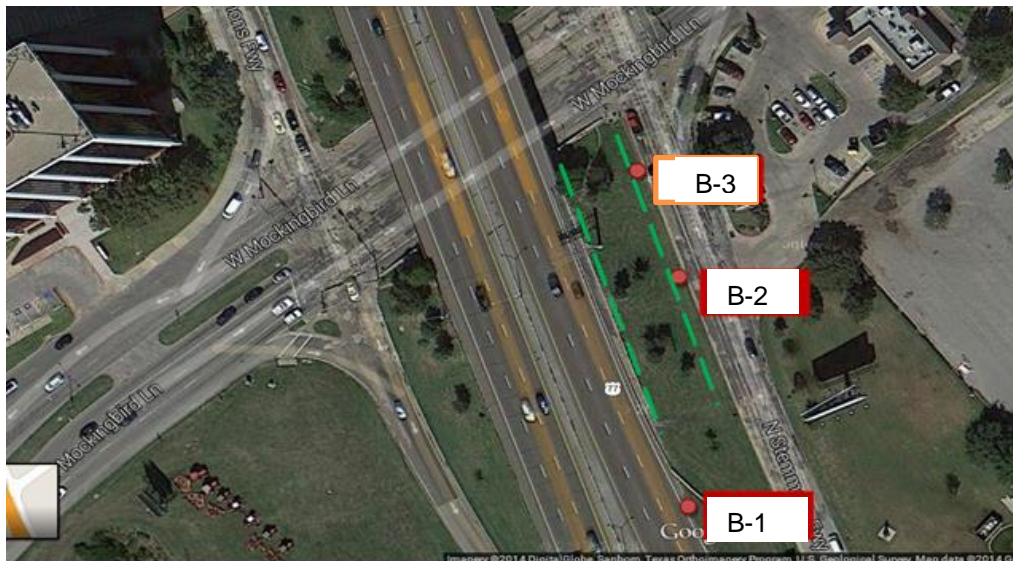
Figure 3-3 Borings and Resistivity Imaging location at I-35

A total of three soil test borings were conducted on February, 2014 in the Mockingbird slope. Borings locations are presented in Figure 3-3. The soil boring BH-1 was located over the crest of the slope. On the other hand, the BH-2 and BH-3 were located near the toe of the slope. The depth of each of the test boring was 30 ft. Both disturbed and undisturbed samples were collected from the borings. The disturbed samples were collected during the time of auger boring. The collected soil samples were tested in the laboratory for use in the design.

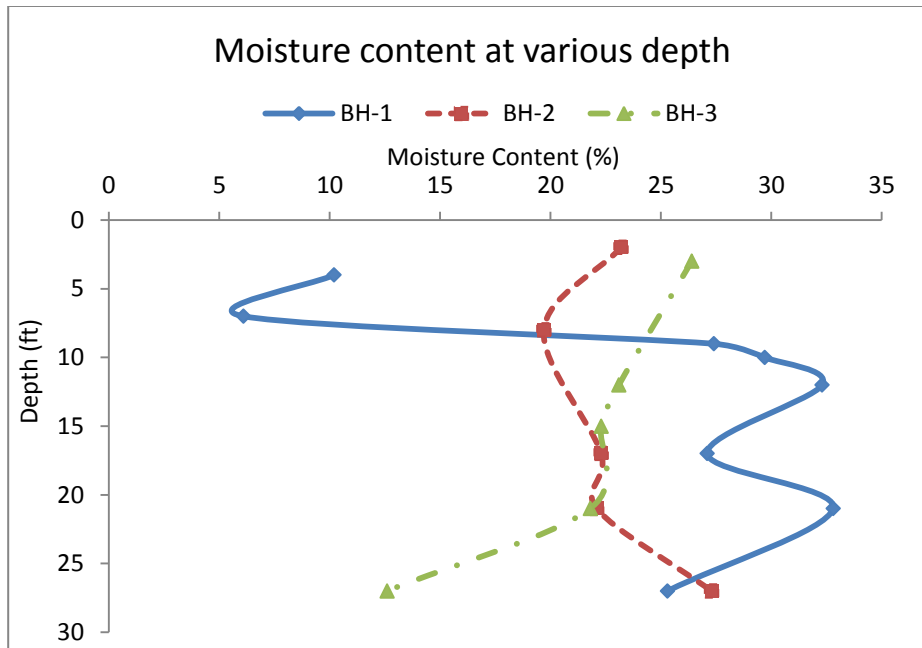
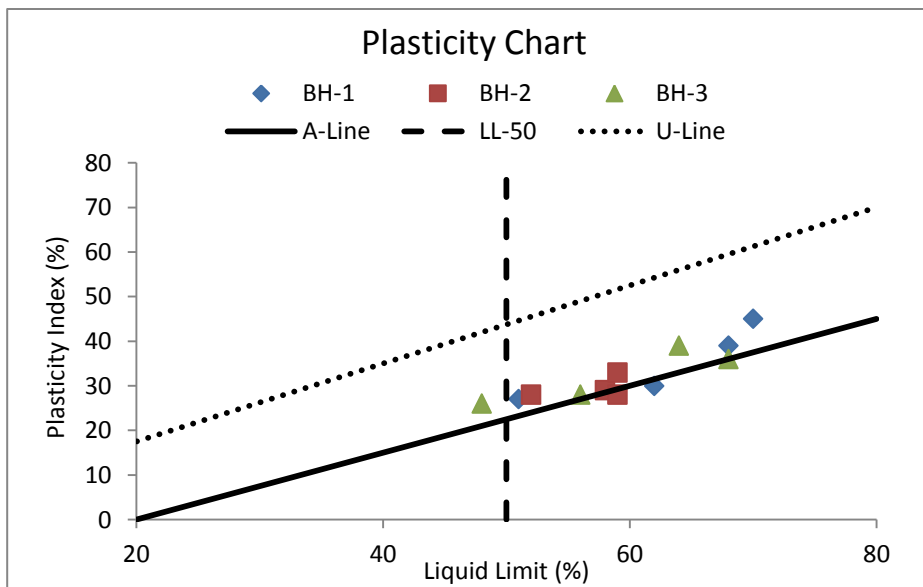
Figure 3-4 Laboratory test results of I-35, (a) Moisture variation along the depth, (b) Plasticity chart of the soil in borings

The soil test borings and laboratory test results are presented in Table 3-1 and also plotted in Figure 3-4. The presence of high moisture zone was observed between 10 and 30 feet based on the laboratory investigation done on samples taken from Boring BH-1. The high moisture zone from BH-1 was in good agreement with the resistivity profile below the failure zone.

The soil boring results presented that the soil type is high plastic clayey soil. Usually, the shear strength of the high plastic clay soil softened within the few years after construction due to the shrinkage and swelling behavior. Moreover, the shrinkage crack acts as a conduit for rain water intrusion and possibly saturates the top of slope. The infiltrated rain water might saturate the top soil and might cause the failure of the slope.

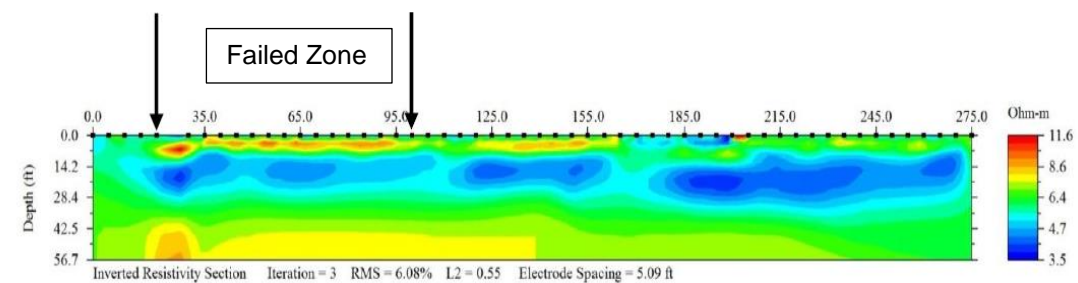
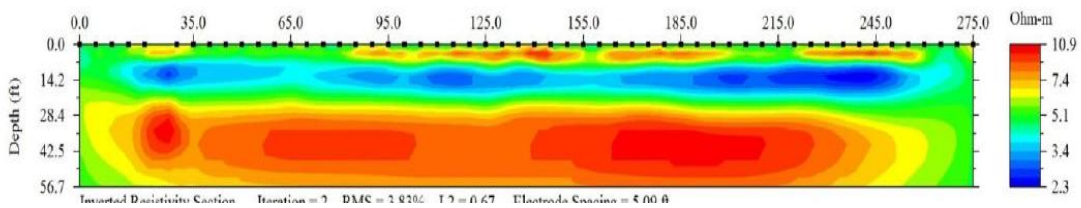
Figure 3-5 Resistivity Imaging results of I-35 slope, (a) RI-1 and (b) RI-2

A total of two 2D resistivity imaging lines were conducted at the site. The 2D imaging sections are identified as RI-1 and RI-2 are presented in Figure 3-5. Resistivity Lines RI-1 and RI-2 were located near the crest of the slope and near the toe of the slope, respectively.

The resistivity profile for RI-1 indicated that there was a high resistivity zone at the surface of the slope at the failure area. The depth of the high resistivity zone was observed as 7 feet. It should be noted that during the surficial soil movement, the failure zone might have become loose and/or disturbed which might have caused the high resistivity zone. Therefore, depth of failure due to the surficial soil movement could be as much as 7 feet. A low resistivity zone was observed immediately below the failure zone. The low resistivity might signify the presence of high moisture zone under the failure area.

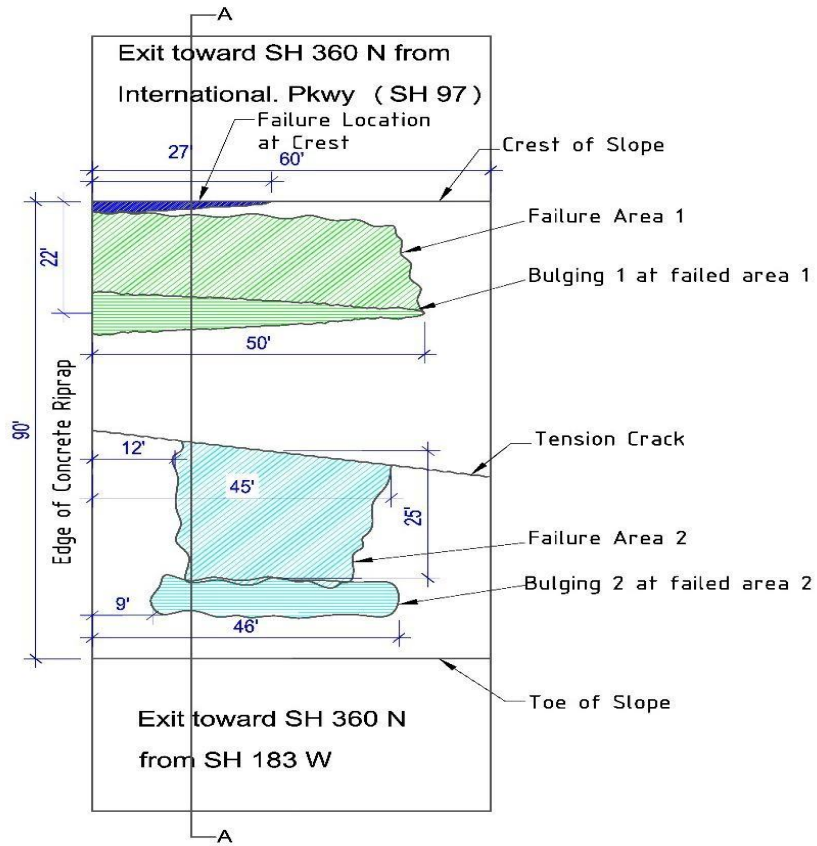
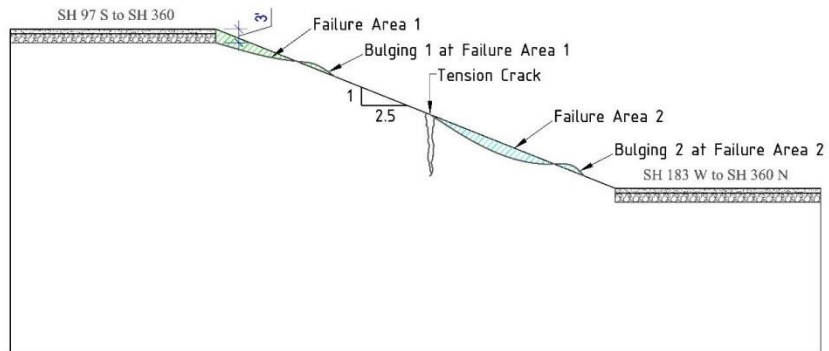
Figure 3-8 Schematic of the failure condition, (a) Front elevation view, (b) Section A-A

The slope is located along SH 183 east of the exit ramp from eastbound SH 183 to northbound SH 360 in the northeast corner of Tarrant County of TxDOT's Fort Worth District as shown in Figure 3-7. Surficial failure and bulging occurred near the crest of the slope. The schematic of the failure condition and failure photos are presented in Figures 3-8 and 3-9, respectively.

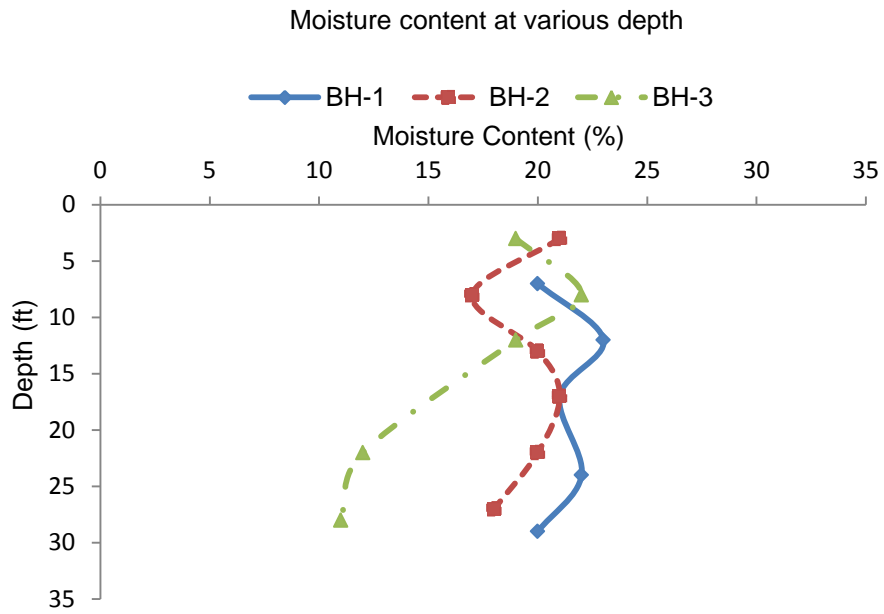
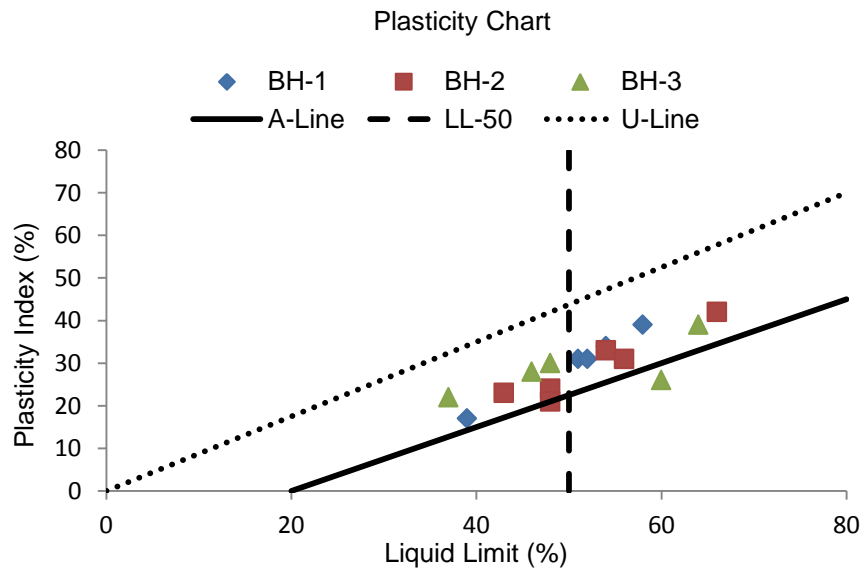
Figure 3-11 Laboratory test results of SH-183, (a) Moisture variation along the depth, (b) Plasticity chart of the soil in borings

The variations of moisture content within the borehole vertical profiles and Plasticity Chart of the Borings are also presented in Figures 3-11(a) and 3-11(b), respectively. It was observed that moisture content of the soil samples collected from Boring BH-1 ranged from 20% to 23% after 5 ft. Moisture content was 17% to 21% for the soil collected from Boring BH-2. During the field visit, shoulder cracks were observed near the crest of the slope which may work as a potential pathway for the intrusion of rainwater. Once the rain water gets in to the slope, it sits there unless it dried up or percolated into the deeper layer. However, the percolation in the clay soil is usually take longer time due to the low permeability.

It should be noted that the high moisture zone below the pavement might take place due to intrusion of rain water through the shoulder crack. However, the low moisture content at the top of the BH-1 might be due to the presence of any possible anomaly in the pavement layer. In Boring BH-3, moisture content was higher at the top 5 ft. (around 20%) and gradually decreased with depth. The high moisture content at the top 5 ft. might indicate the formation of the perched water condition due to the intrusion of rain water and low permeability of the high plastic clay soil.

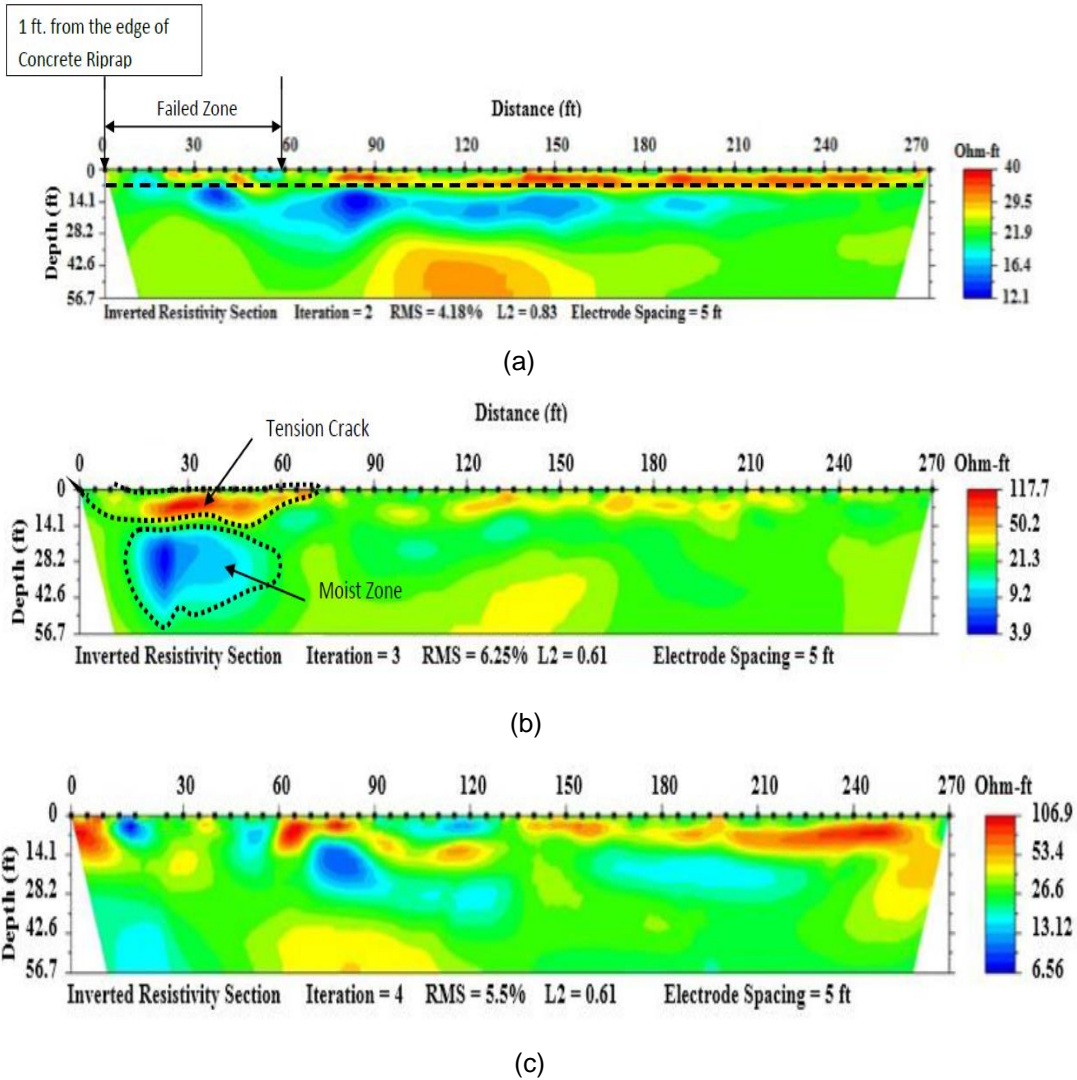
Figure 3-13 Resistivity Imaging profiles of SH 183, (a) RI Line 1, (b) RI Line 2, (c) RI Line 3

Based on the 2D RI profiles, a 7 ft. deep high resistivity zone was observed near the crest of the slope which might occur due to the disturbance during slope failure or the presence of the active zone. It should be noted that the resistivity of the soil depends on the soil type, moisture conditions and void ratio of the soil. Due to slope movement, the soils at the failed zone become loose which may result in higher void ratio and high

resistivity. In contrary, the presence of moisture results in the low resistivity of the soil. As presented in Figure 3-13 a high resistivity zone exist along the tension crack which may indicate the extent of the tension crack and a low resistivity zone that may indicated a moist zone due to the intruded rainwater through the tension crack. Based on Figure 3-13, the extent of the tension crack is up to 10 ft.

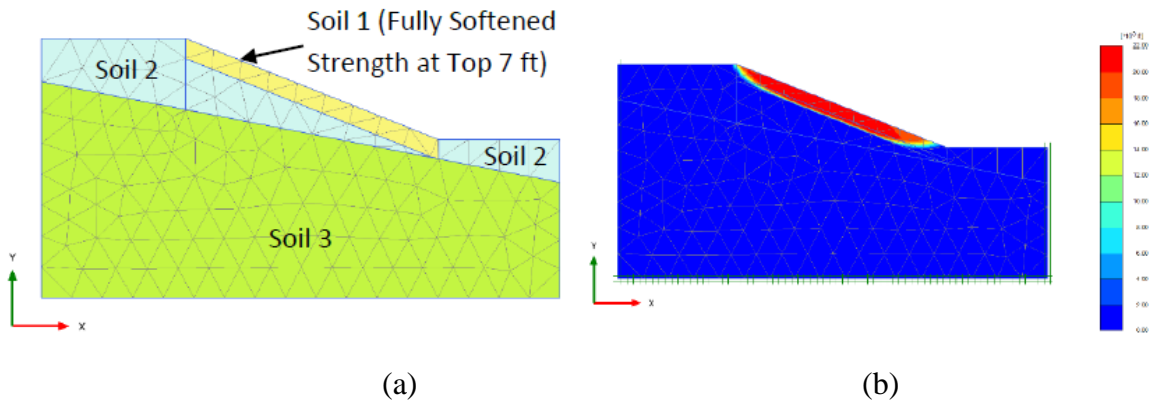
Figure 3-14 Slope stability analysis of SH 183 slope, (a) Soil Model, (b) Fully softened strength at top 7 ft. (FOS 1.463),

Slope stability analyses were performed using the Finite Element Modeling program PLAXIS using Mohr-Coulomb soil model. The general Mohr-Coulomb soil model was used for the stability analyses. Modeling was performed using the fully softened shear strength of the soil for the top 7 feet of soil, as a possible softened zone (disturbance) was observed at a depth of 7 feet during resistivity imaging. To simulate the fully softened layer, a new layer was introduced during the analysis considering the fully softened strength. The fully softened strength was utilized from the shear strength test results considering the wet-dry cycles. Soil strength beyond the failure zone was not reduced for the analysis. The Soil Slope model and soil properties are presented in Figure 3-14 and Table 36, respectively. The Factor of Safety (FS) obtained from the analyses was found to be 1.463.

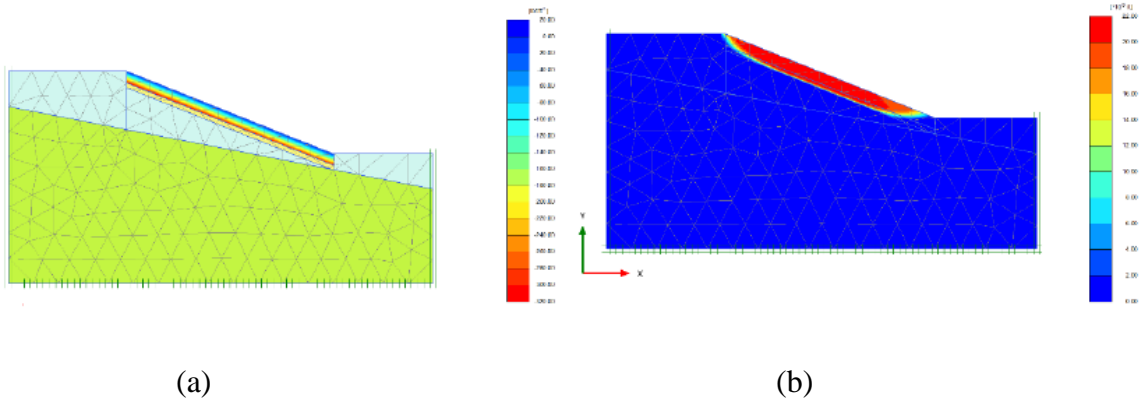
Figure 3-15 Slope stability analysis of SH 183, (a) Soil Model,
(b) Perched water at top 5 ft (FOS 1.098)

The analyses were further continued considering a perched water zone (a fully moistened zone) formation due to rainfall. It is theorized that due to the seasonal wet-dry cycles, the high plastic CH clay contracted and created a path for the intrusion of rain water. The intruded rain water may saturate the top few feet of the soil and sit there may be for few days due to the low permeability of the high plastic clay soil and might form a temporary a perched water zone. During this analysis, the temporary perched water zone (fully moistened zone) was considered at 5 ft. The slope stability analysis result indicated

that the Factor of Safety may be reduced to almost 1.09 at a presence of 5 ft. perched water table from the top of the slope. The outputs from the slope stability analyses are also presented in Figures 3-15(a) and 3-15 (b).

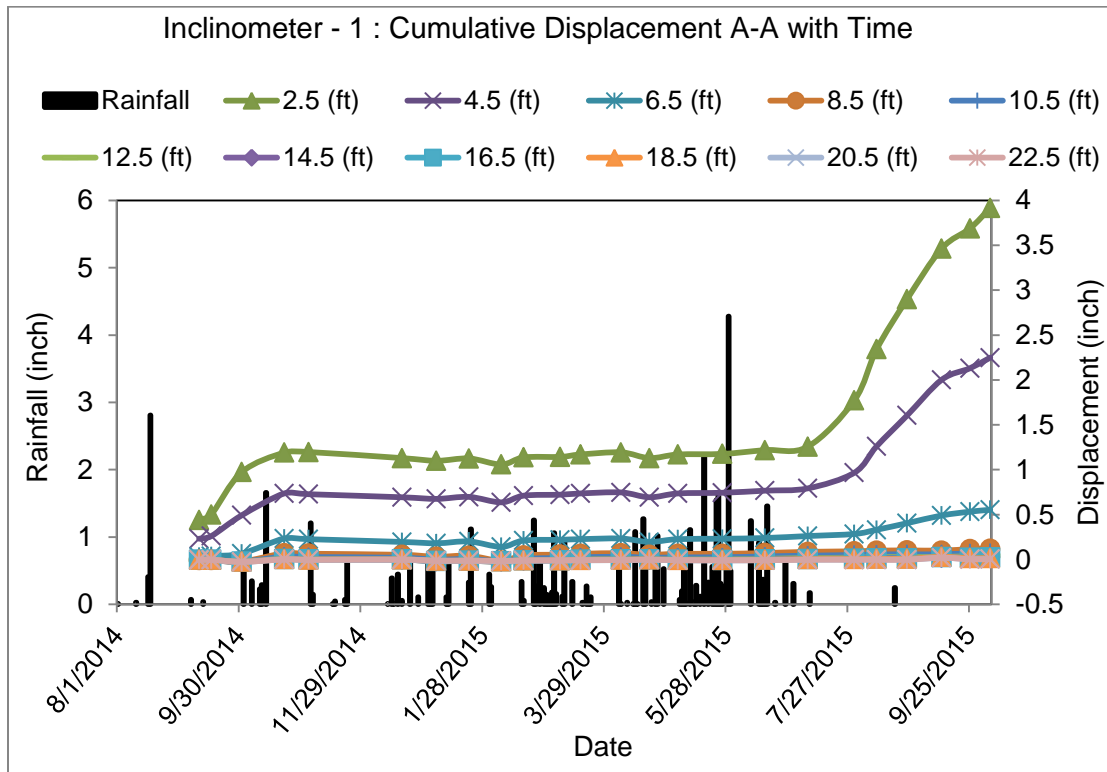
Figure 4-5 Displacement in inclinometer 1 at I-35

In Inclinometer I-1, after the second phase of the instillation during September 2015 at I-35, the movement of the slope is constant at approximately 1.25 inches at upper 2.5 feet. In addition, movement at the deeper depth is also constant, indicating that the movement of the slope has gradually stabilized.

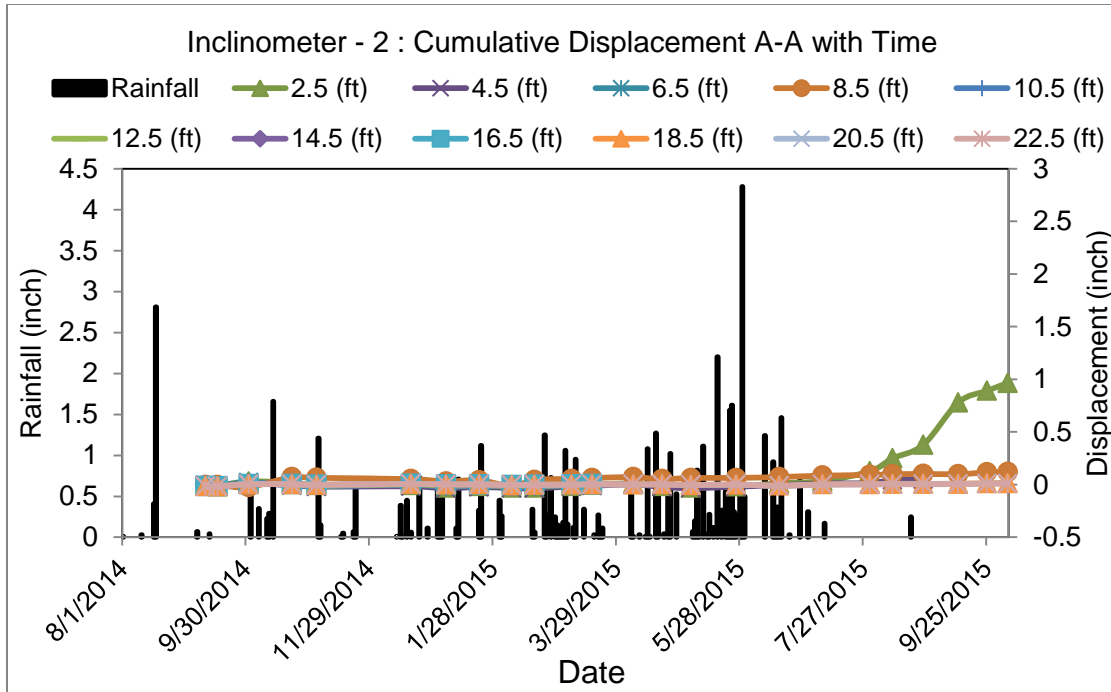
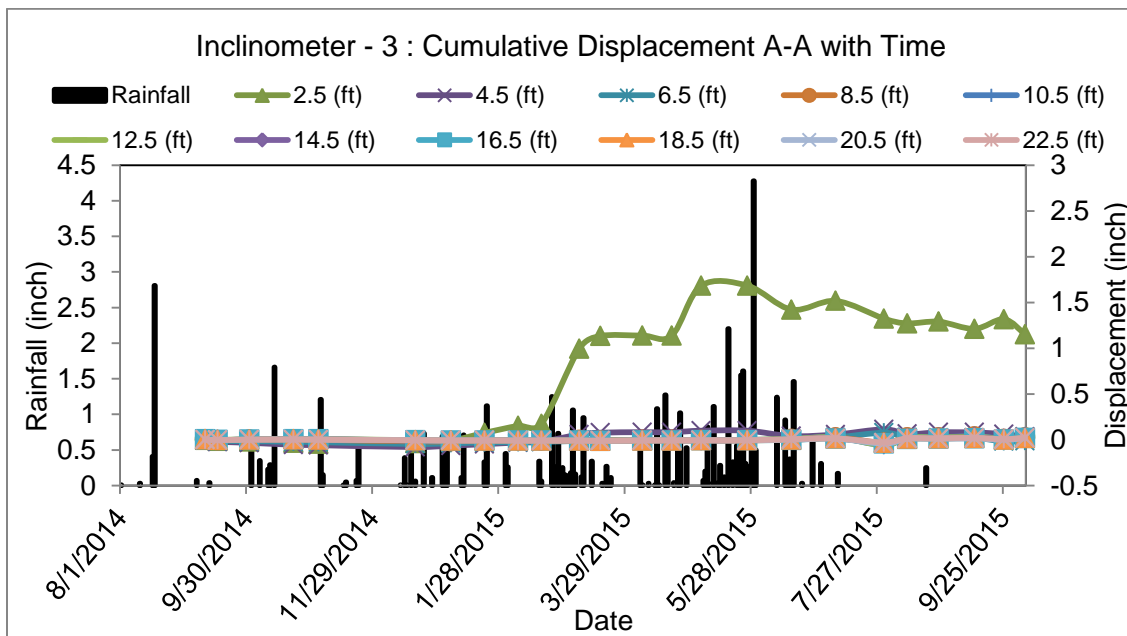
Similarly, movements at Inclinometer I-2 and I-3 are negligible which also indicated that the movement at the slope has stabilized as shown in Figures 4-6 and 4-7.

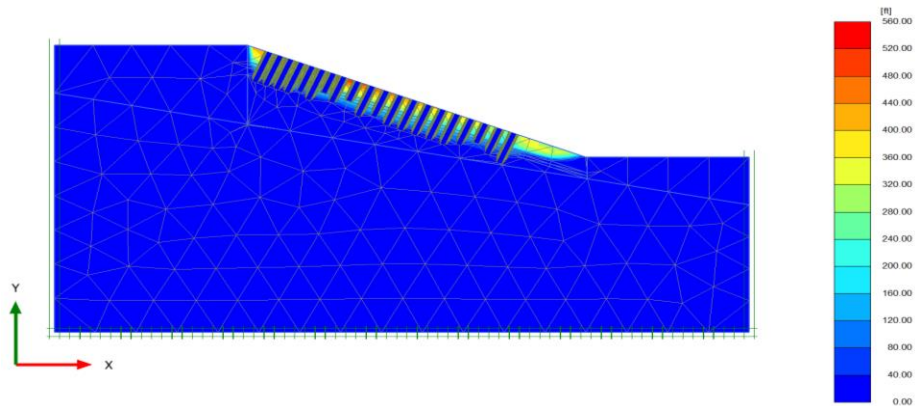
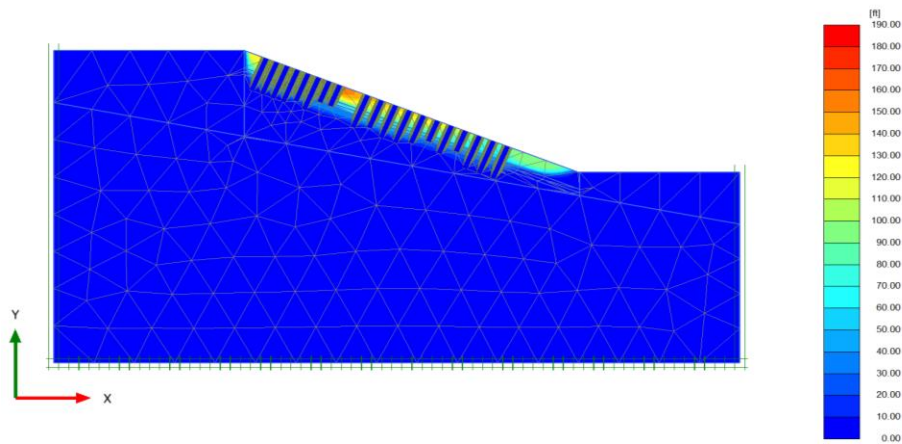
Figure 4-14 As built Slope Stability analysis of (a) Section 1-1 and
(b) Section 2-2

There was some section at the slope where RPP could not be installed due to the previous retaining system present at the slope. The as build layout of the slope is presented in Figure 4-13 and the numerical modeling of the as built section 1-1 and section 2-2 are presented in Figure 4-14(a) and 4-14(b). The as built factor of safety for section 1-1 and section 2-2 were 1.62 and 1.61, respectively

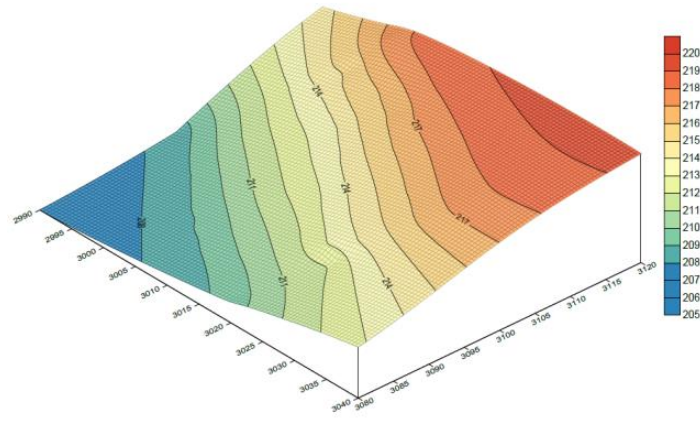
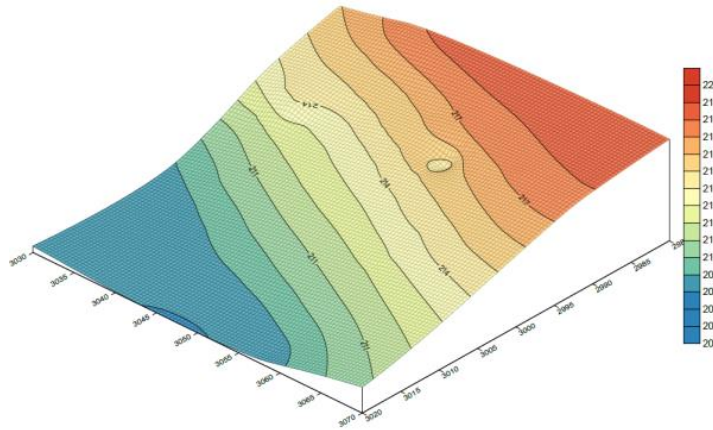
Figure 4-16 Contour Survey at SH-183 Slope, (a) Survey on January 7, 2015, (b) Survey Performed on June 14, 2015

Contour Survey of the SH 183 slope was also performed quarterly basis to monitor the slope movement. Based on the contour survey, there was no substantial movement of the slope. However, there was little dip observed at the area where pins

could not be installed due to the previous retaining structure. In addition, some movements were observed close to the abutment of the bridge which verifies the results of the topographic survey. The contour survey of the SH 183 slope is presented in Figures 4-16(a) and 4-16(b).

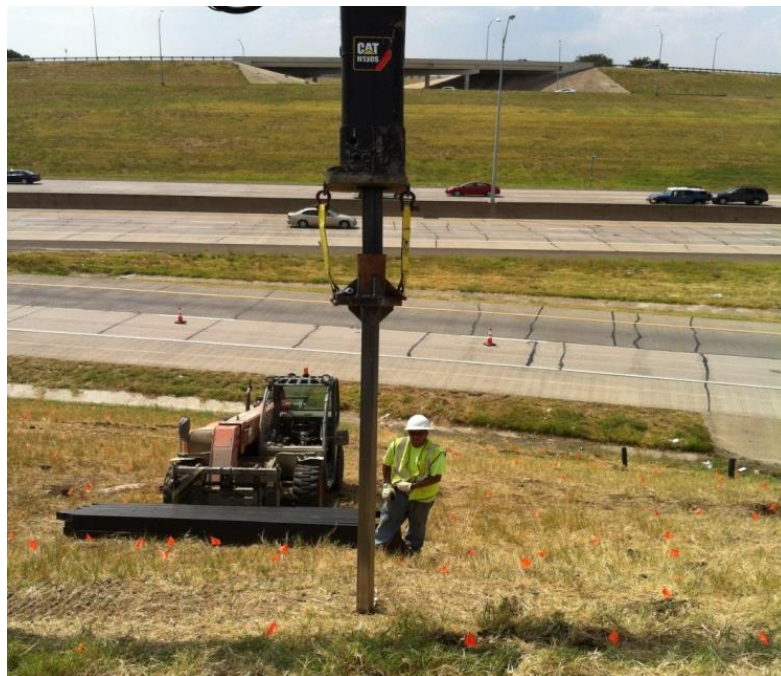
Figure 4-18 Iron nail being hammered into ground

Pin installation was carried out during month of September and October which experienced the drought season in the entire Texas region, followed by the driest summer. Hence, during the time of the pin installation, soil conditions were extremely dry and very stiff to hard in consistency. First couple of attempt of push the RPPs into the ground without any iron nail failed. So, attempts were made to hammer the iron nail that

Initially few plastic pins were hammered into the ground at the toe of the slope without using the iron nail. However, this method ended soon as pins broke off due the high resistance from the stiff soil. So, the iron nail with cross-section size of the RPP was constructed to hammer into the ground up to the depth of 8 feet and then drive the RPP in the same hole. Using this method, the process of installing the pins was efficient and fewer pins were damaged while driving the pins.
