INTERLAMINAR FRACTURE OF UNIDIRECTIONAL REINFORCED
COMPOSITES WITH TOUGHENED RESIN SYSTEMS

Presented to the Faculty of the Graduate School of
The University of Texas at Arlington in Partial Fulfillment
of the Requirements
for the Degree of
MASTER OF SCIENCE IN MATERIALS SCIENCE AND ENGINEERING

THE UNIVERSITY OF TEXAS AT ARLINGTON

May 2007

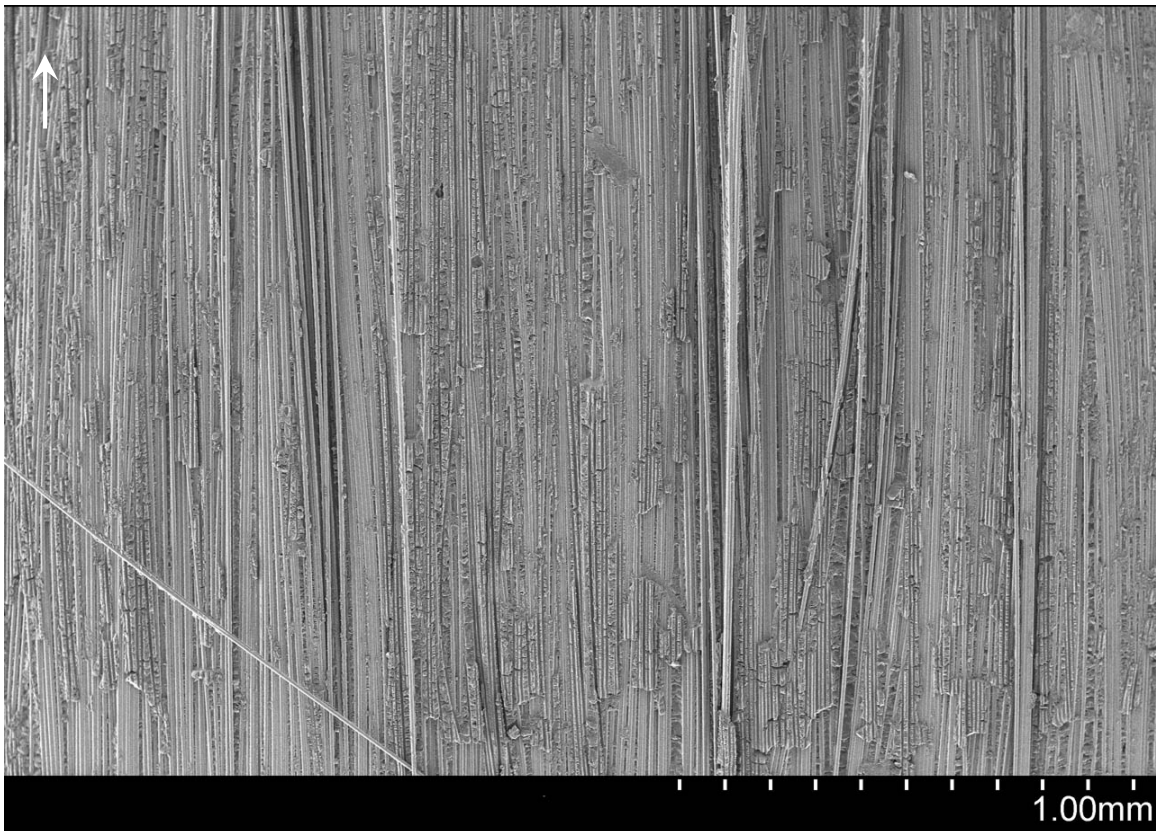
Figure 3.35: Overall view of Material B tested under Mode II loading revealing a small amount of fiber bridging, but a relatively smooth fracture surface (arrow indicates crack direction).

A small amount of fiber bridging was found on the fracture surface, which is due to the roving fiber form, otherwise the surface was relatively flat at lower magnifications. Just like the Mode I specimens, tiny pores from volatiles during panel fabrication were found in the middle of scallops, which would not be the primary location for microcrack nucleation. Viewing the flat surfaces of hackles would only confirm if the microcrack was initiated from a void, but would be very difficult to observe. Very little resin/fiber adhesion was apparent, but micro resin flow and river patterns on the hackles and scallops could be seen. In some areas, compact microcracks or undeveloped hackles were noted within unorganized fracture features.
